# Hazardous Building Materials Assessment

## Dulwich Hill Library

12-14 Seaview Street,  
Dulwich Hill NSW 2203

Inner West Council  
April 2018

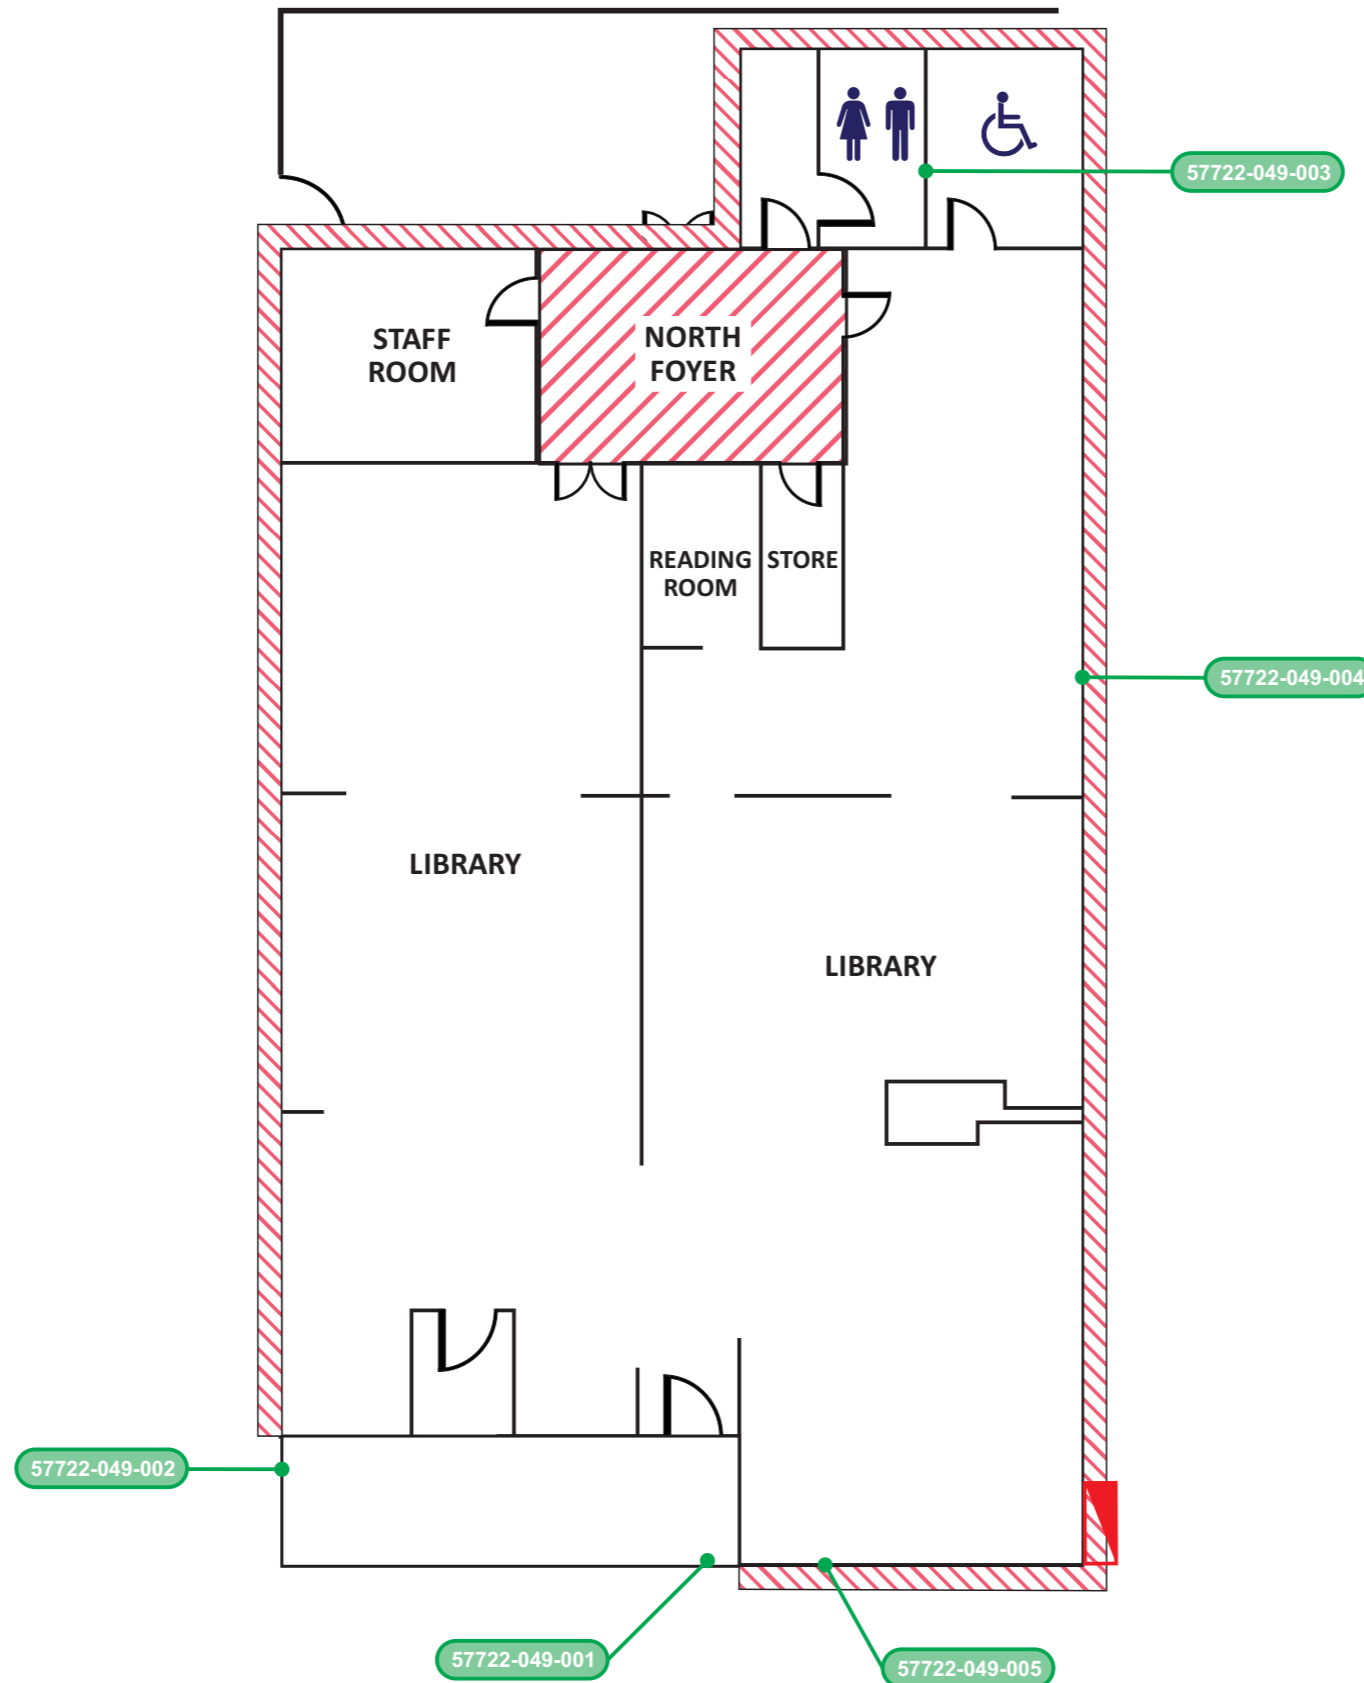
# Dulwich Hill Library - Ground Level

*Only asbestos-containing materials (ACM) have been labelled on the attached site plan to prevent confusion and ensure that these materials are given priority for action. Therefore, other hazardous materials may be present within the building and the register attached in **Section 1** should be consulted prior to work commencing.*
