# Hazardous Building Materials Assessment Dulwich Hill Language School 12A Seaview Street, Dulwich Hill NSW 2203

Inner West Council  
April 2018

Job No.: 57722-050

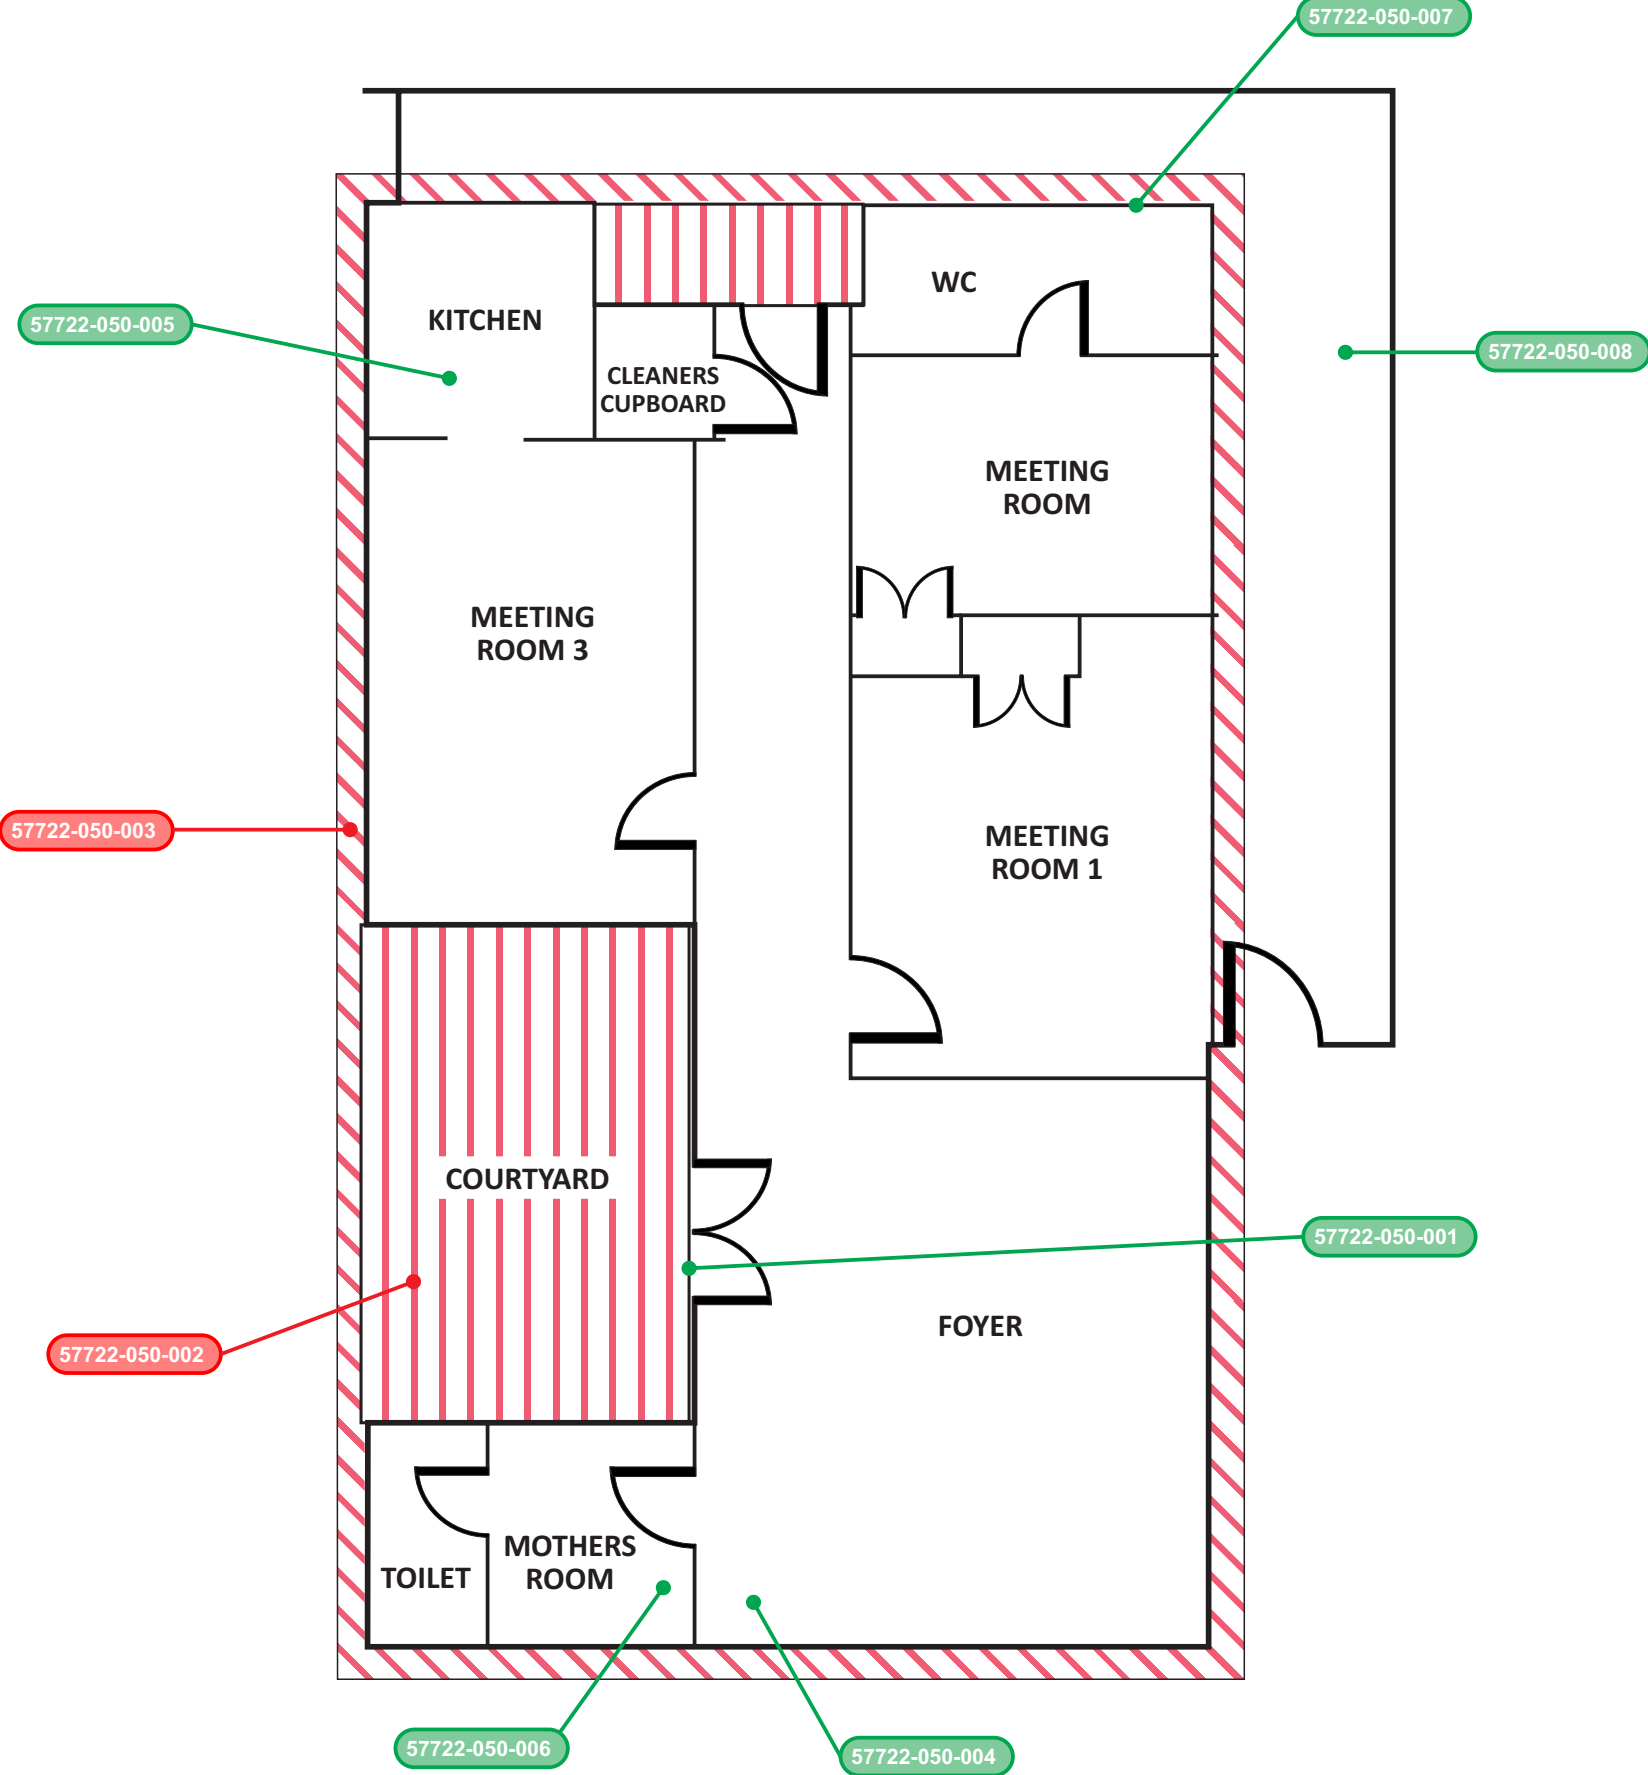
# Dulwich Hill Language School - Ground Level

*Only asbestos-containing materials (ACM) have been labelled on the attached site plan to prevent confusion and ensure that these materials are given priority for action. Therefore, other hazardous materials may be present within the building and the register attached in **Section 1** should be consulted prior to work commencing.*
