Hazardous Building Materials Assessment Arlington Recreational Reserve - Grandstand Williams Parade Dulwich Hill NSW 2203

Inner West Council
April 2018

Job No.: 57722-042

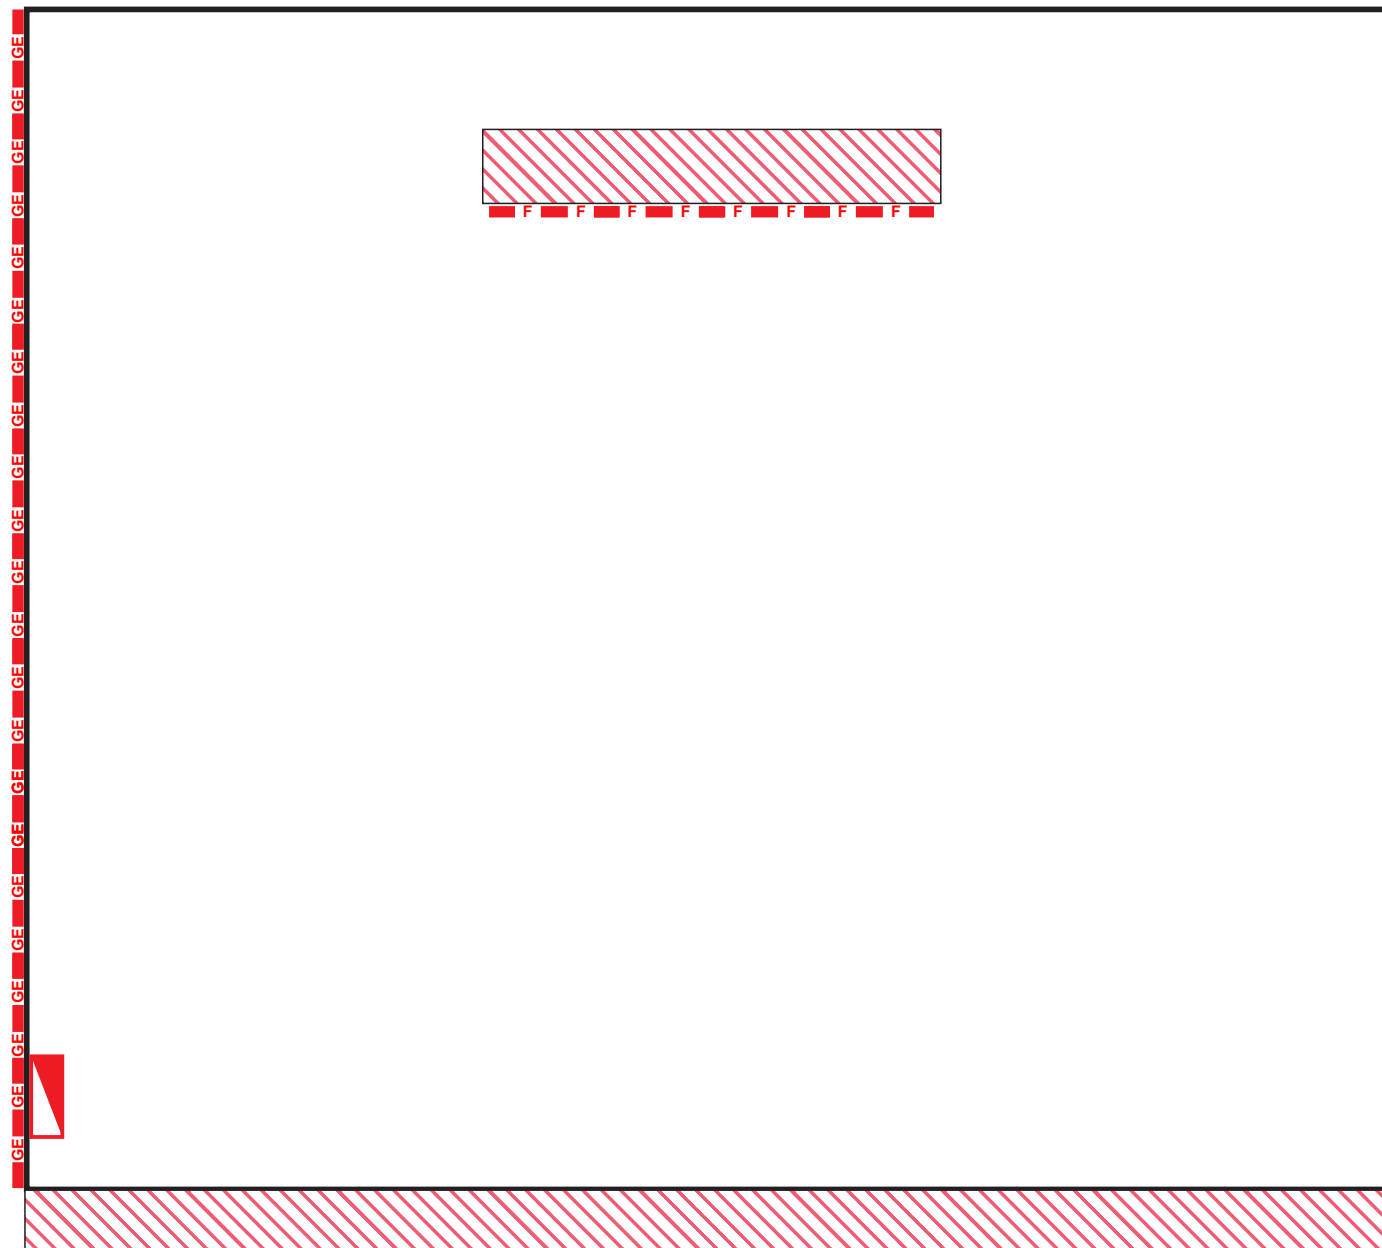
Drawn by: TME	Date: 19/02/2018
Checked by: MM	Date: 19/02/2018
Figure number: 1	Revision: 2
File name: 57722-042 - Rev 2

*Only asbestos-containing materials (ACM) have been labelled on the attached site plan to prevent confusion and ensure that these materials are given priority for action. Therefore, other hazardous materials may be present within the building and the register attached in **Section 1** should be consulted prior to work commencing.*
