Hazardous Building Materials Assessment

Enmore Children Centre

303-305 Enmore road,
Enmore NSW 2042

Inner West Council
April 2018

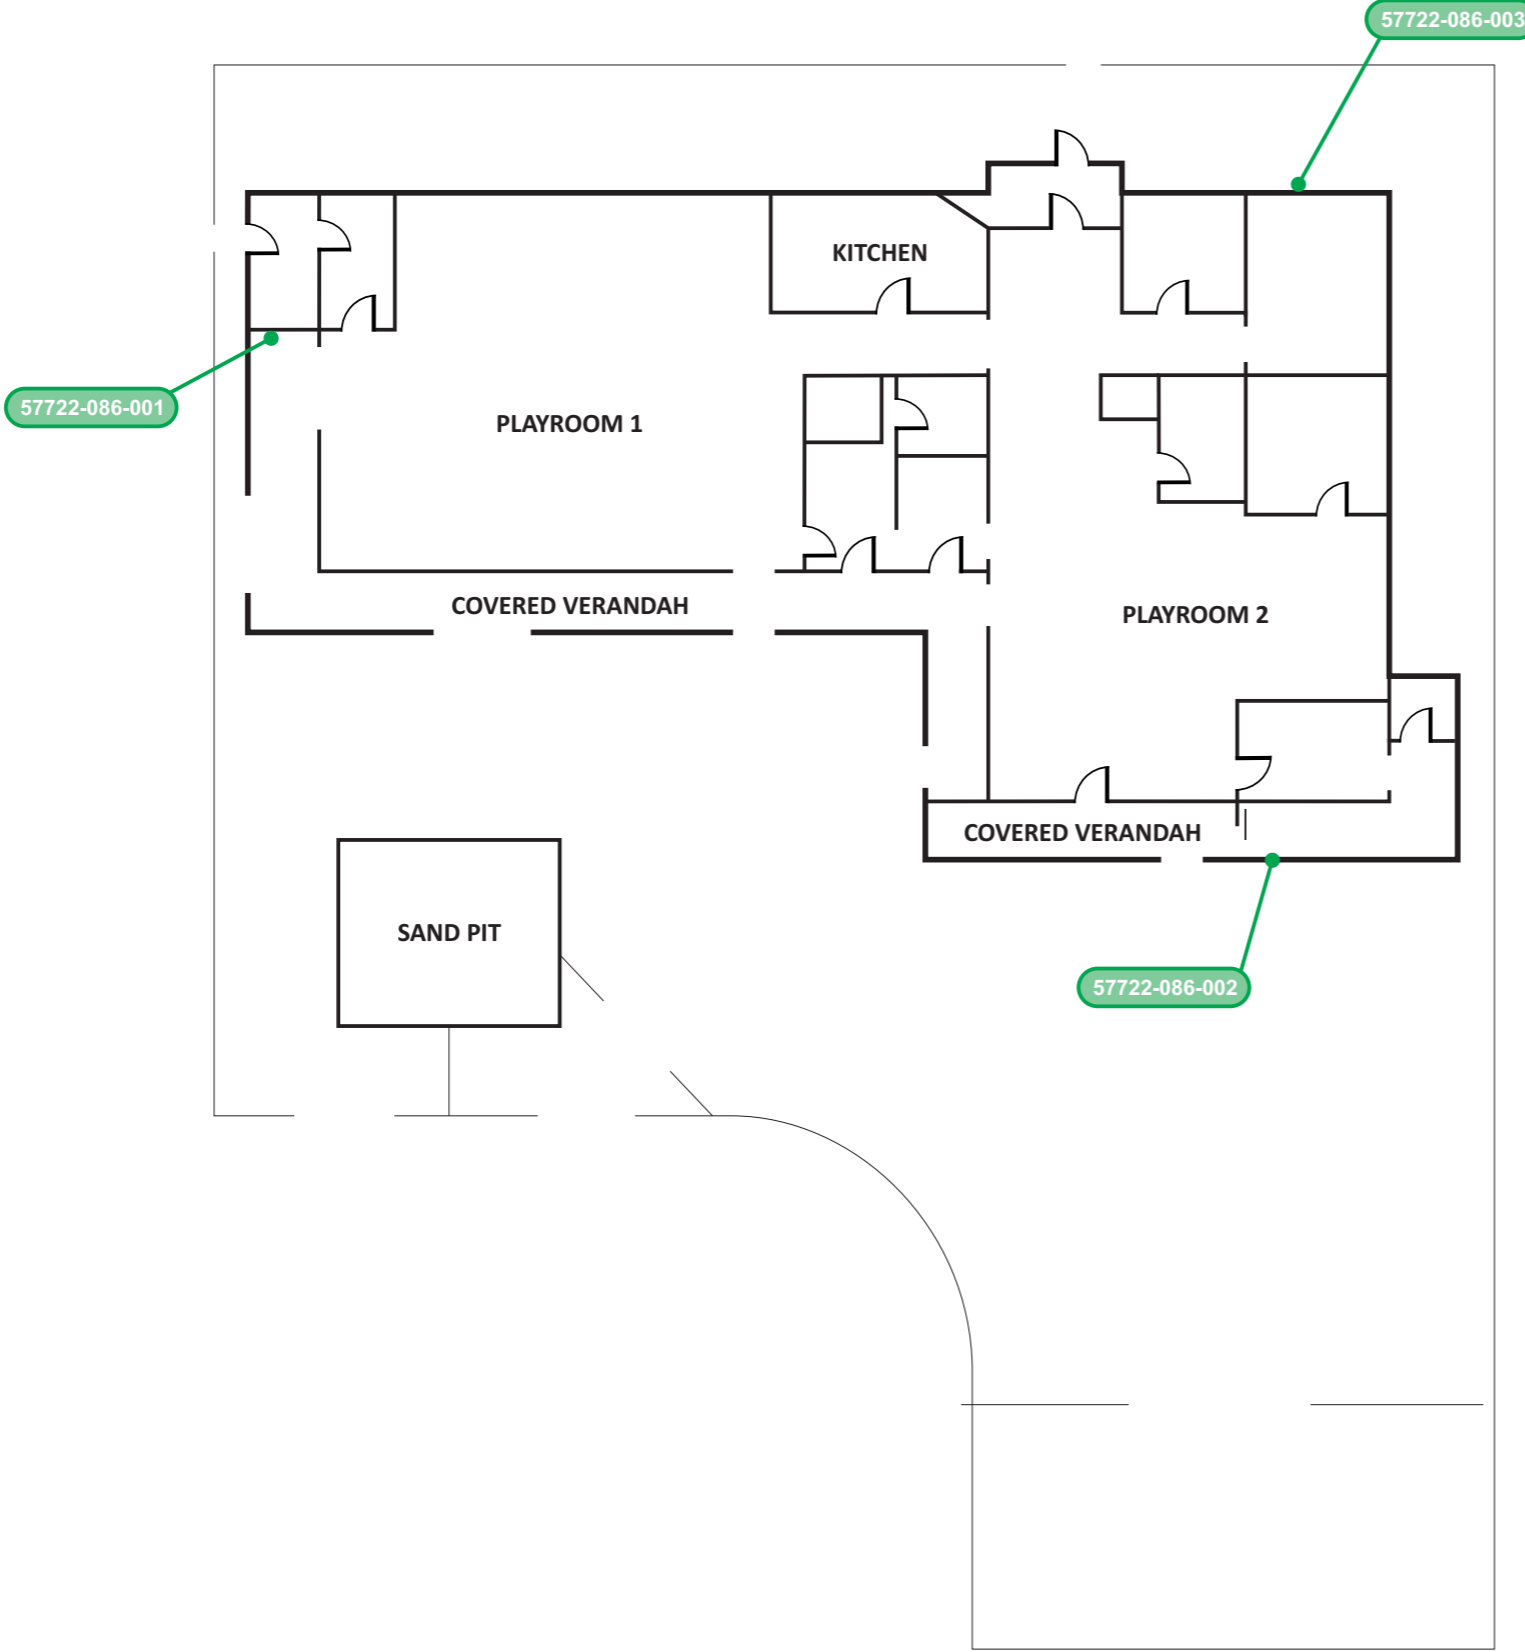
Client:	Inner West Council
Project:	Hazardous Building Materials Assessment
Address:	303 - 305 Enmore Rd, Enmore NSW
Drawing Title:	Enmore Early Learning Centre
Job No.:	57722-086
Client No.:	S0149
IWC Code:

*Only asbestos-containing materials (ACM) have been labelled on the attached site plan to prevent confusion and ensure that these materials are given priority for action. Therefore, other hazardous materials may be present within the building and the register attached in **Section 1** should be consulted prior to work commencing.*
