# Hazardous Building Materials Assessment Hawthorne Canal Reserve Café Bones 1 Canal Road, Leichhardt NSW 2040

Inner West Council  
April 2018

Count ID: CID: 160

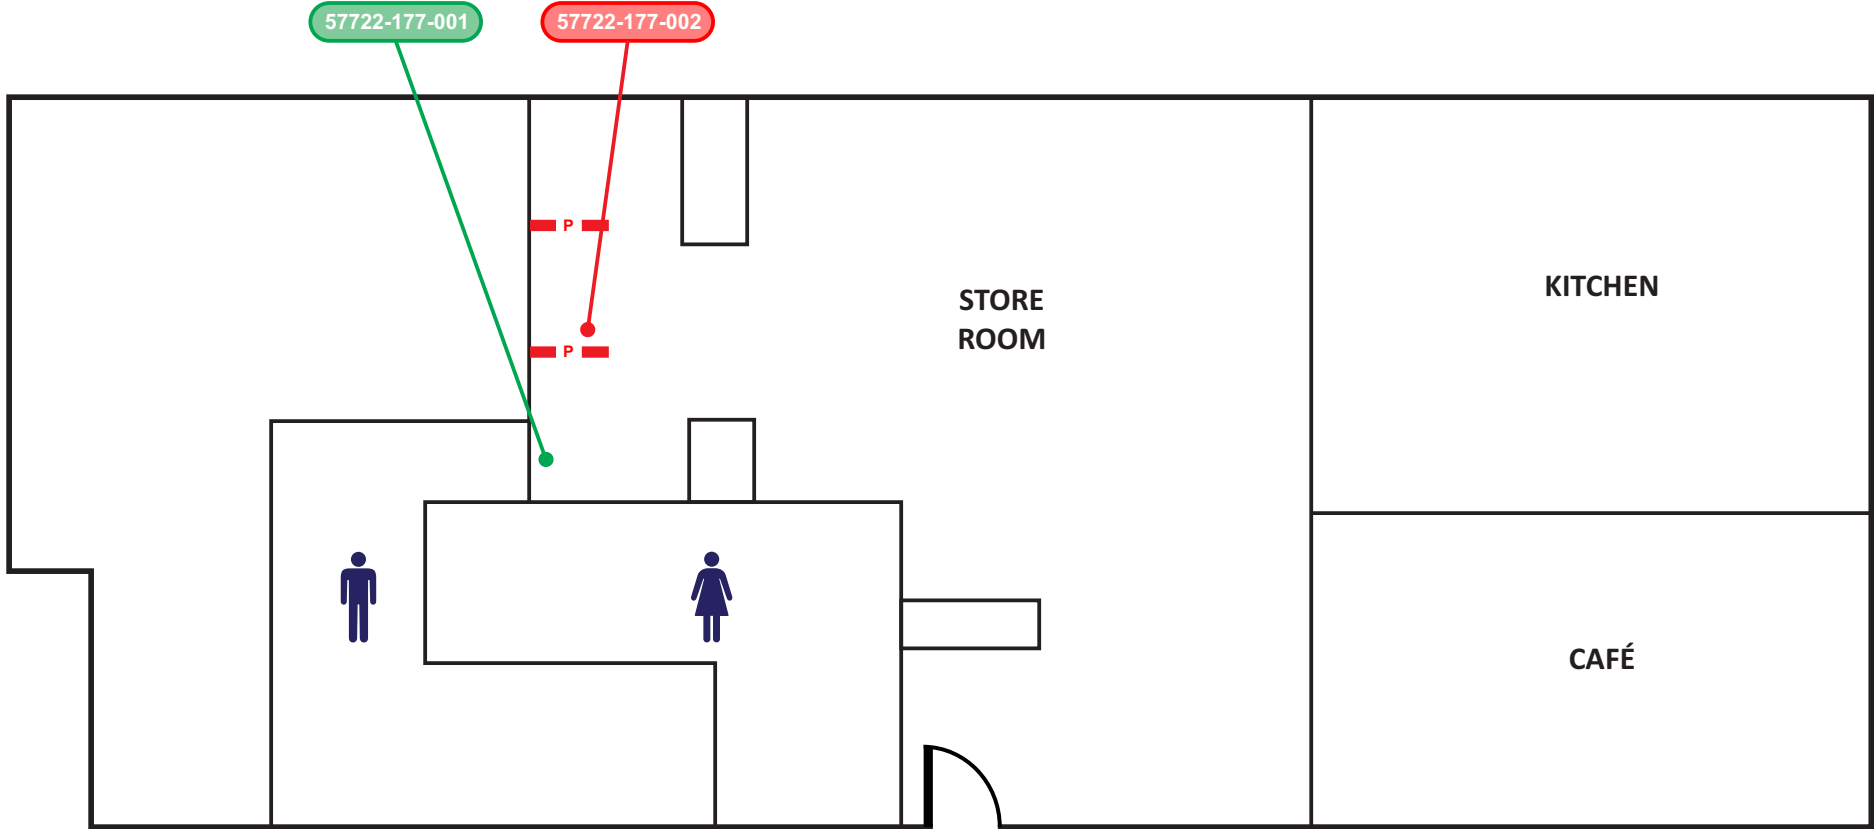
Drawn by: TME	Date: 07/05/2018
Checked by: MM	Date: 07/05/2018
Figure number: 1	Revision: 3
File name: 57722-177 - Rev 3

*Only asbestos-containing materials (ACM) have been labelled on the attached site plan to prevent confusion and ensure that these materials are given priority for action. Therefore, other hazardous materials may be present within the building and the register attached in **Section 1** should be consulted prior to work commencing.*
