Hazardous Building Materials Assessment Blackmore Park – Amenities A Canal Road, Leichhardt NSW 2040

Inner West Council
April 2018

Job No.: 57722-179

Count ID: CID: 73

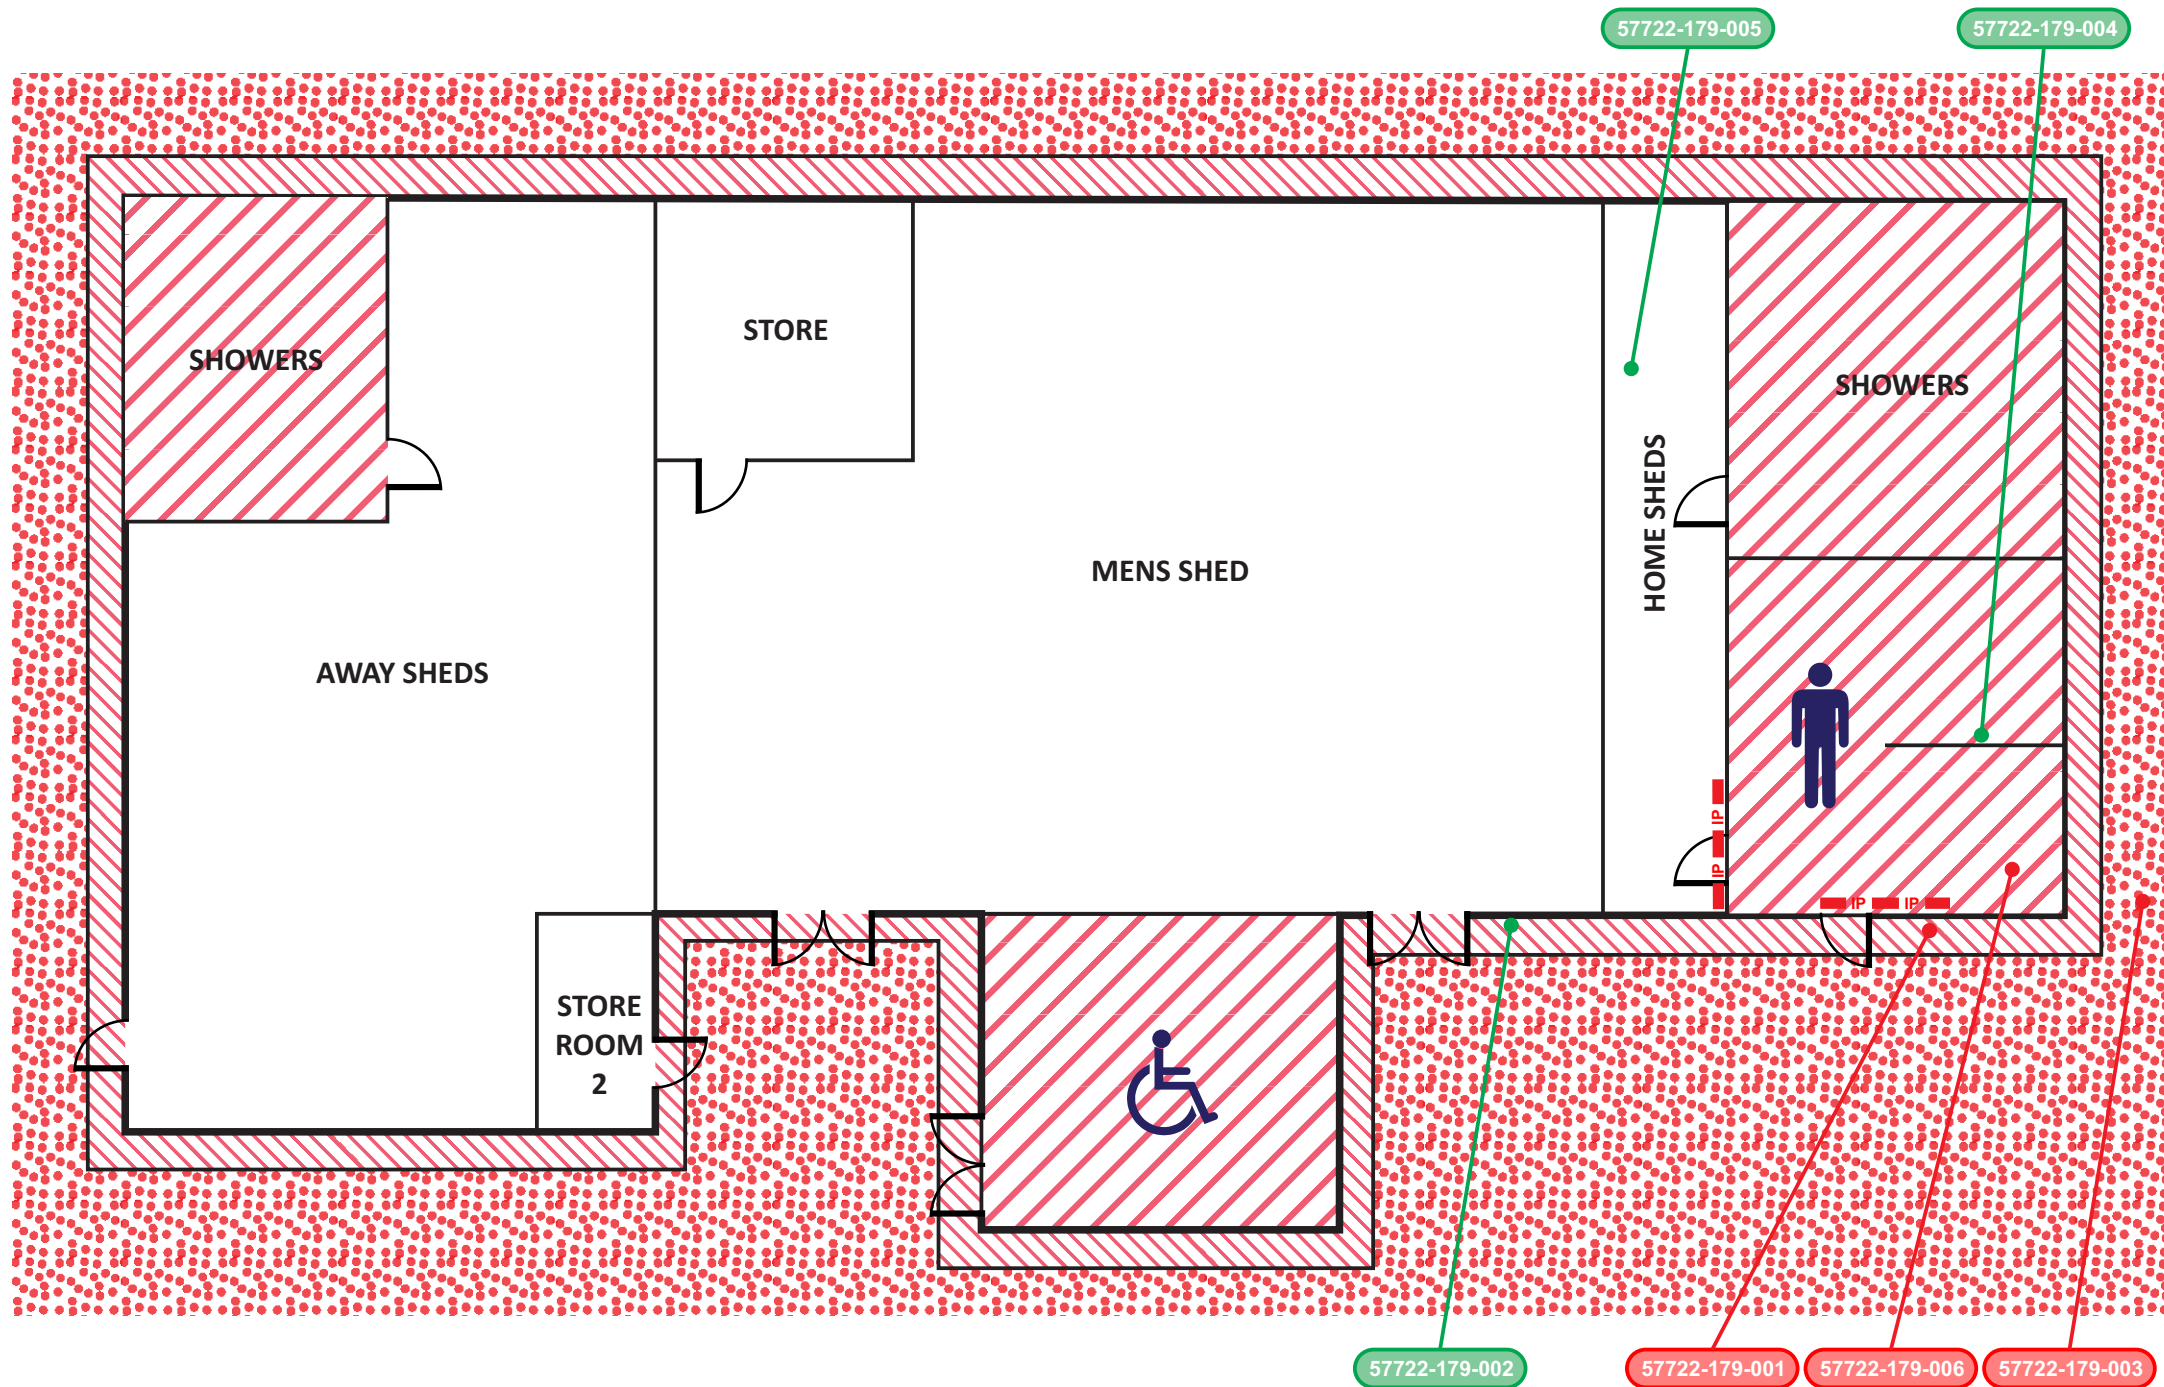
Blackmore Park Amenities Block A, Leichhardt - Ground Level

*Only asbestos-containing materials (ACM) have been labelled on the attached site plan to prevent confusion and ensure that these materials are given priority for action. Therefore, other hazardous materials may be present within the building and the register attached in **Section 1** should be consulted prior to work commencing.*
