# Hazardous Building Materials Assessment Blackmore Park – Caretakers Cottage Canal Road, Leichhardt NSW 2040

Inner West Council  
April 2018

Job No.: 57722-176

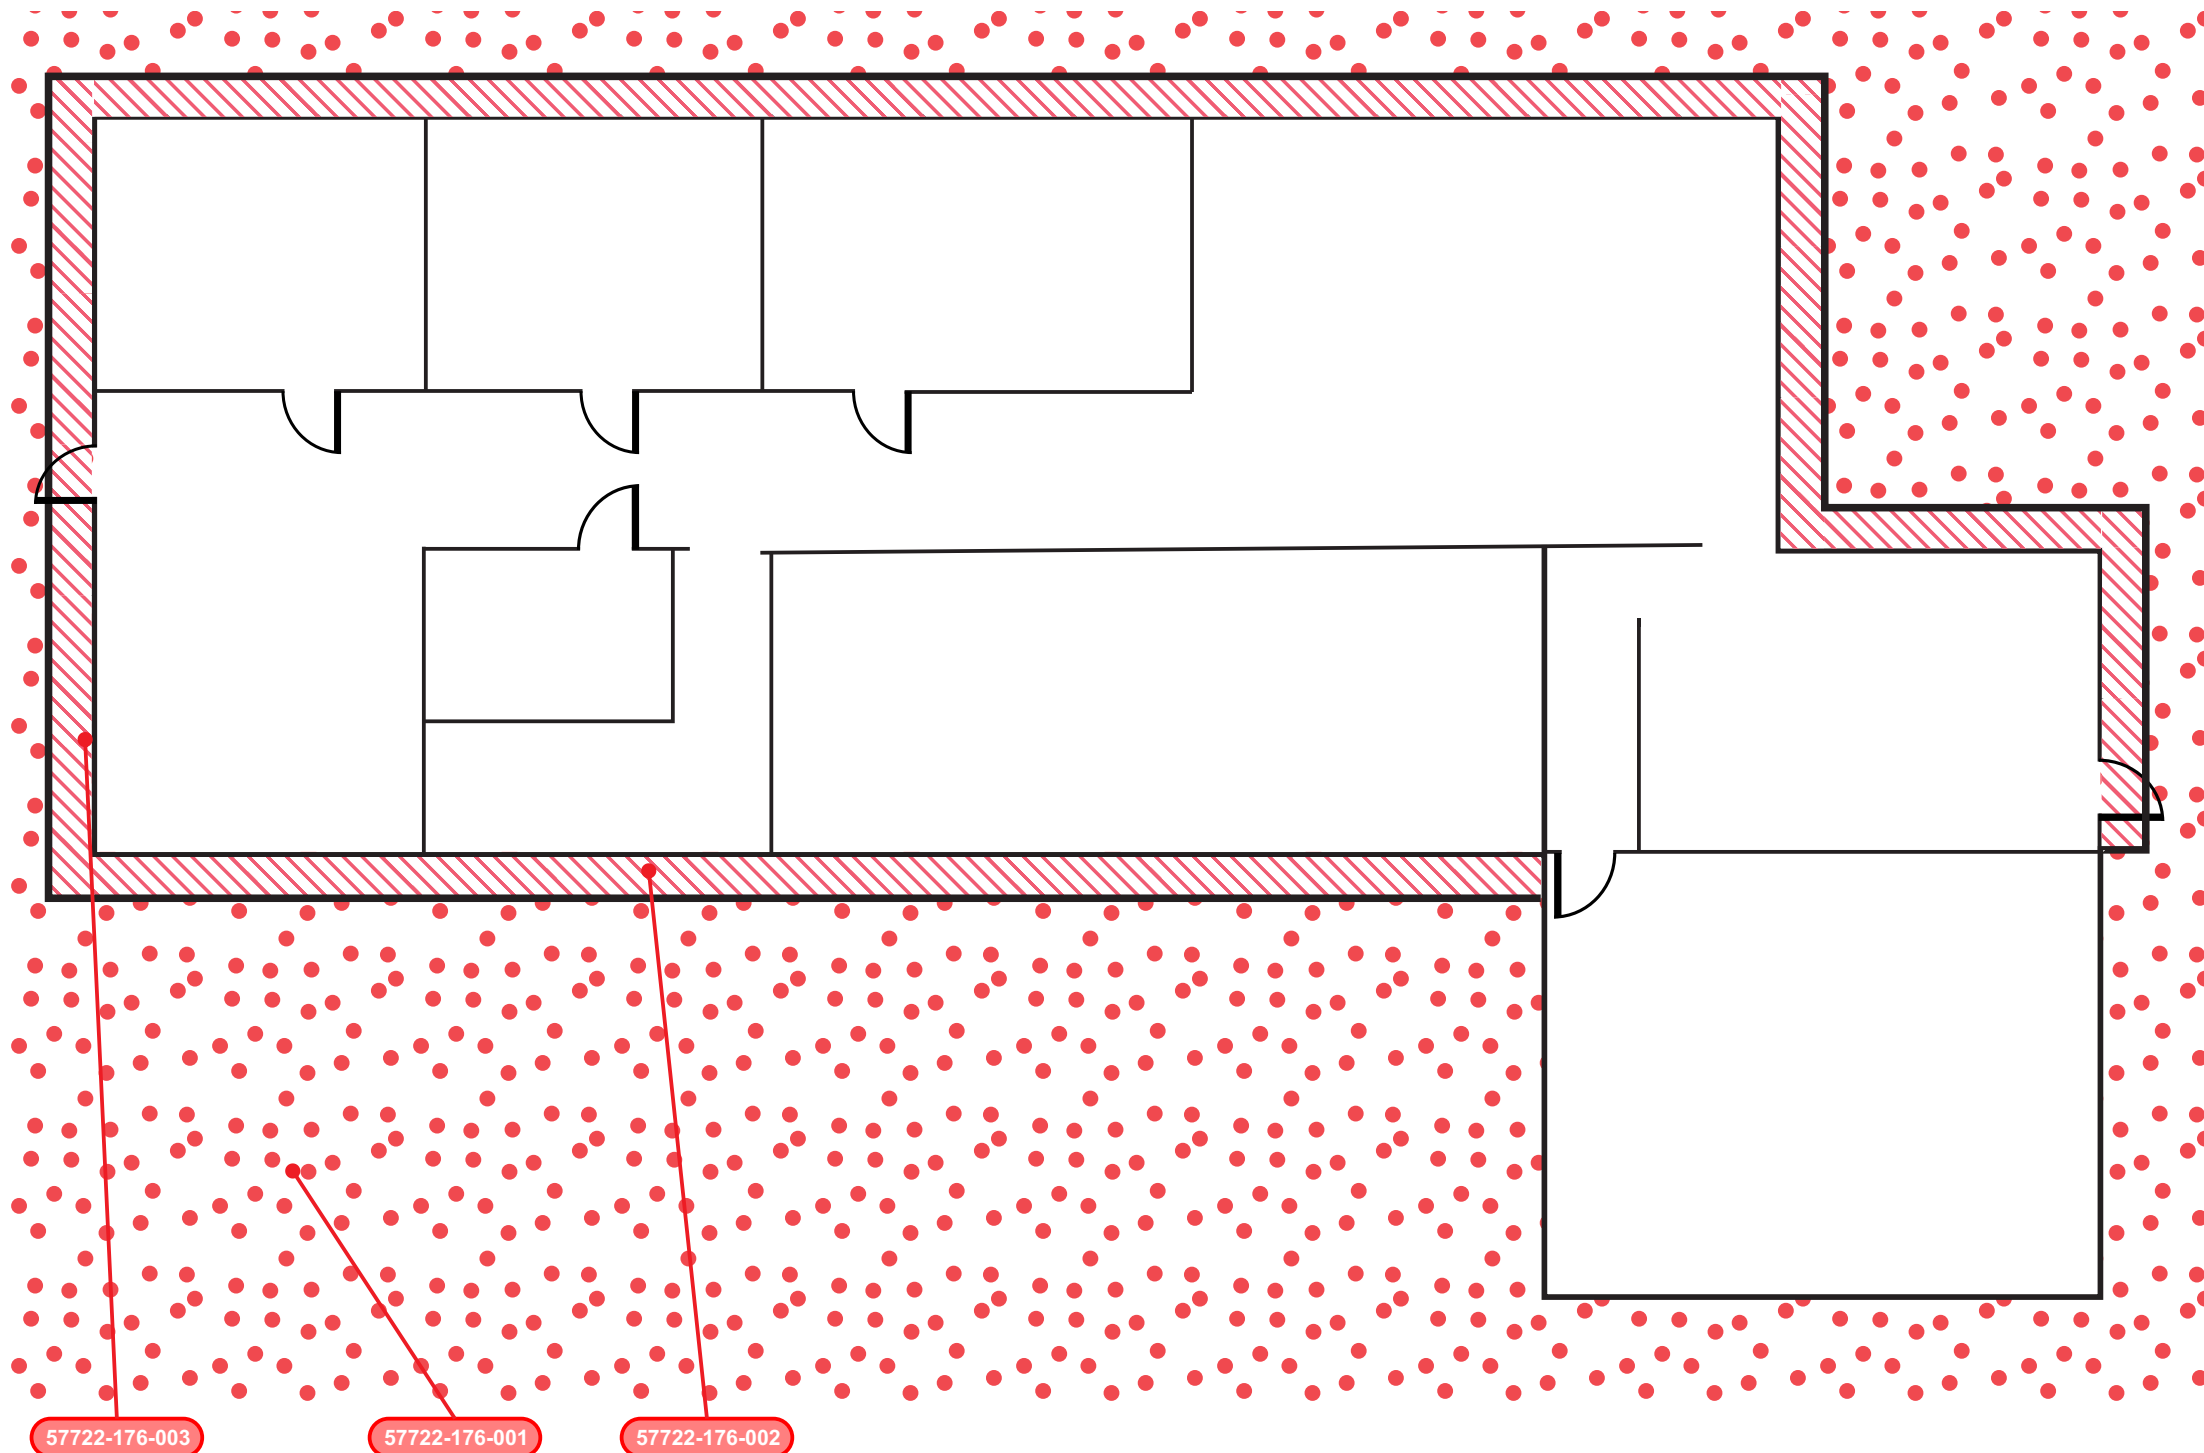
Figure number: 1  
Revision: 2

*Only asbestos-containing materials (ACM) have been labelled on the attached site plan to prevent confusion and ensure that these materials are given priority for action. Therefore, other hazardous materials may be present within the building and the register attached in **Section 1** should be consulted prior to work commencing.*
