Hazardous Building Materials Assessment

Leichhardt Depot – Shed

229 Catherine Street
Leichhardt NSW 2040

Inner West Council
April 2018

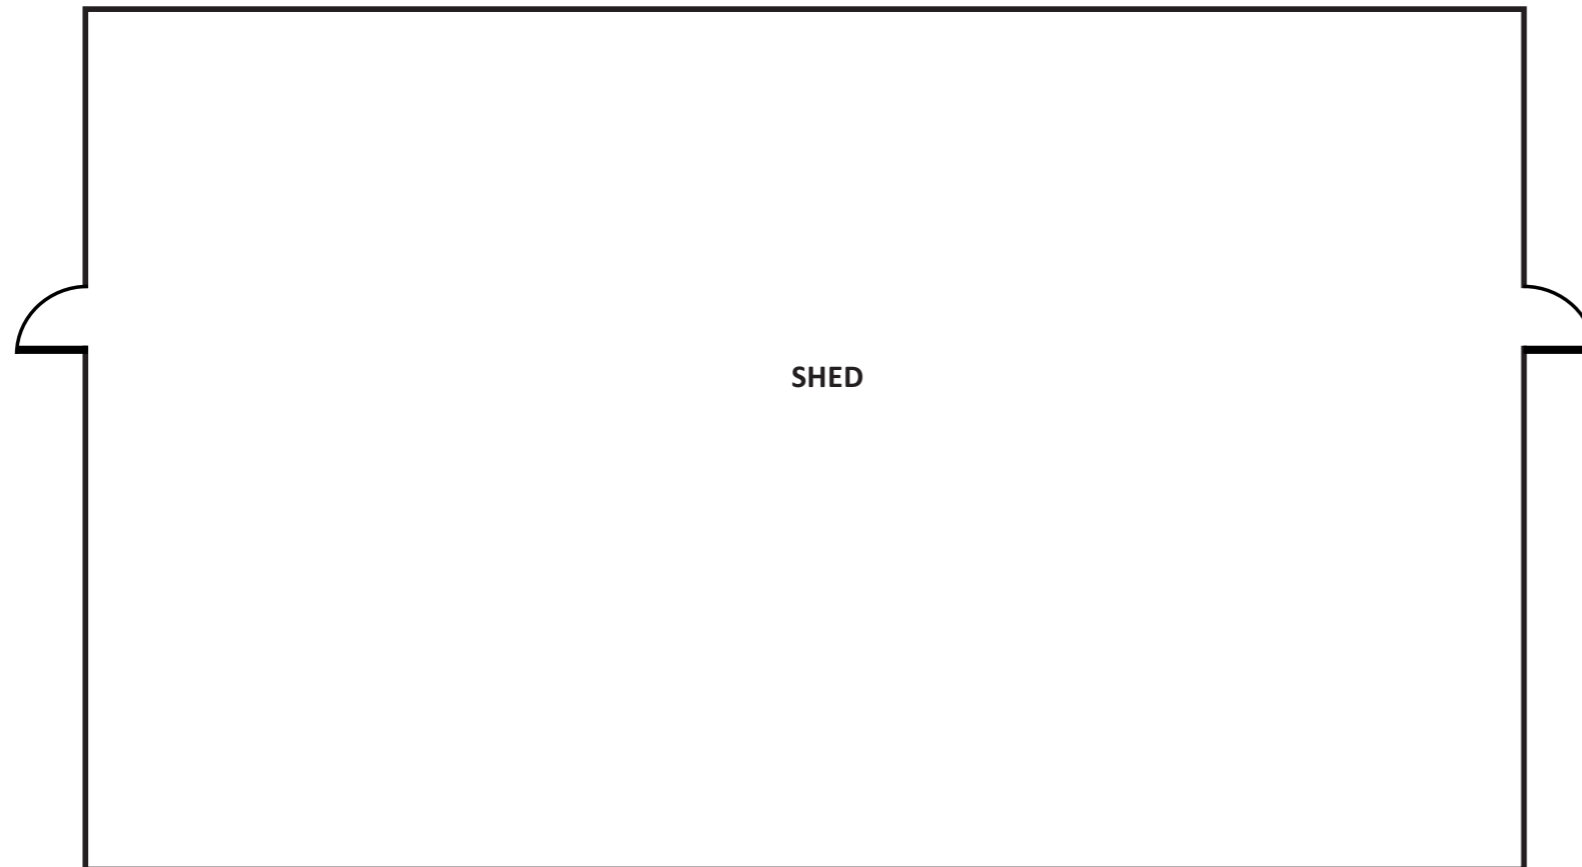
Leichhardt Depot Shed Ground Level

*Only asbestos-containing materials (ACM) have been labelled on the attached site plan to prevent confusion and ensure that these materials are given priority for action. Therefore, other hazardous materials may be present within the building and the register attached in **Section 1** should be consulted prior to work commencing.*
