Hazardous Building Materials Assessment War Memorial Park - Toilet Block Catherine Street, Leichhardt NSW 2040

Inner West Council
April 2018

Job No.: 57722-093

Count ID: CID: 382

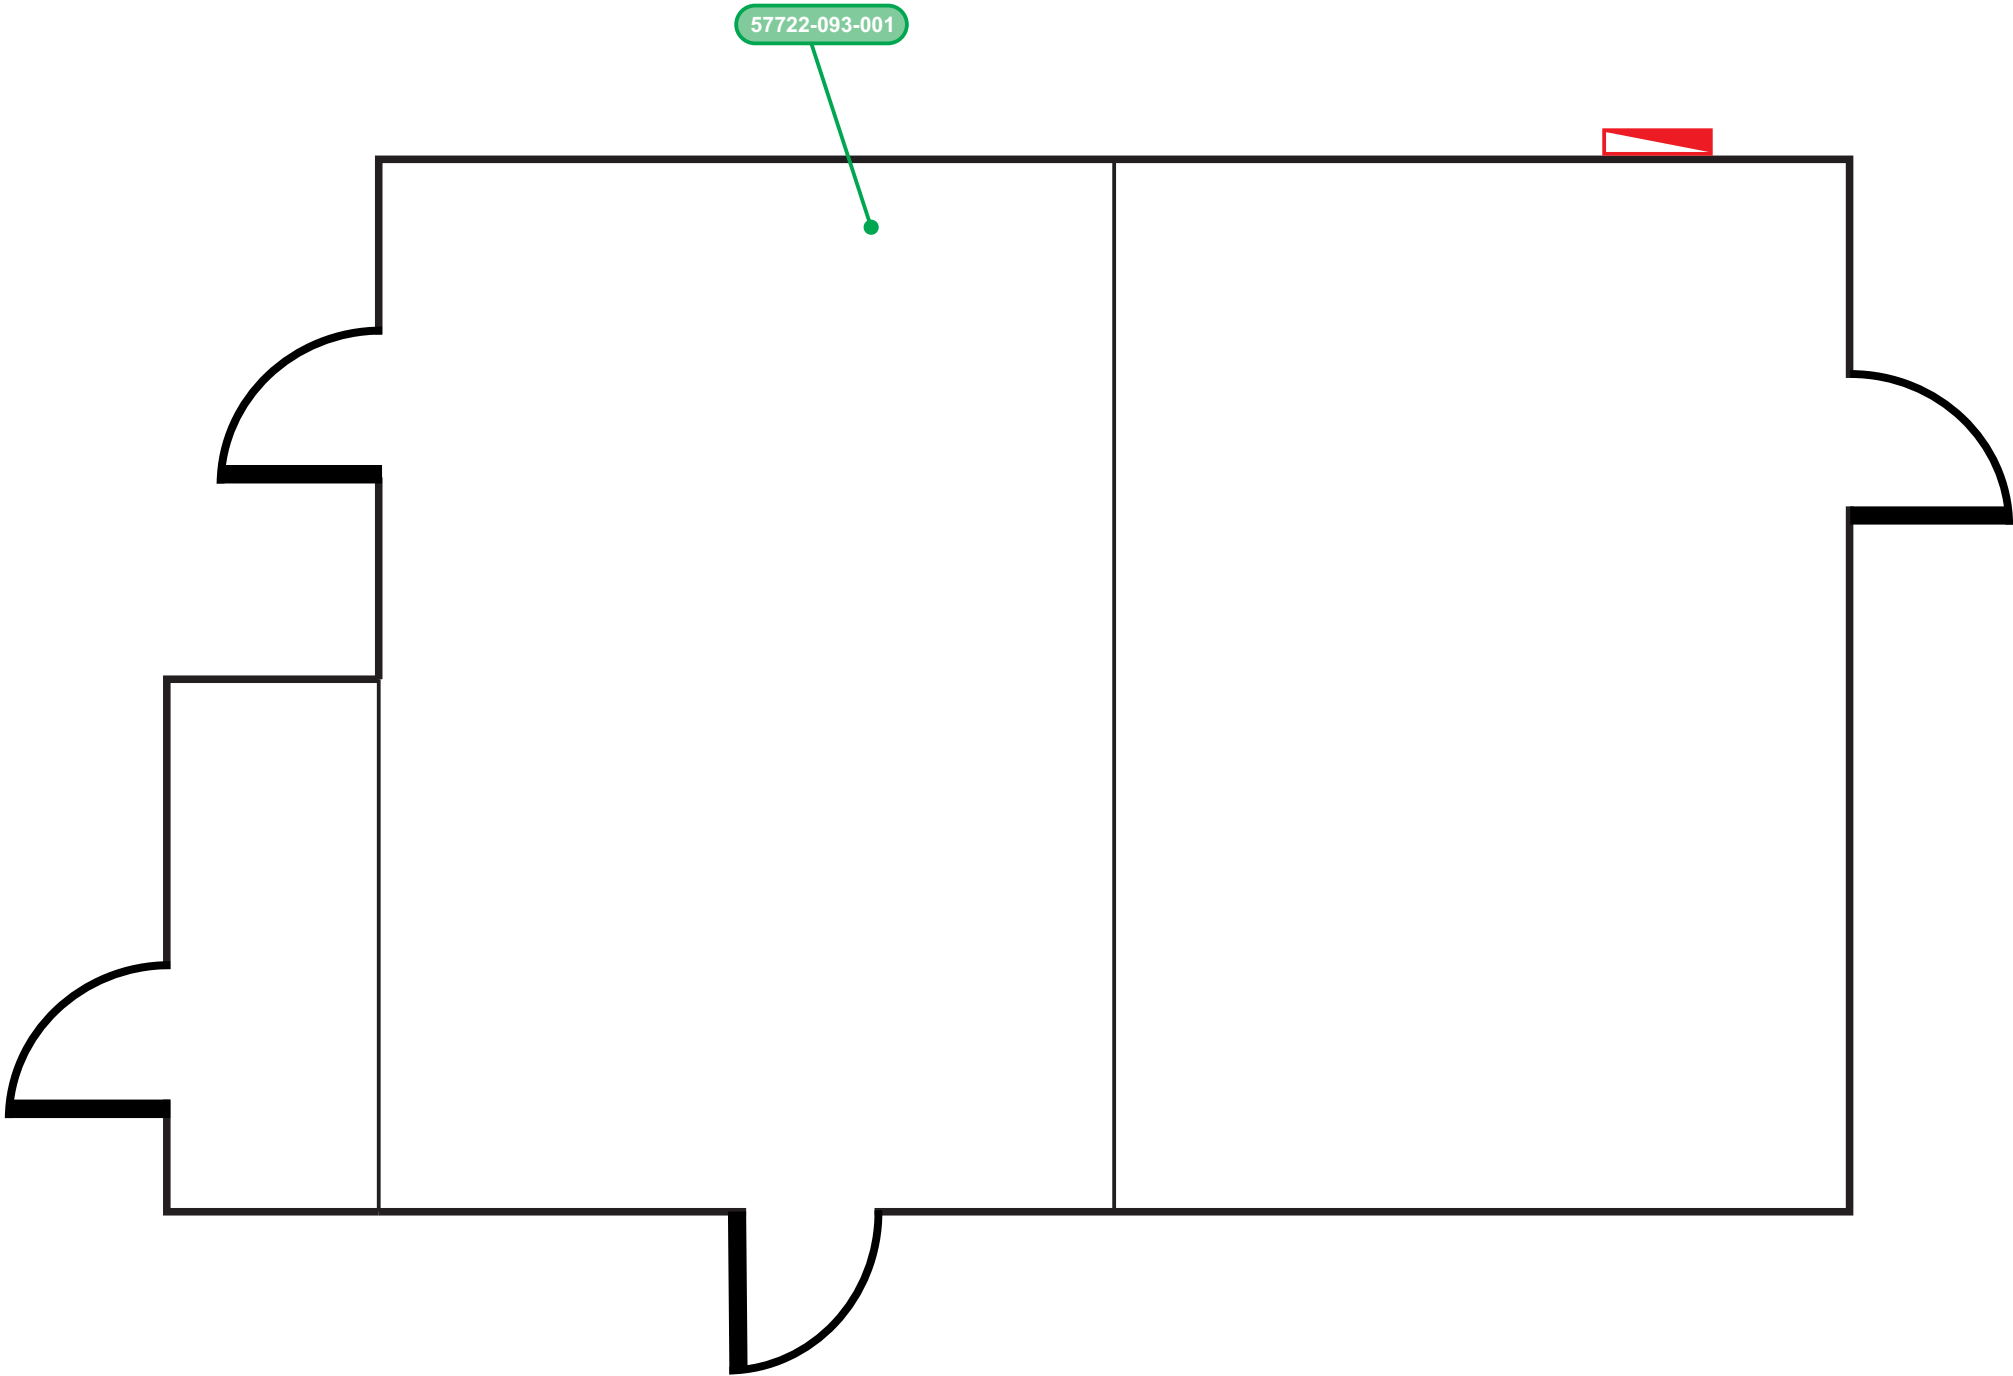
Figure number: 1 Revision: 4

*Only asbestos-containing materials (ACM) have been labelled on the attached site plan to prevent confusion and ensure that these materials are given priority for action. Therefore, other hazardous materials may be present within the building and the register attached in **Section 1** should be consulted prior to work commencing.*
