Hazardous Building Materials Assessment Foster Street Family Day Care Centre – Store/Garage 22 Foster Street, Leichhardt NSW 2040

Inner West Council

April 2018

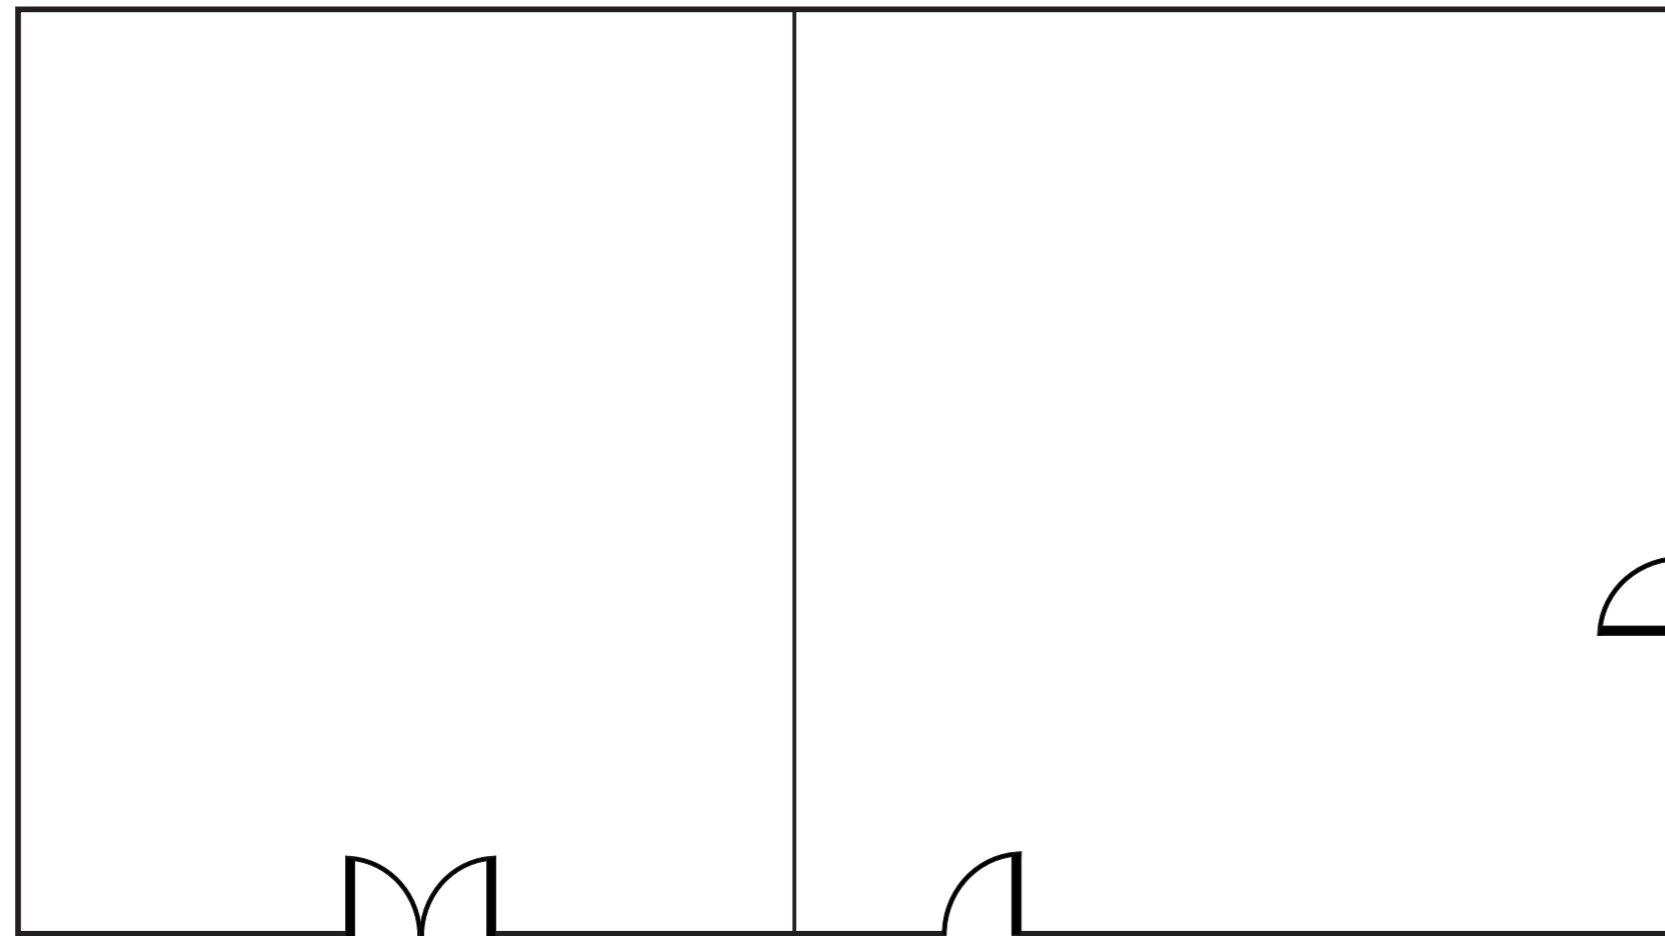
Foster St Family Day Care Centre Store/Garage Leichhardt, Ground Level

*Only asbestos-containing materials (ACM) have been labelled on the attached site plan to prevent confusion and ensure that these materials are given priority for action. Therefore, other hazardous materials may be present within the building and the register attached in **Section 1** should be consulted prior to work commencing.*
