Hazardous Building Materials Assessment Foster Street Family Day Care Centre 22 Foster Street, Leichhardt NSW 2040

Inner West Council
April 2018

Executive Summary

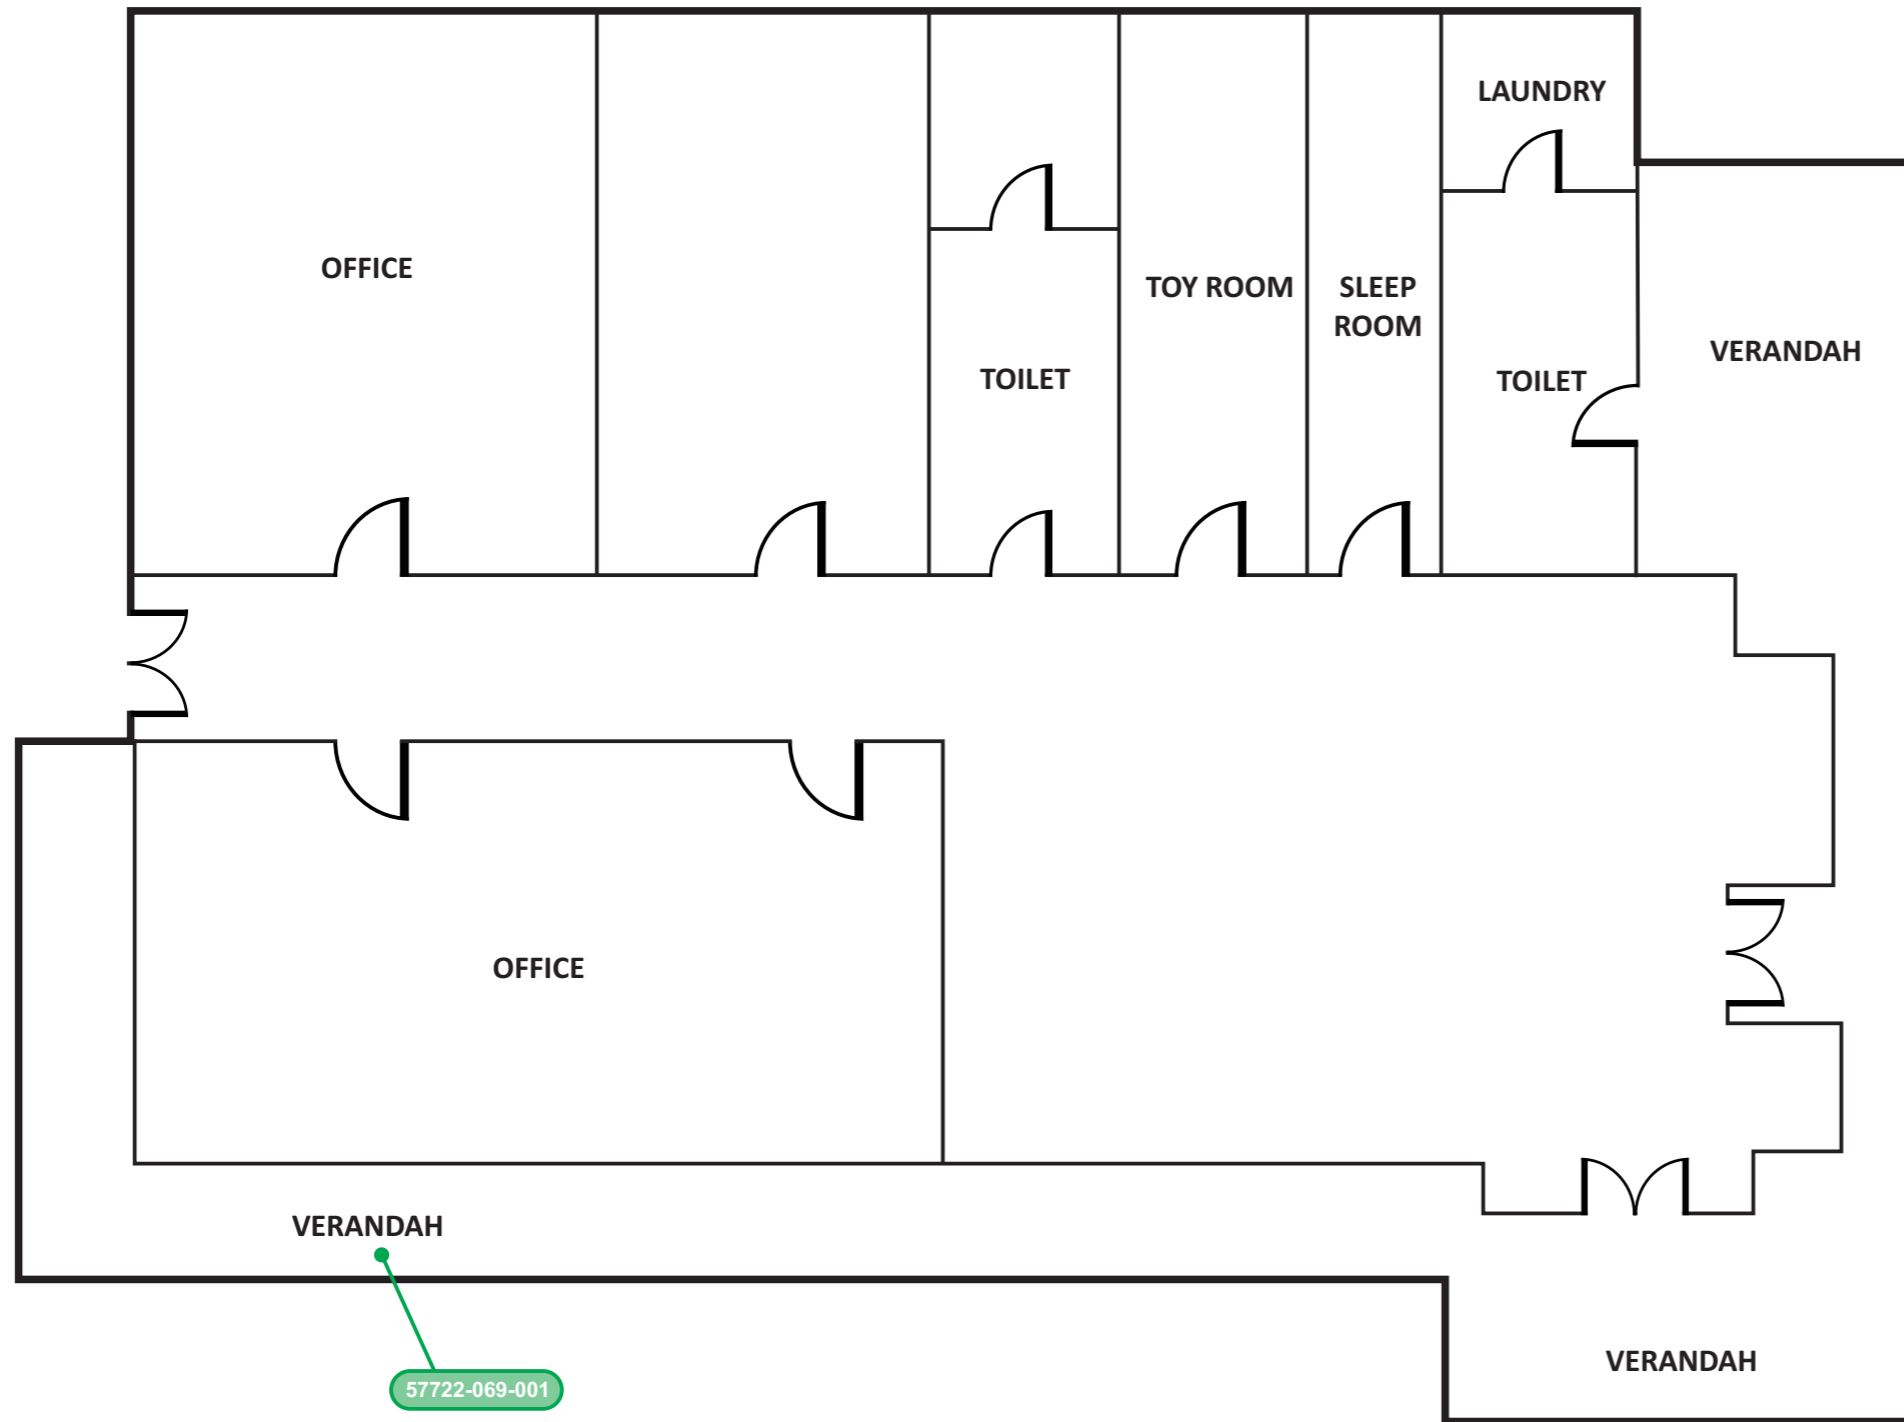
Foster St Family Day Care Centre Leichardt- Ground Level

*Only asbestos-containing materials (ACM) have been labelled on the attached site plan to prevent confusion and ensure that these materials are given priority for action. Therefore, other hazardous materials may be present within the building and the register attached in **Section 1** should be consulted prior to work commencing.*
