Hazardous Building Materials Assessment Leichhardt Long Day Care Centre - Shed 19 Leichhardt Street, Leichhardt NSW 2040

Inner West Council
April 2018

Job No.: 57722-102

Count ID: CID: 204

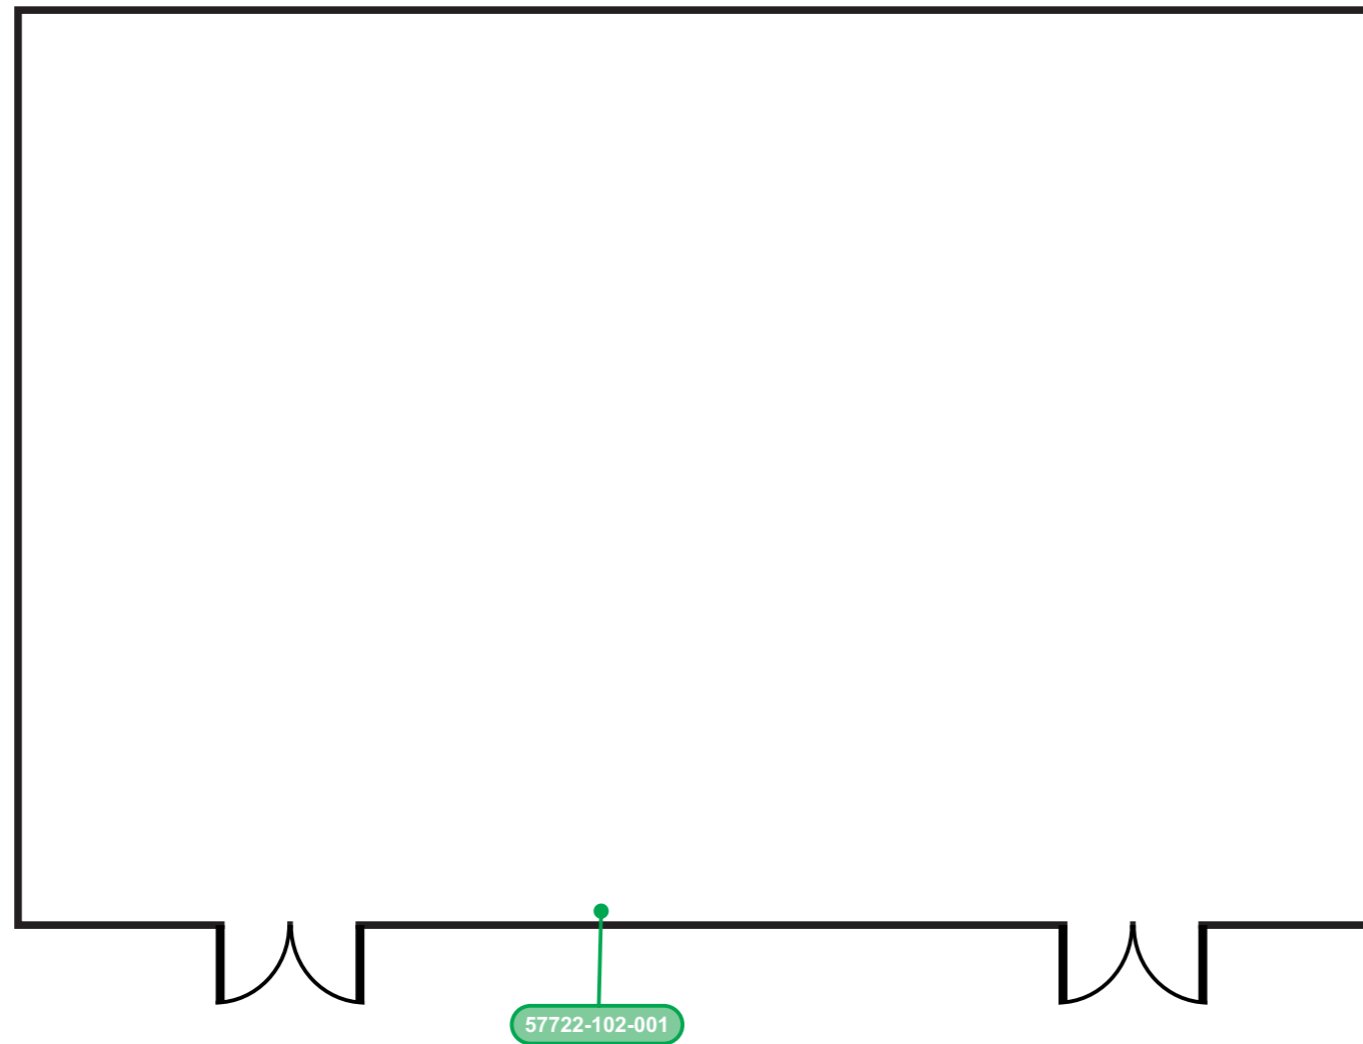
Leichhardt-Ground Level

*Only asbestos-containing materials (ACM) have been labelled on the attached site plan to prevent confusion and ensure that these materials are given priority for action. Therefore, other hazardous materials may be present within the building and the register attached in **Section 1** should be consulted prior to work commencing.*
