# Hazardous Building Materials Assessment Lambert Park – Toilet Block Marion Street, Leichhardt NSW 2040

Inner West Council  
April 2018

Job No.: 57722-064

Count ID: CID: 191

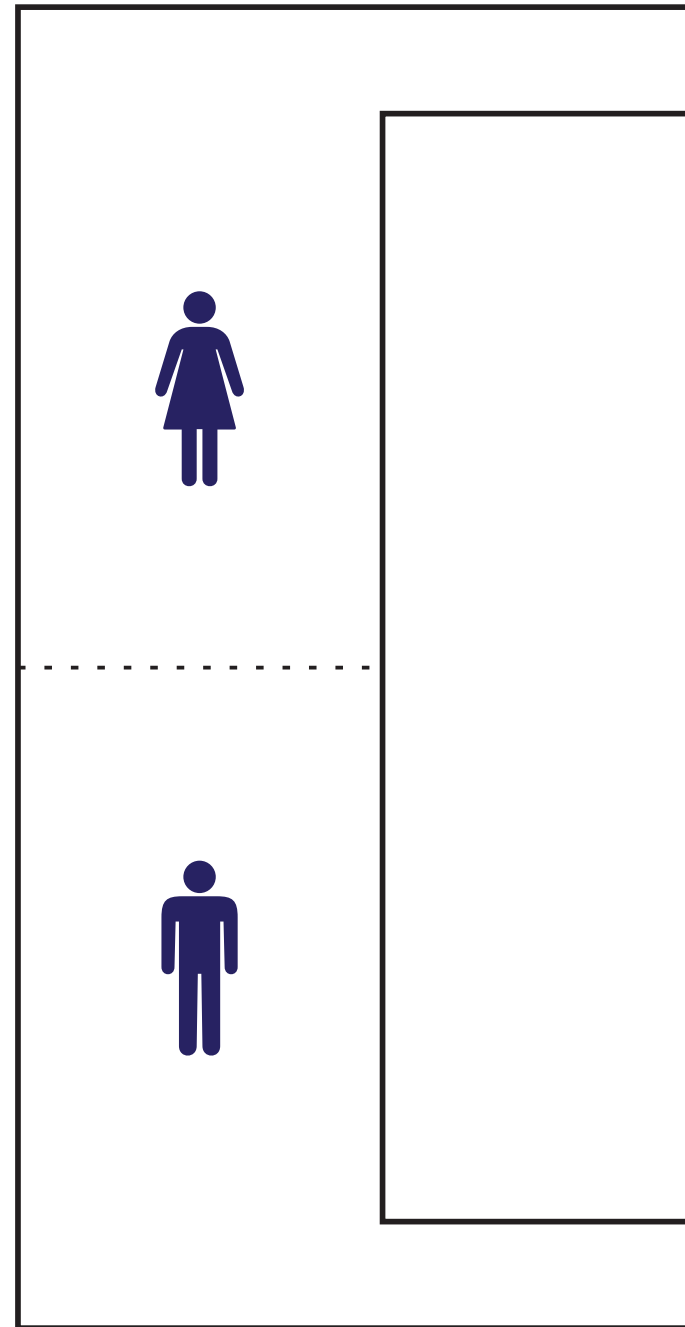
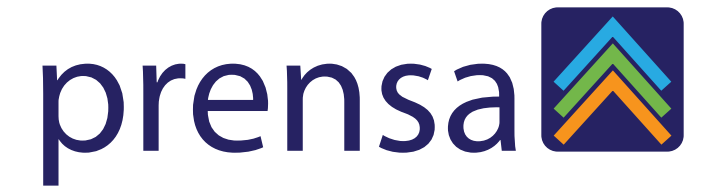
# Lambert Park Toilet Block, Leichhardt Ground Level

*Only asbestos-containing materials (ACM) have been labelled on the attached site plan to prevent confusion and ensure that these materials are given priority for action. Therefore, other hazardous materials may be present within the building and the register attached in **Section 1** should be consulted prior to work commencing.*
