Hazardous Building Materials Assessment Pioneer Memorial Park – Amenities Block / Tool Shed Norton Street, Leichhardt NSW 2040

Inner West Council
April 2018

Job No.: 57722-092

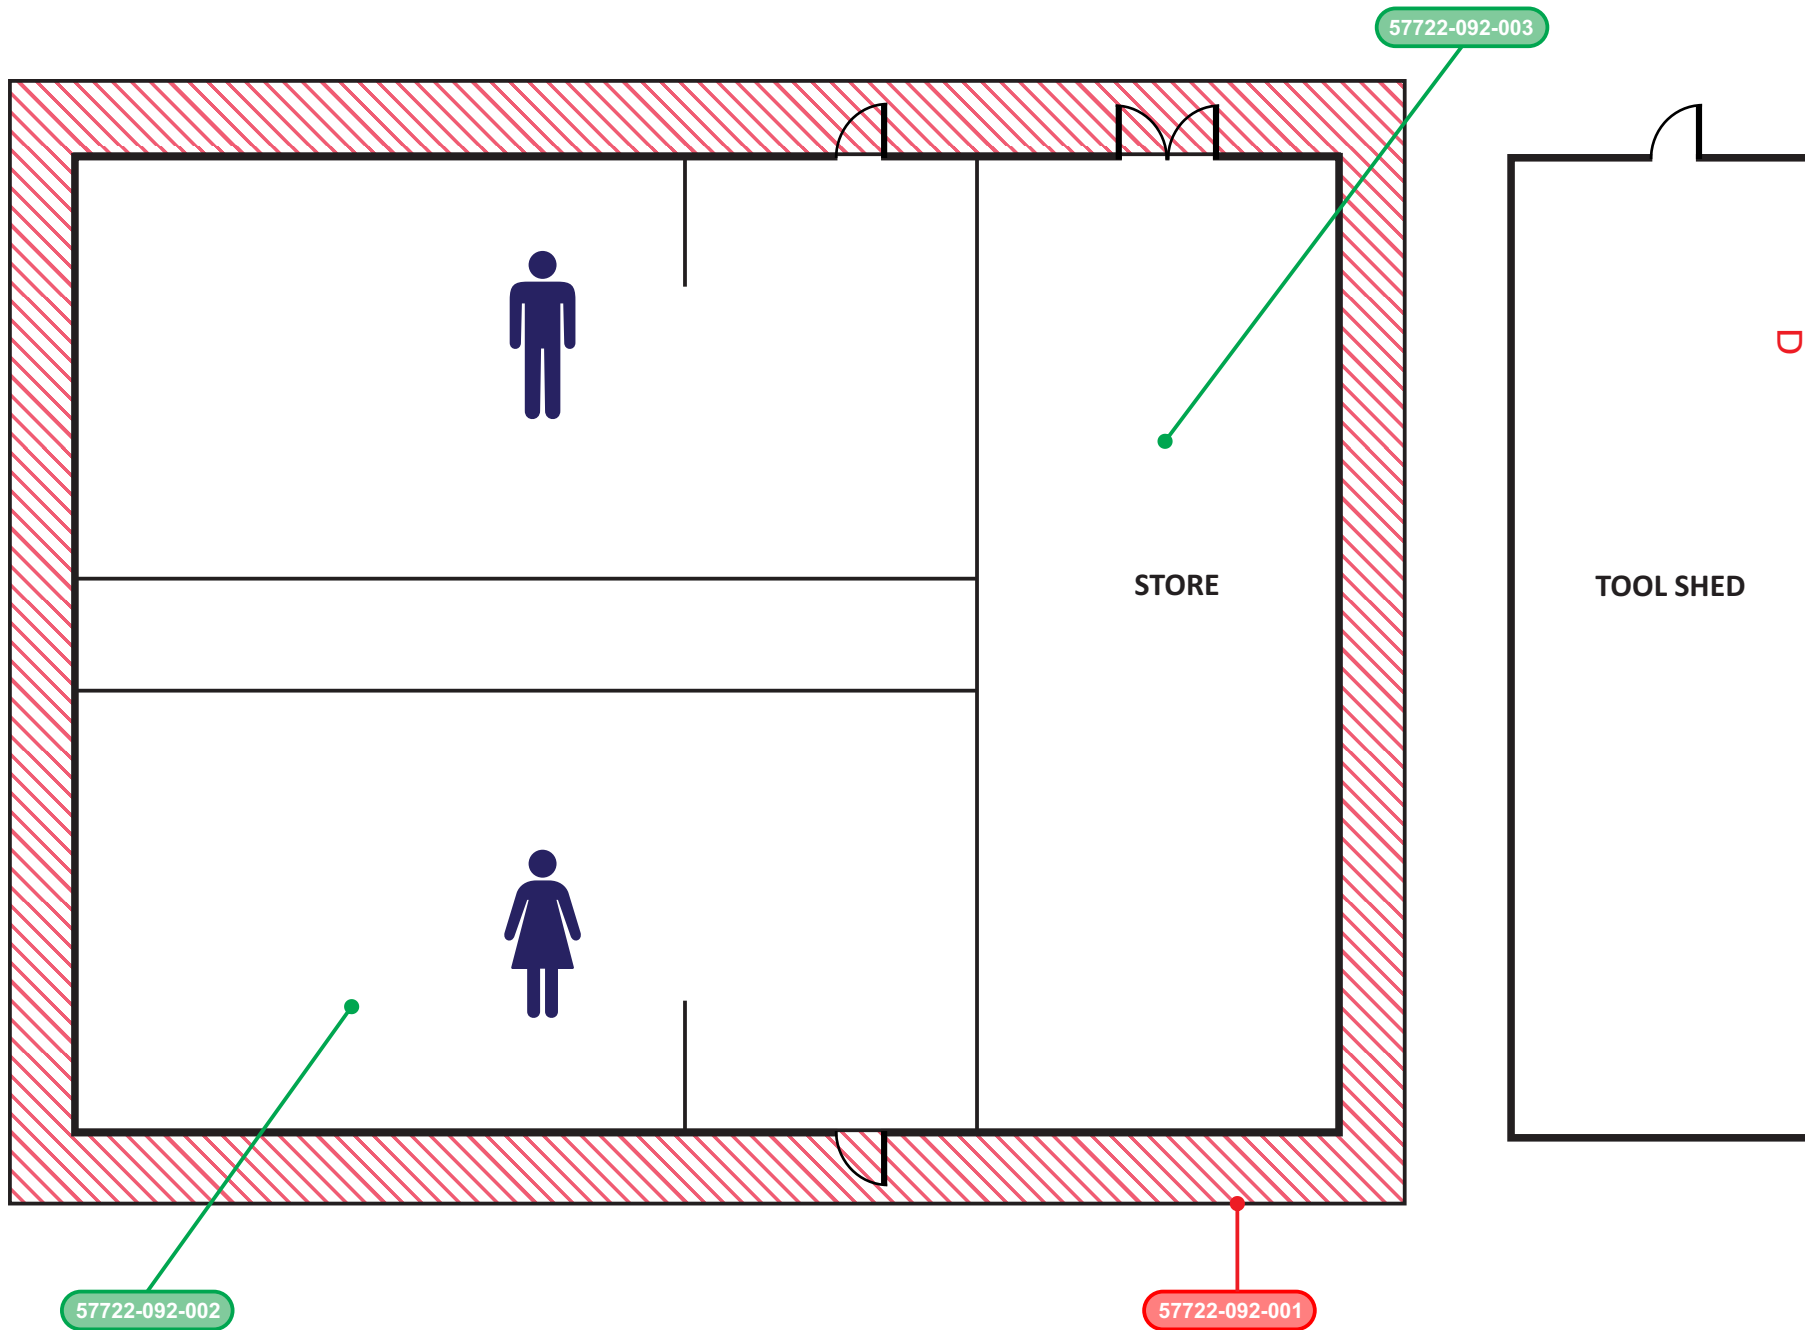
Pioneer Memorial Park Amenities Block/Tool Shed Leichhardt - Ground Level

*Only asbestos-containing materials (ACM) have been labelled on the attached site plan to prevent confusion and ensure that these materials are given priority for action. Therefore, other hazardous materials may be present within the building and the register attached in **Section 1** should be consulted prior to work commencing.*
