Hazardous Building Materials Assessment Prospect St Kindergarten / Kiosk / Store 8 Prospect Street, Leichhardt NSW 2040

Inner West Council
April 2018

Job No.: 57722-095

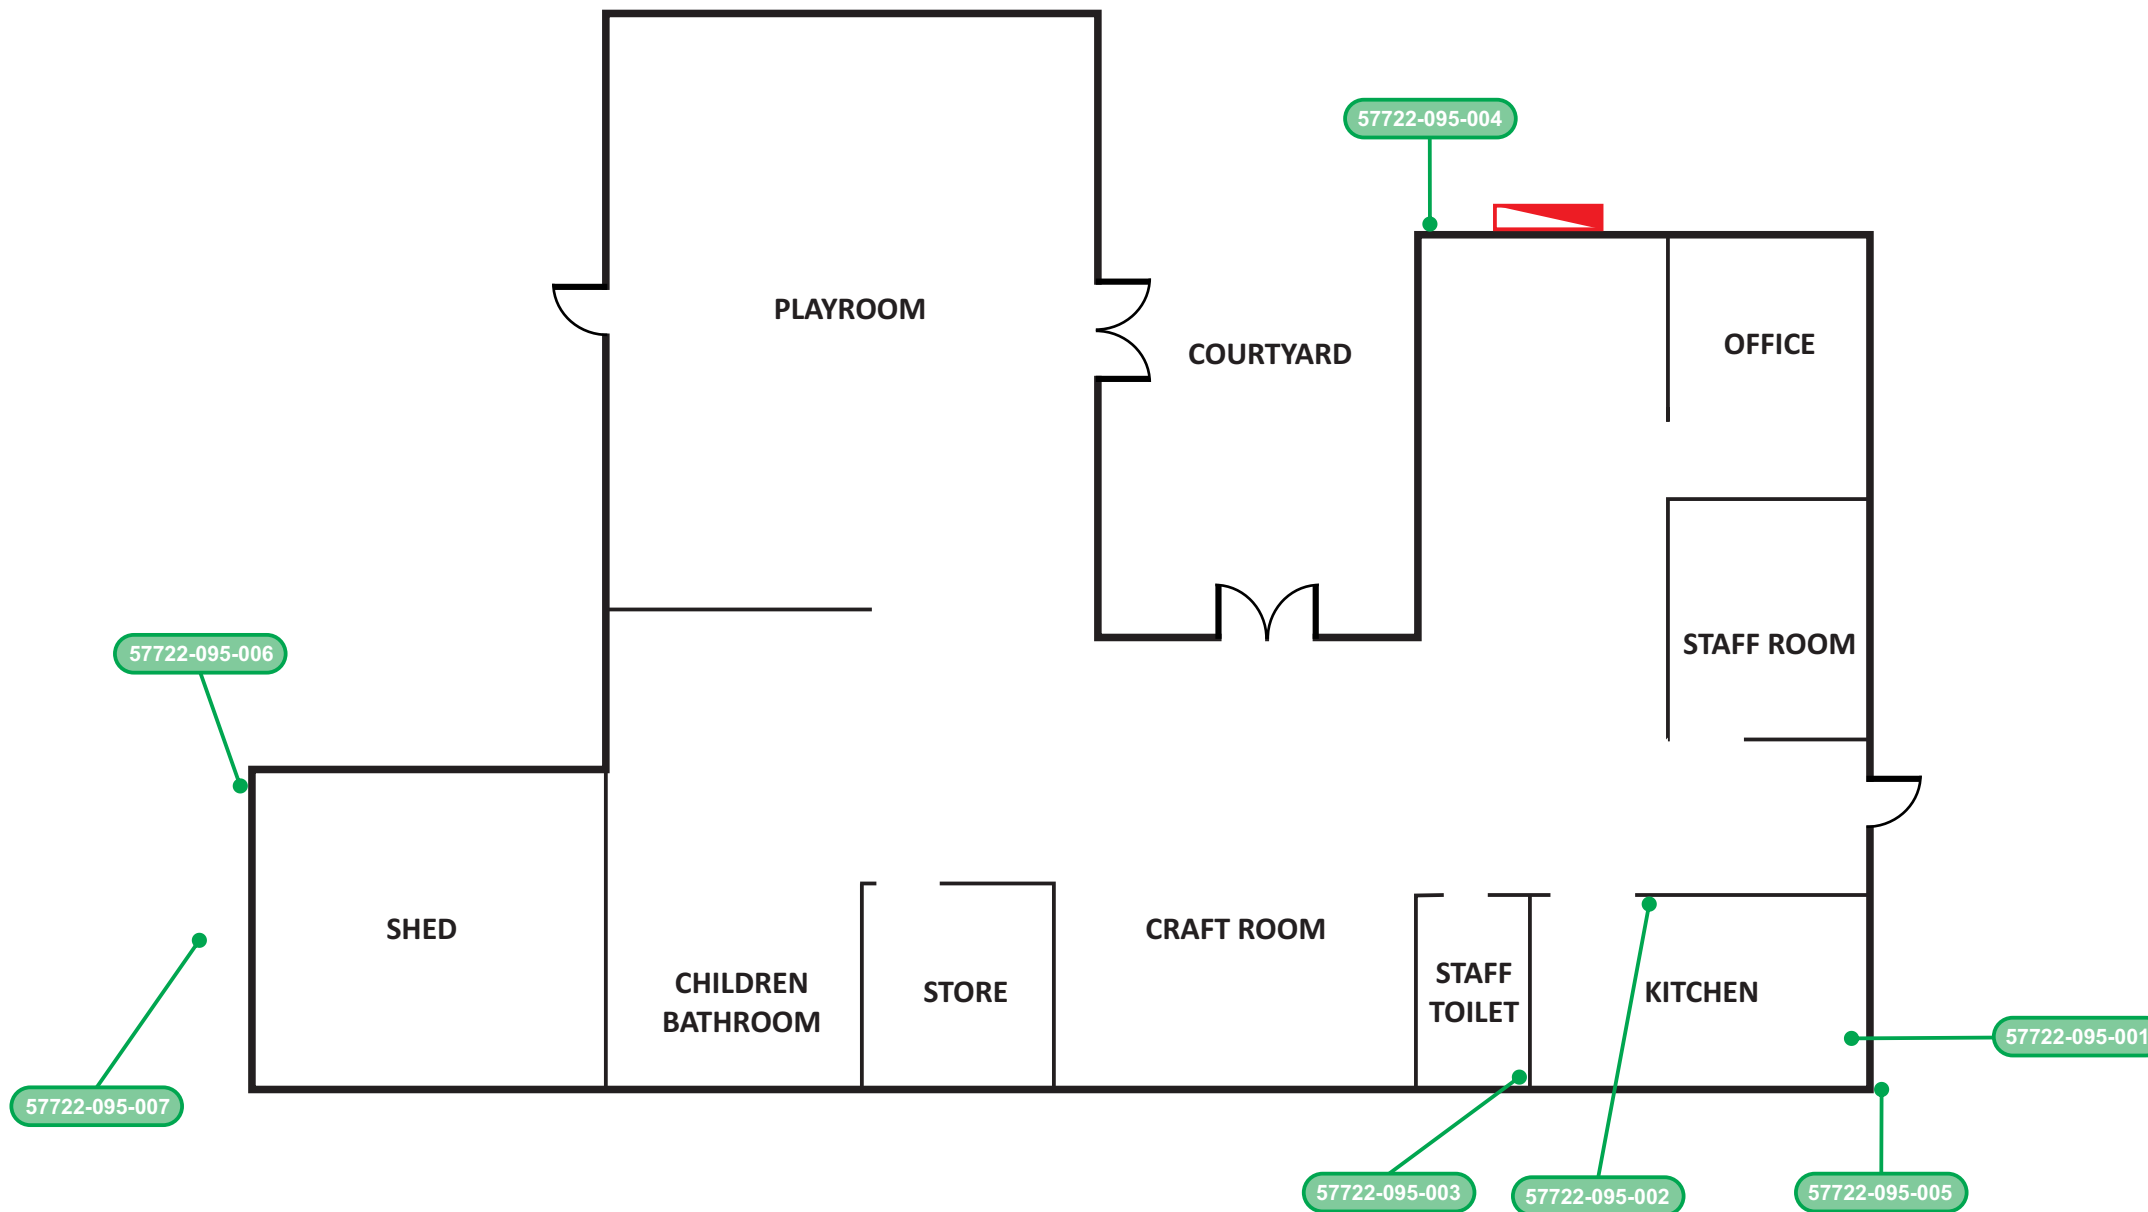
Prospect Street Kindergarten/Kiosk/Store Leichhardt - Ground Level

*Only asbestos-containing materials (ACM) have been labelled on the attached site plan to prevent confusion and ensure that these materials are given priority for action. Therefore, other hazardous materials may be present within the building and the register attached in **Section 1** should be consulted prior to work commencing.*
