# Hazardous Building Materials Assessment Leichhardt Service Centre 7-15 Wetherill Street, Leichhardt NSW 2040

Inner West Council  
April 2018

Client: Inner West Council

Job No.: 57722-094

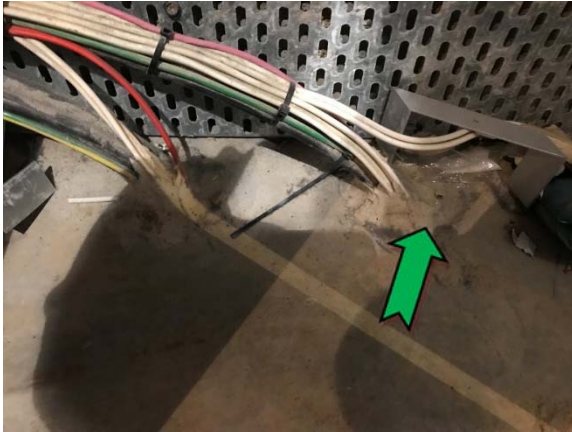
**Photo 7.** Interior, level 3, switch room, floor, to penetration point – non asbestos-containing mastic sealant.

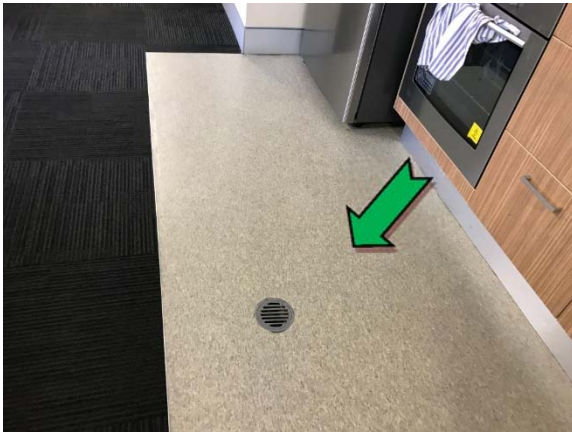
**Photo 9.** Interior, level 3, main office, kitchenette, floor coverings – suspected non asbestos-containing sheet vinyl.
