Hazardous Building Materials Assessment Callan Park – Recreational Hall Balmain Road, Lilyfield NSW 2040

Inner West Council
April 2018

Job No.: 57722-180

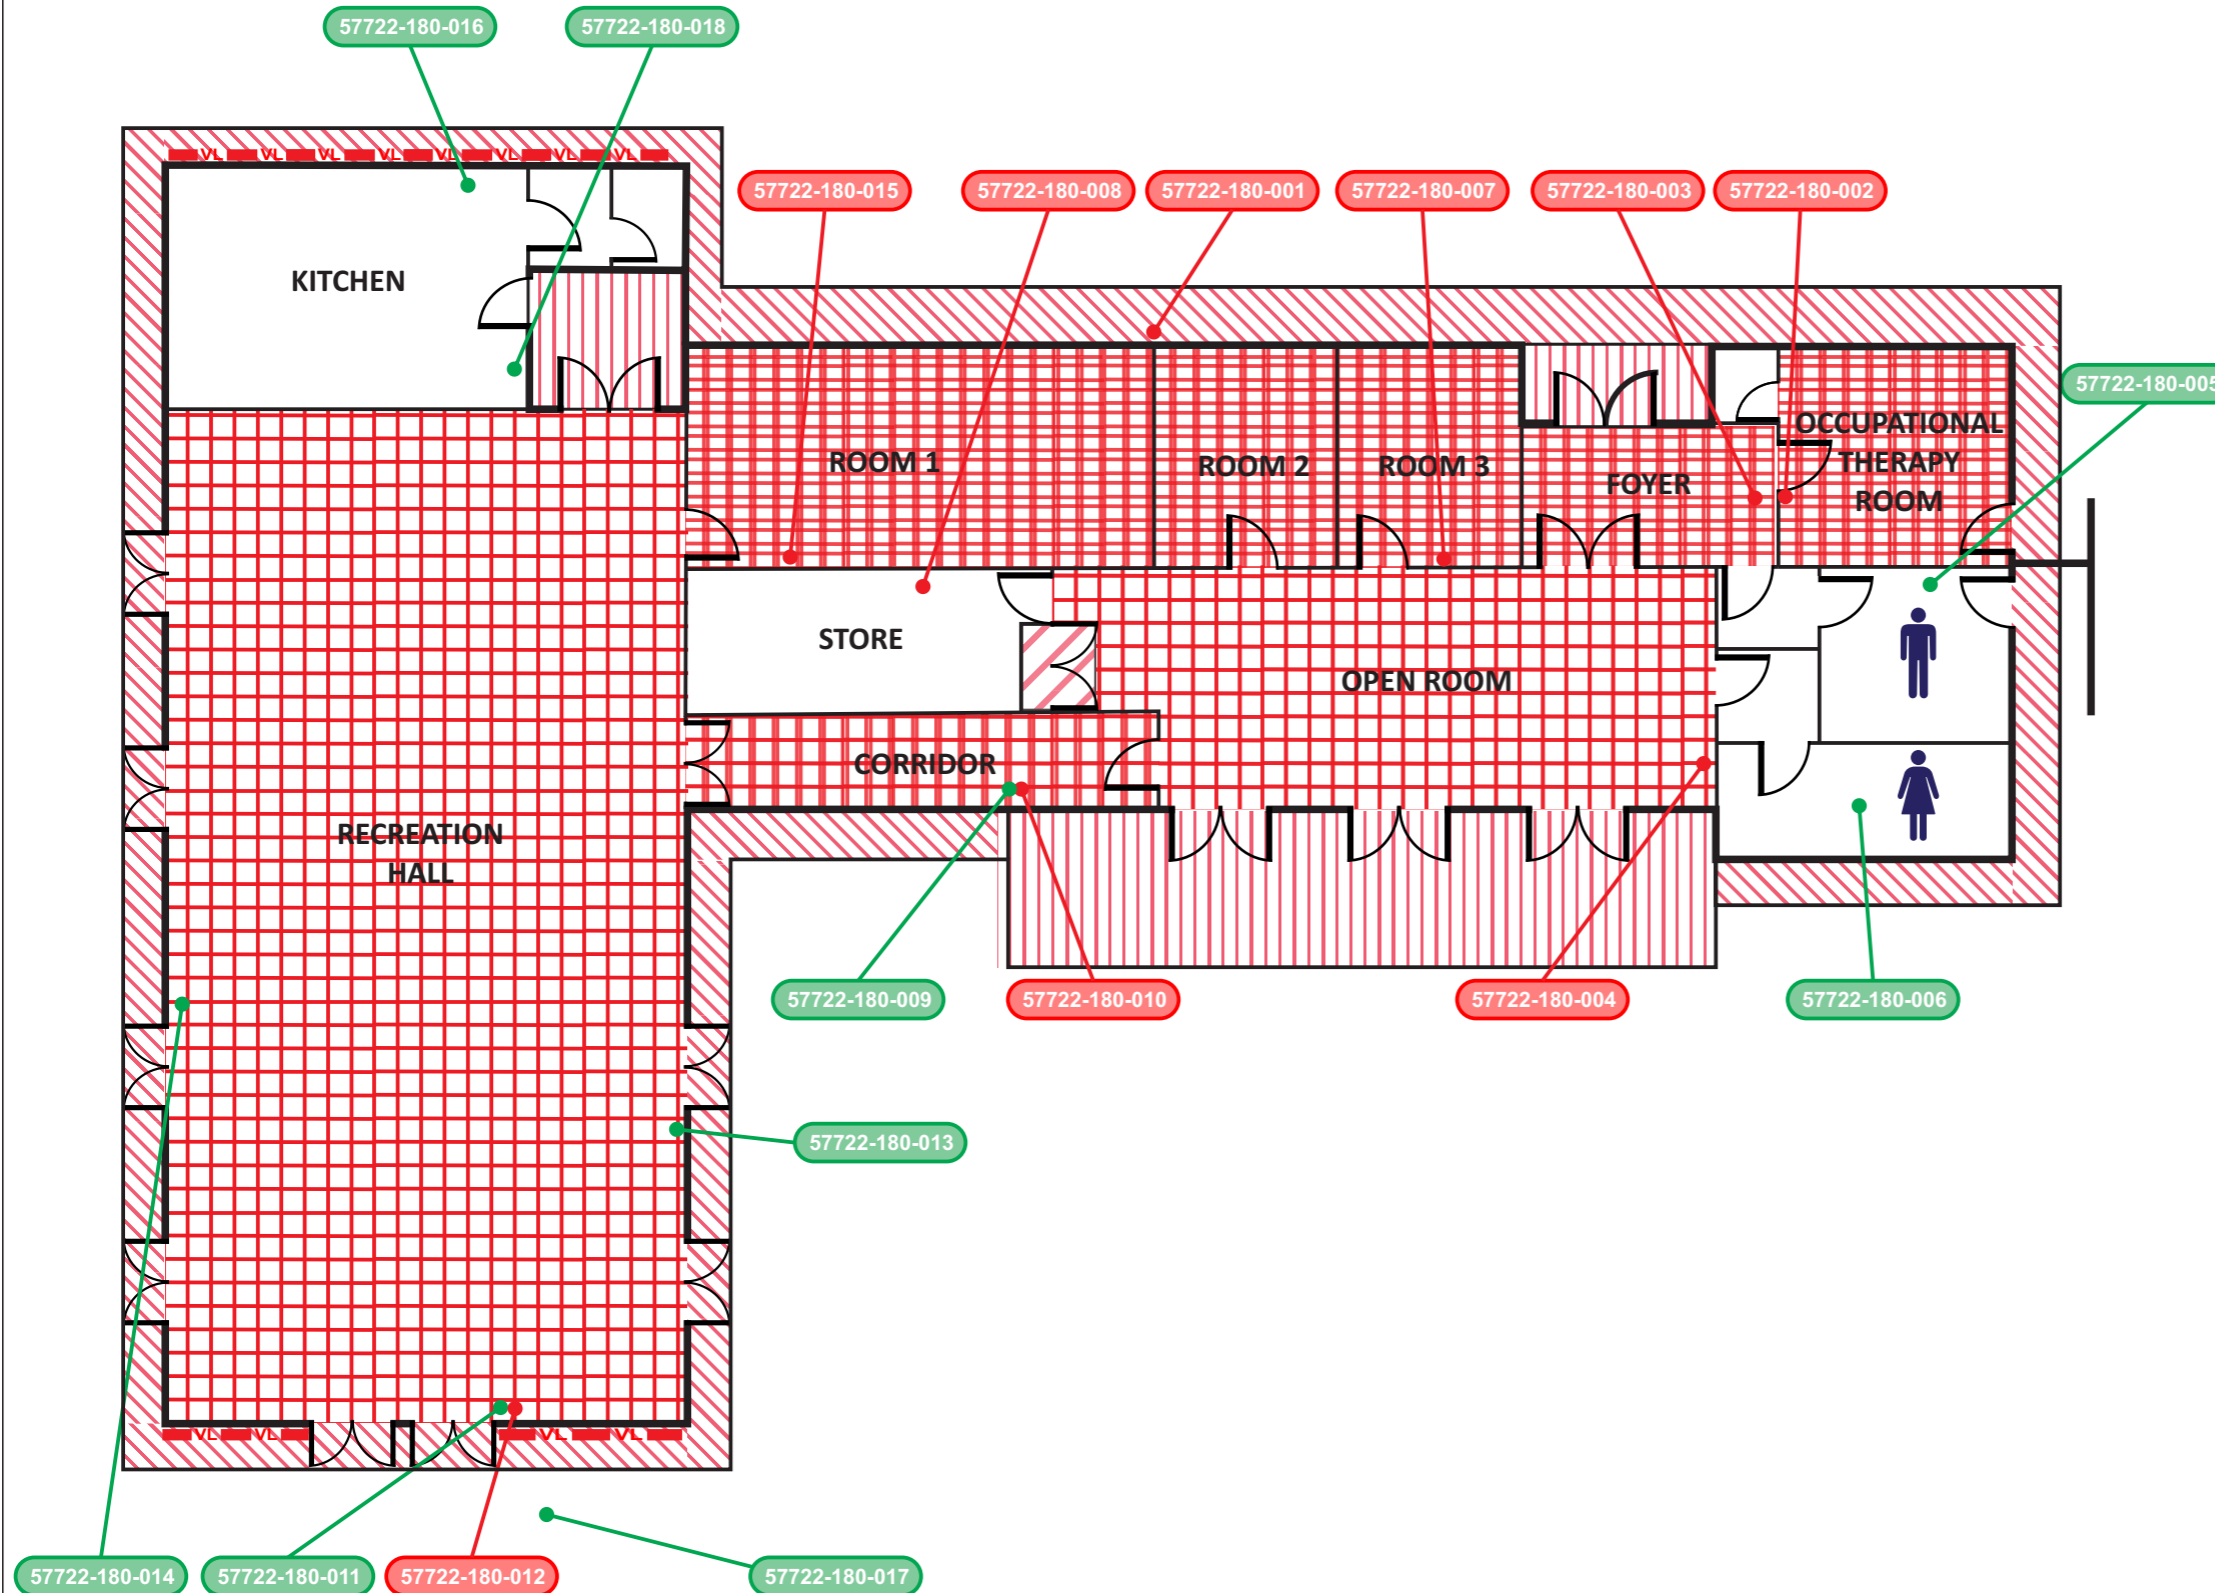
Callan Park Recreational Hall, Lilyfield - Ground Level

*Only asbestos-containing materials (ACM) have been labelled on the attached site plan to prevent confusion and ensure that these materials are given priority for action. Therefore, other hazardous materials may be present within the building and the register attached in **Section 1** should be consulted prior to work commencing.*
