# Hazardous Building Materials Assessment

## Callan Park - Storage

Balmain Road,  
Lilyfield NSW 2040

Inner West Council  
April 2018

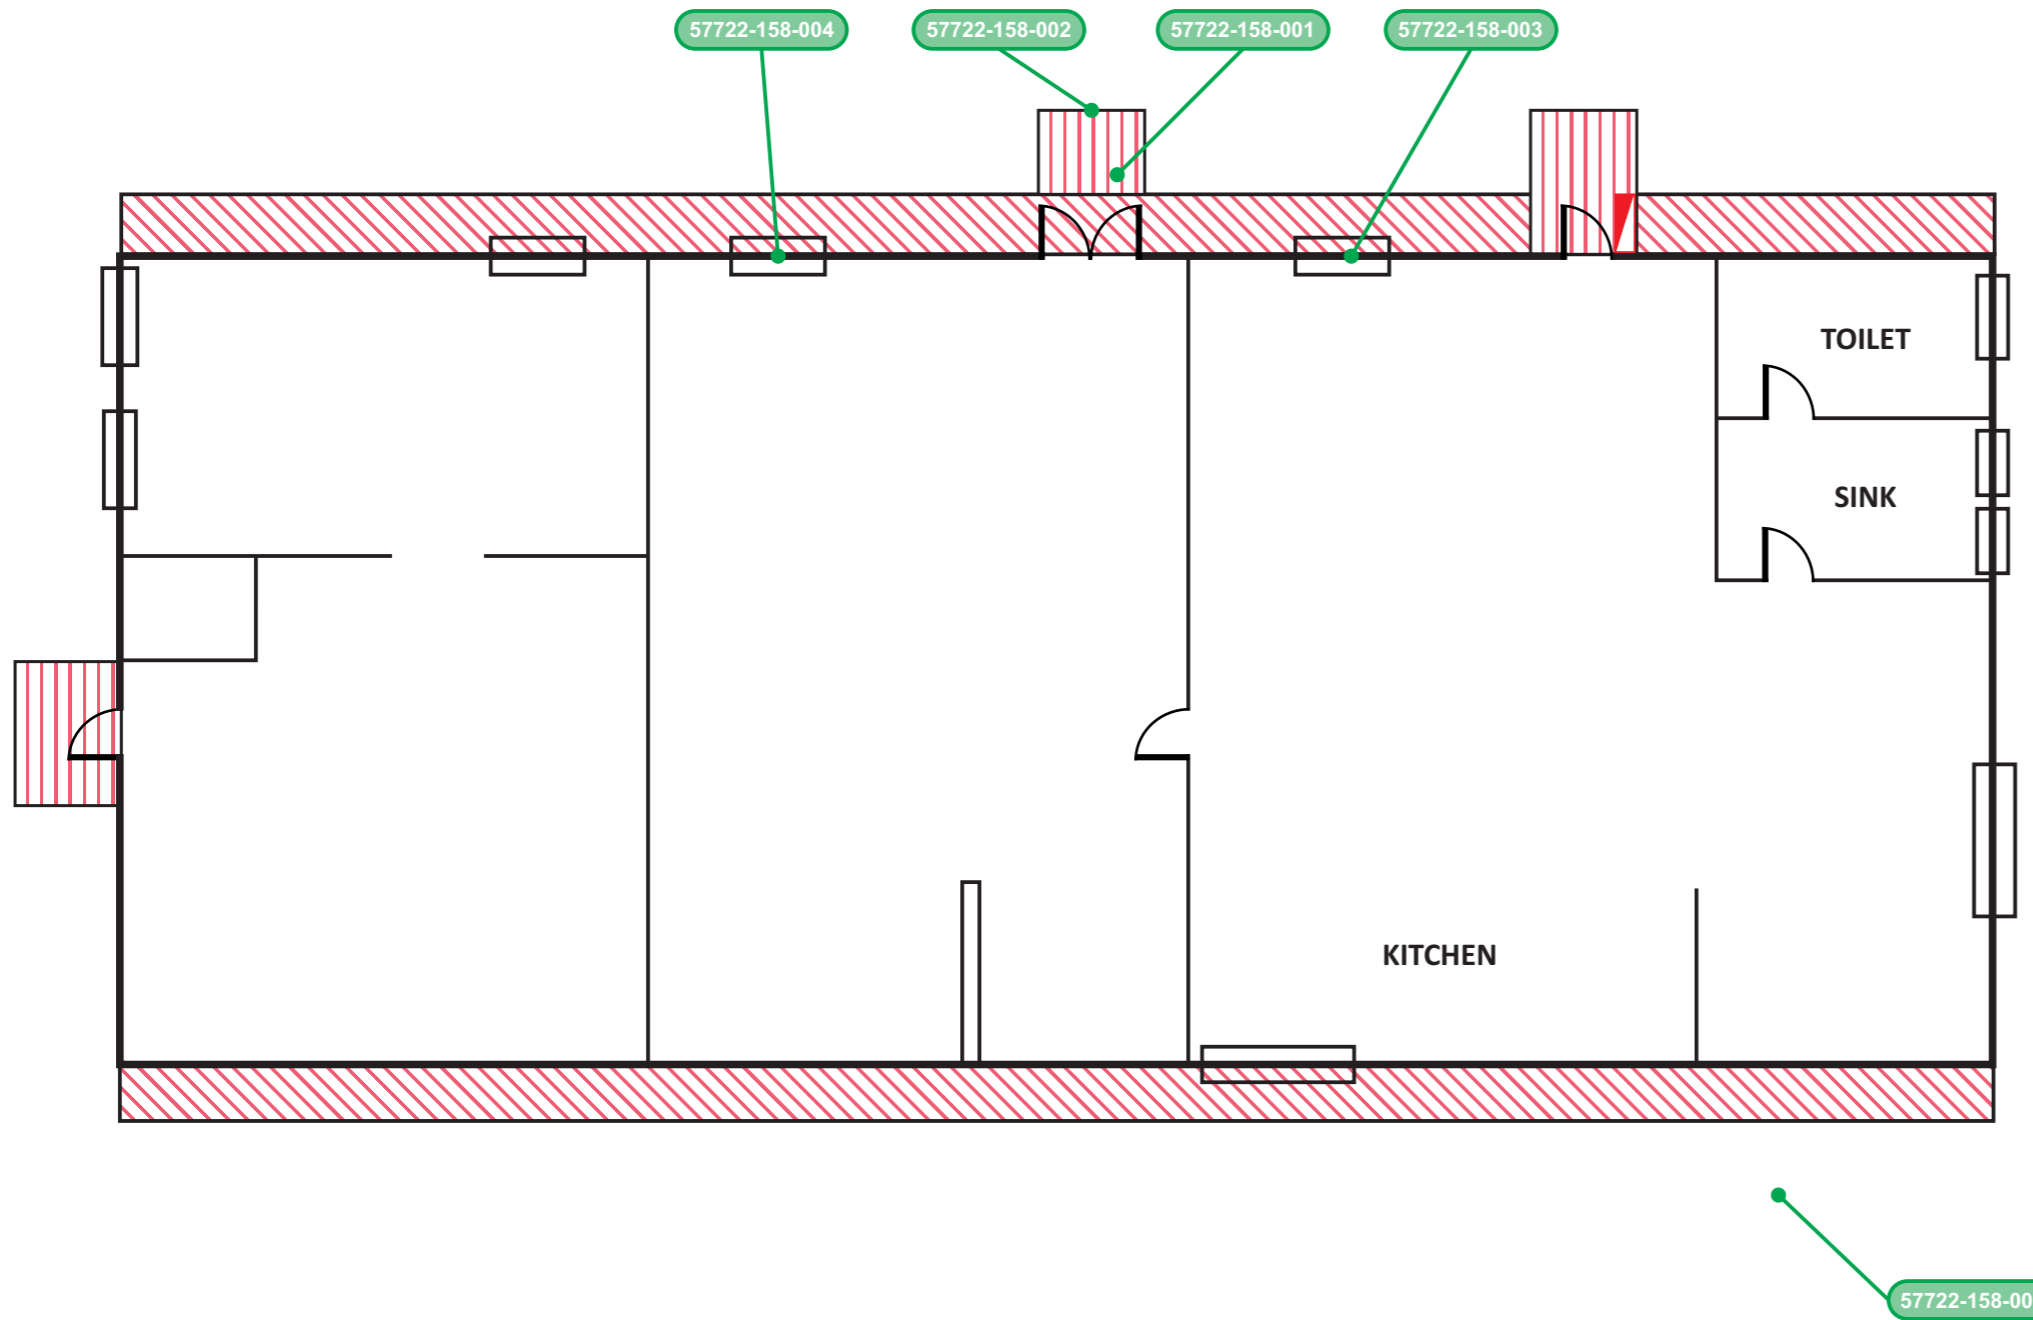
# Callan Park Storage, Lilyfield - Ground Level

*Only asbestos-containing materials (ACM) have been labelled on the attached site plan to prevent confusion and ensure that these materials are given priority for action. Therefore, other hazardous materials may be present within the building and the register attached in **Section 1** should be consulted prior to work commencing.*
