# Hazardous Building Materials Assessment

## Callan Park - Toilets

### Balmain Road

Inner West Council  
April 2018

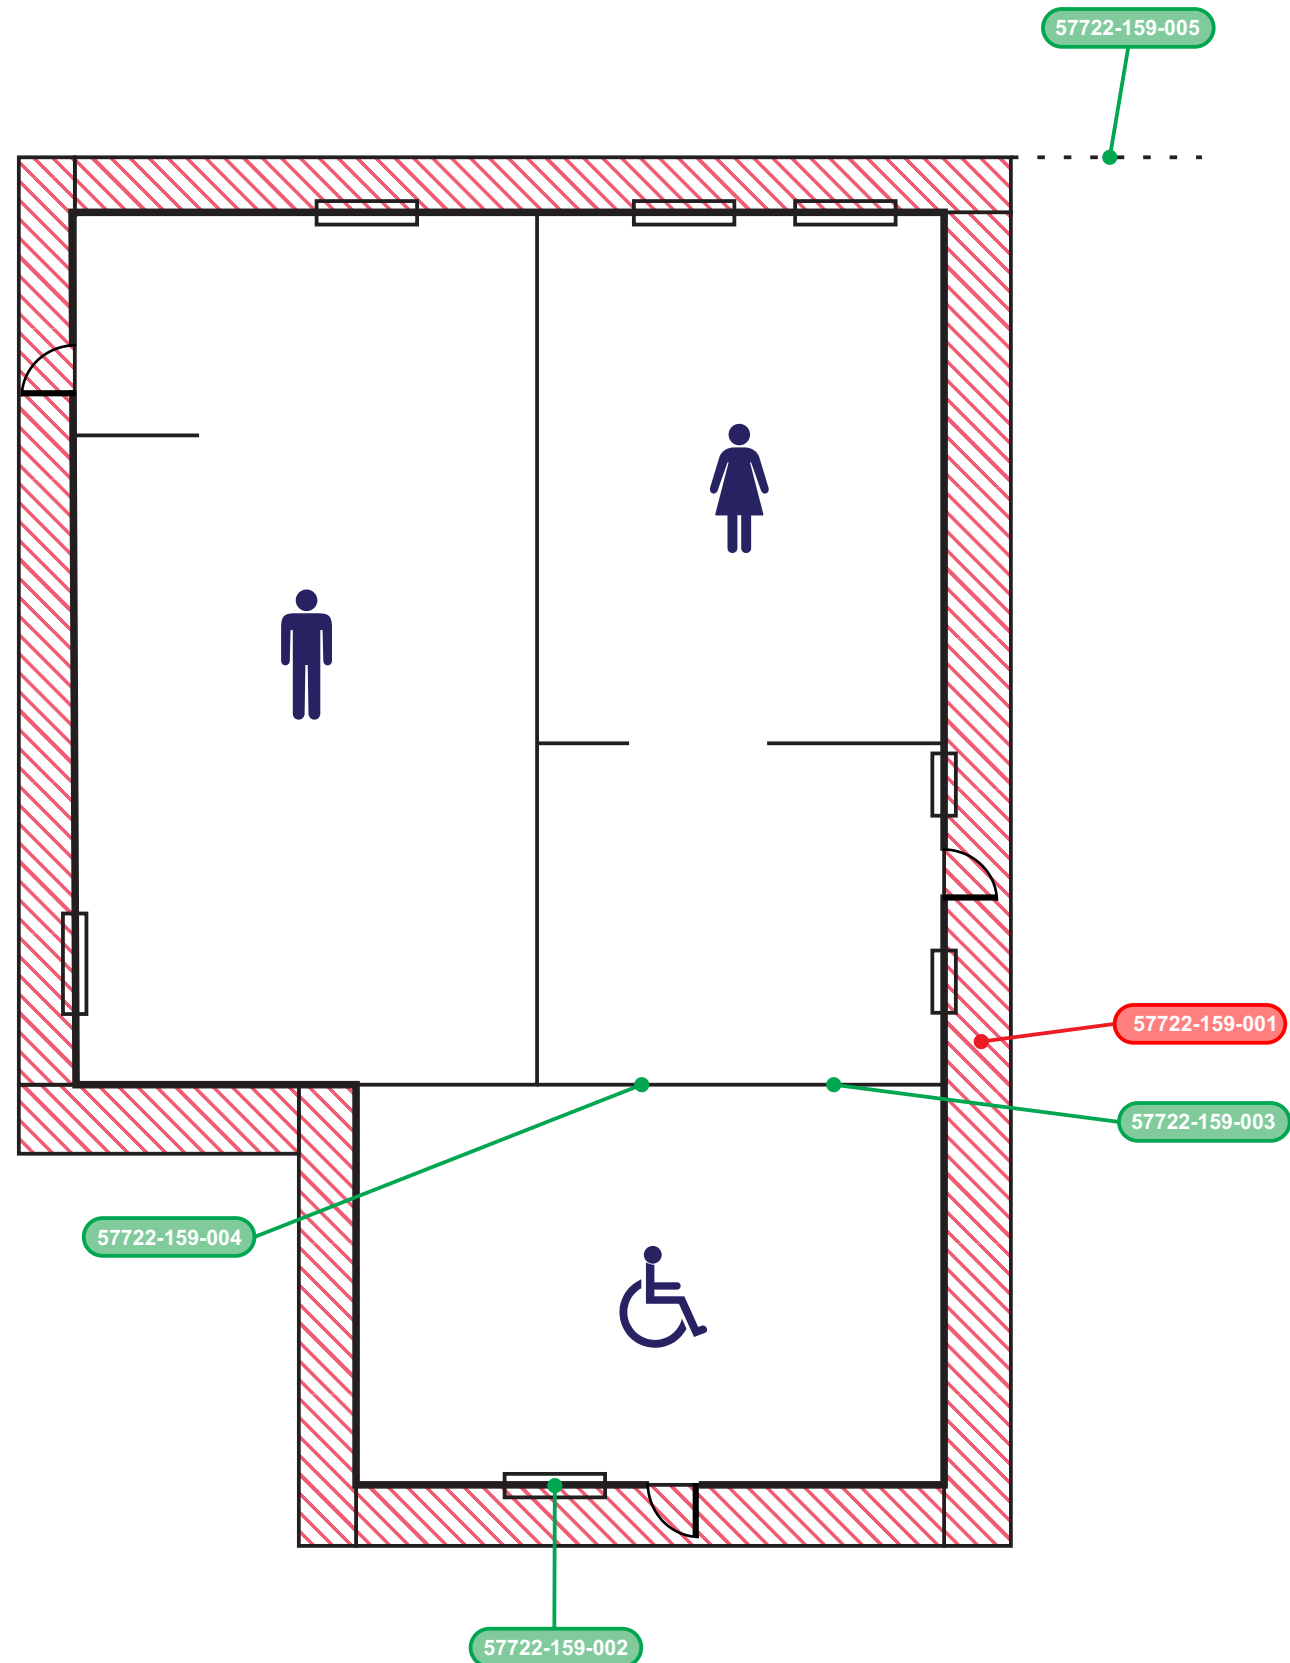
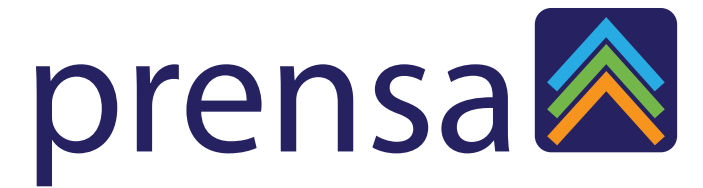
# Callan Park Toilets, Lilyfield - Ground Level

*Only asbestos-containing materials (ACM) have been labelled on the attached site plan to prevent confusion and ensure that these materials are given priority for action. Therefore, other hazardous materials may be present within the building and the register attached in **Section 1** should be consulted prior to work commencing.*
