Hazardous Building Materials Assessment Cecily Street Community Centre 19 Cecily Street, Lilyfield NSW 2040

Inner West Council
April 2018

Job No.: 57722-027

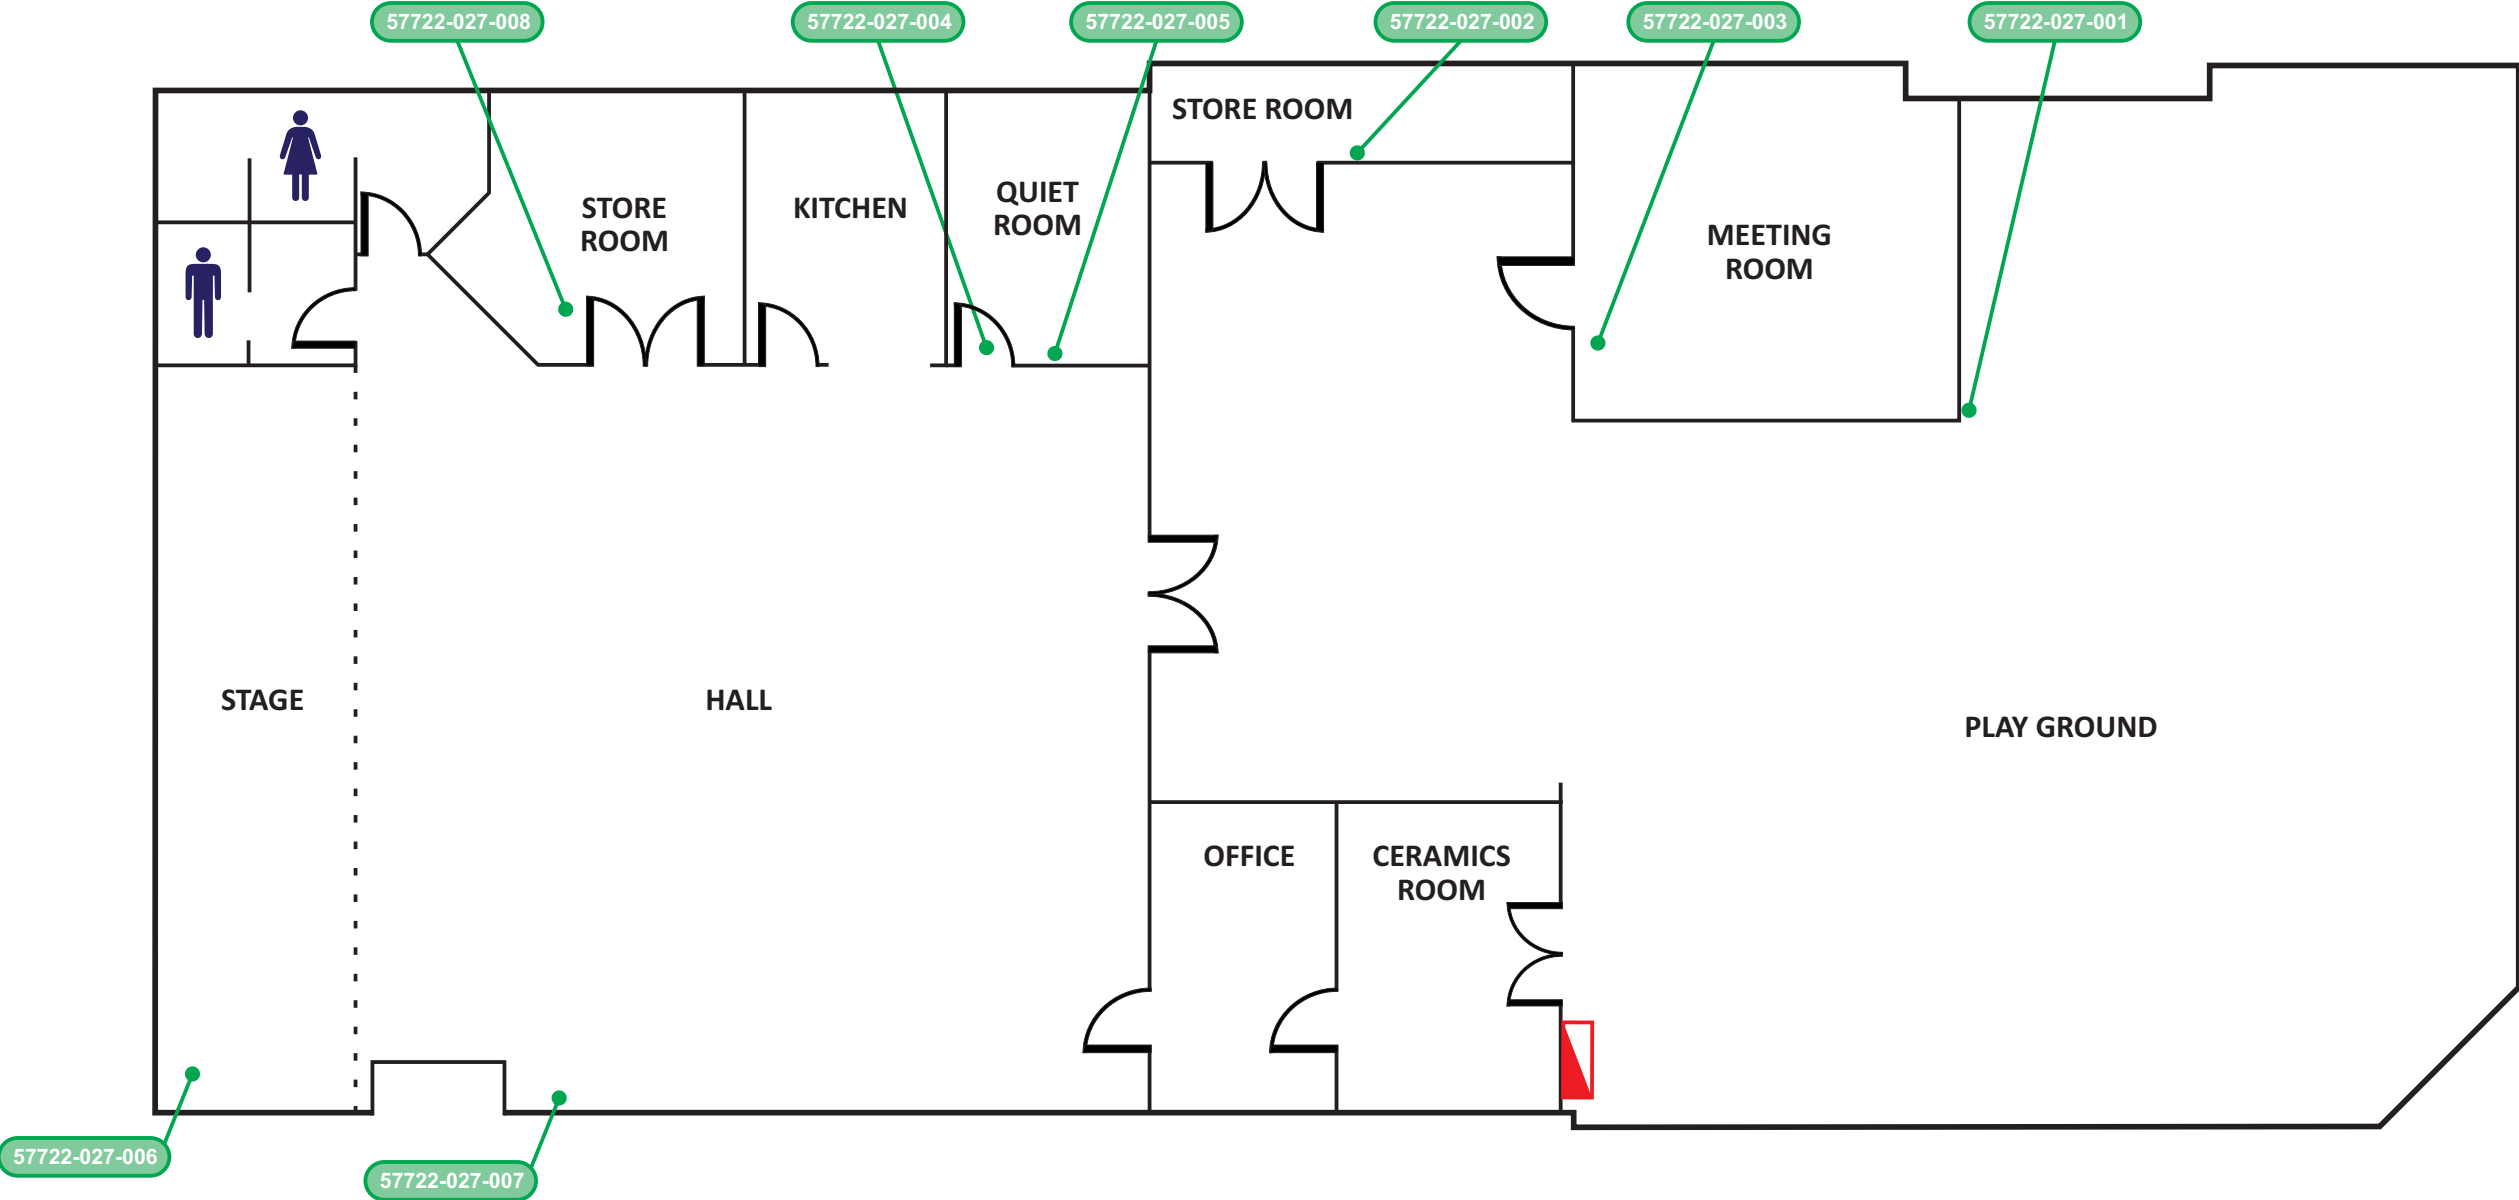
Cecily Street Community Centre, Lilyfield - Ground Level

*Only asbestos-containing materials (ACM) have been labelled on the attached site plan to prevent confusion and ensure that these materials are given priority for action. Therefore, other hazardous materials may be present within the building and the register attached in **Section 1** should be consulted prior to work commencing.*
