Hazardous Building Materials Assessment Leichhardt Oval No.1 Groundsman's Room Mary Street, Lilyfield NSW 2040

Inner West Council
April 2018

Executive Summary

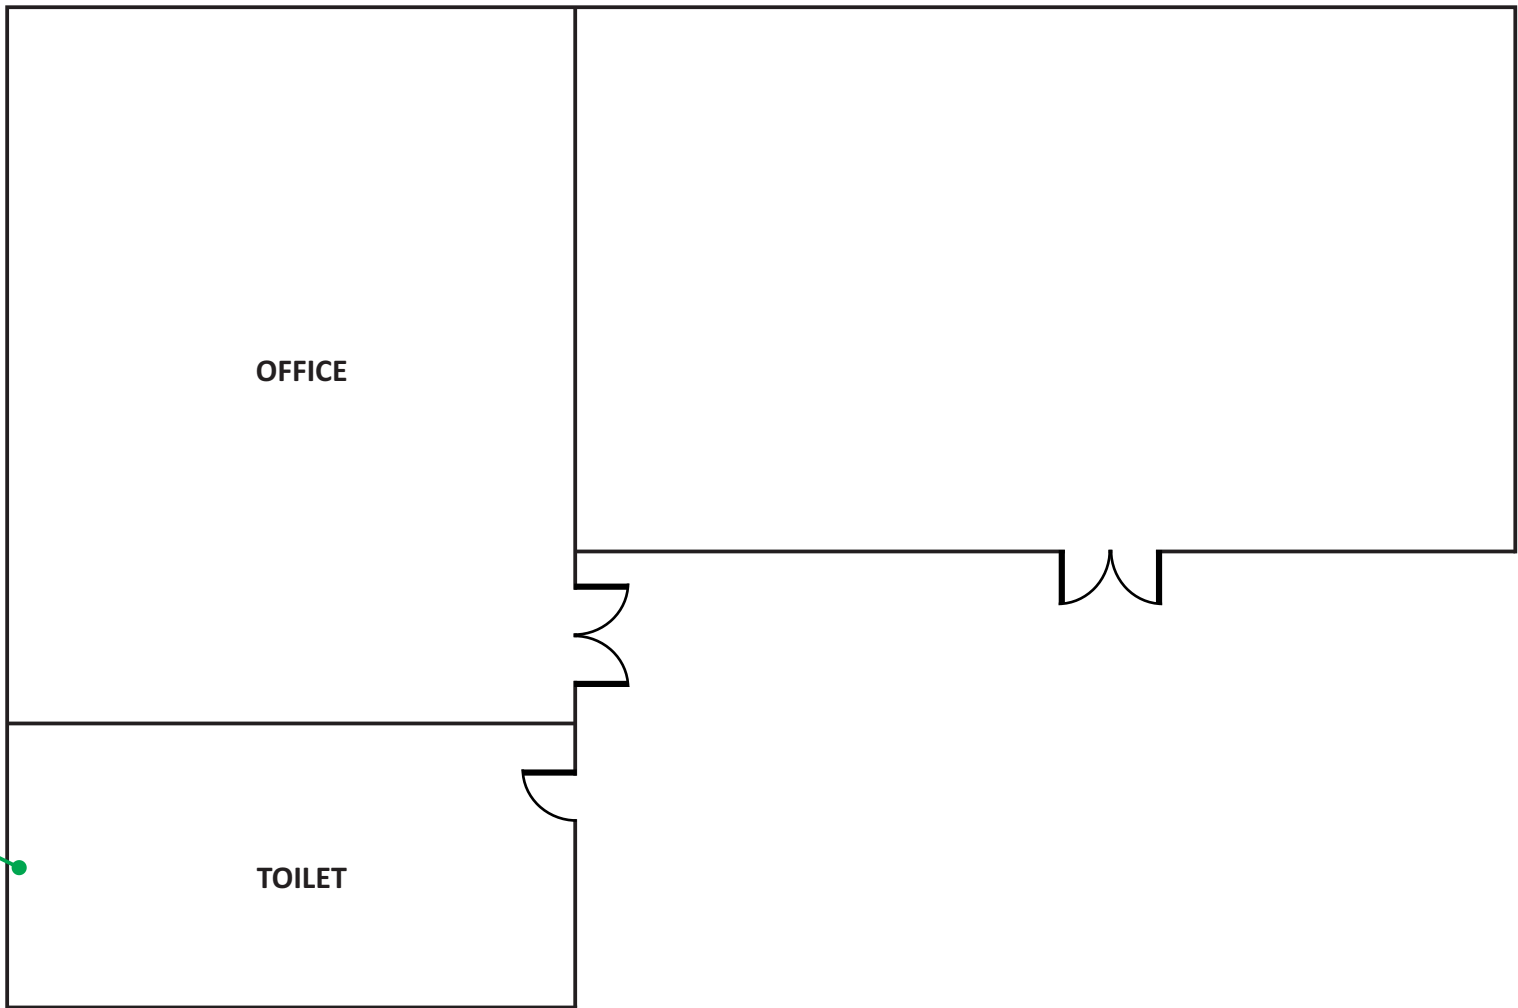
Figure number: 1
Revision: 2

*Only asbestos-containing materials (ACM) have been labelled on the attached site plan to prevent confusion and ensure that these materials are given priority for action. Therefore, other hazardous materials may be present within the building and the register attached in **Section 1** should be consulted prior to work commencing.*
