Hazardous Building Materials Assessment Leichhardt Oval No. 2 – Toilet Block / Change Room Glover Street, Lilyfield NSW 2040

Inner West Council
April 2018

Executive Summary

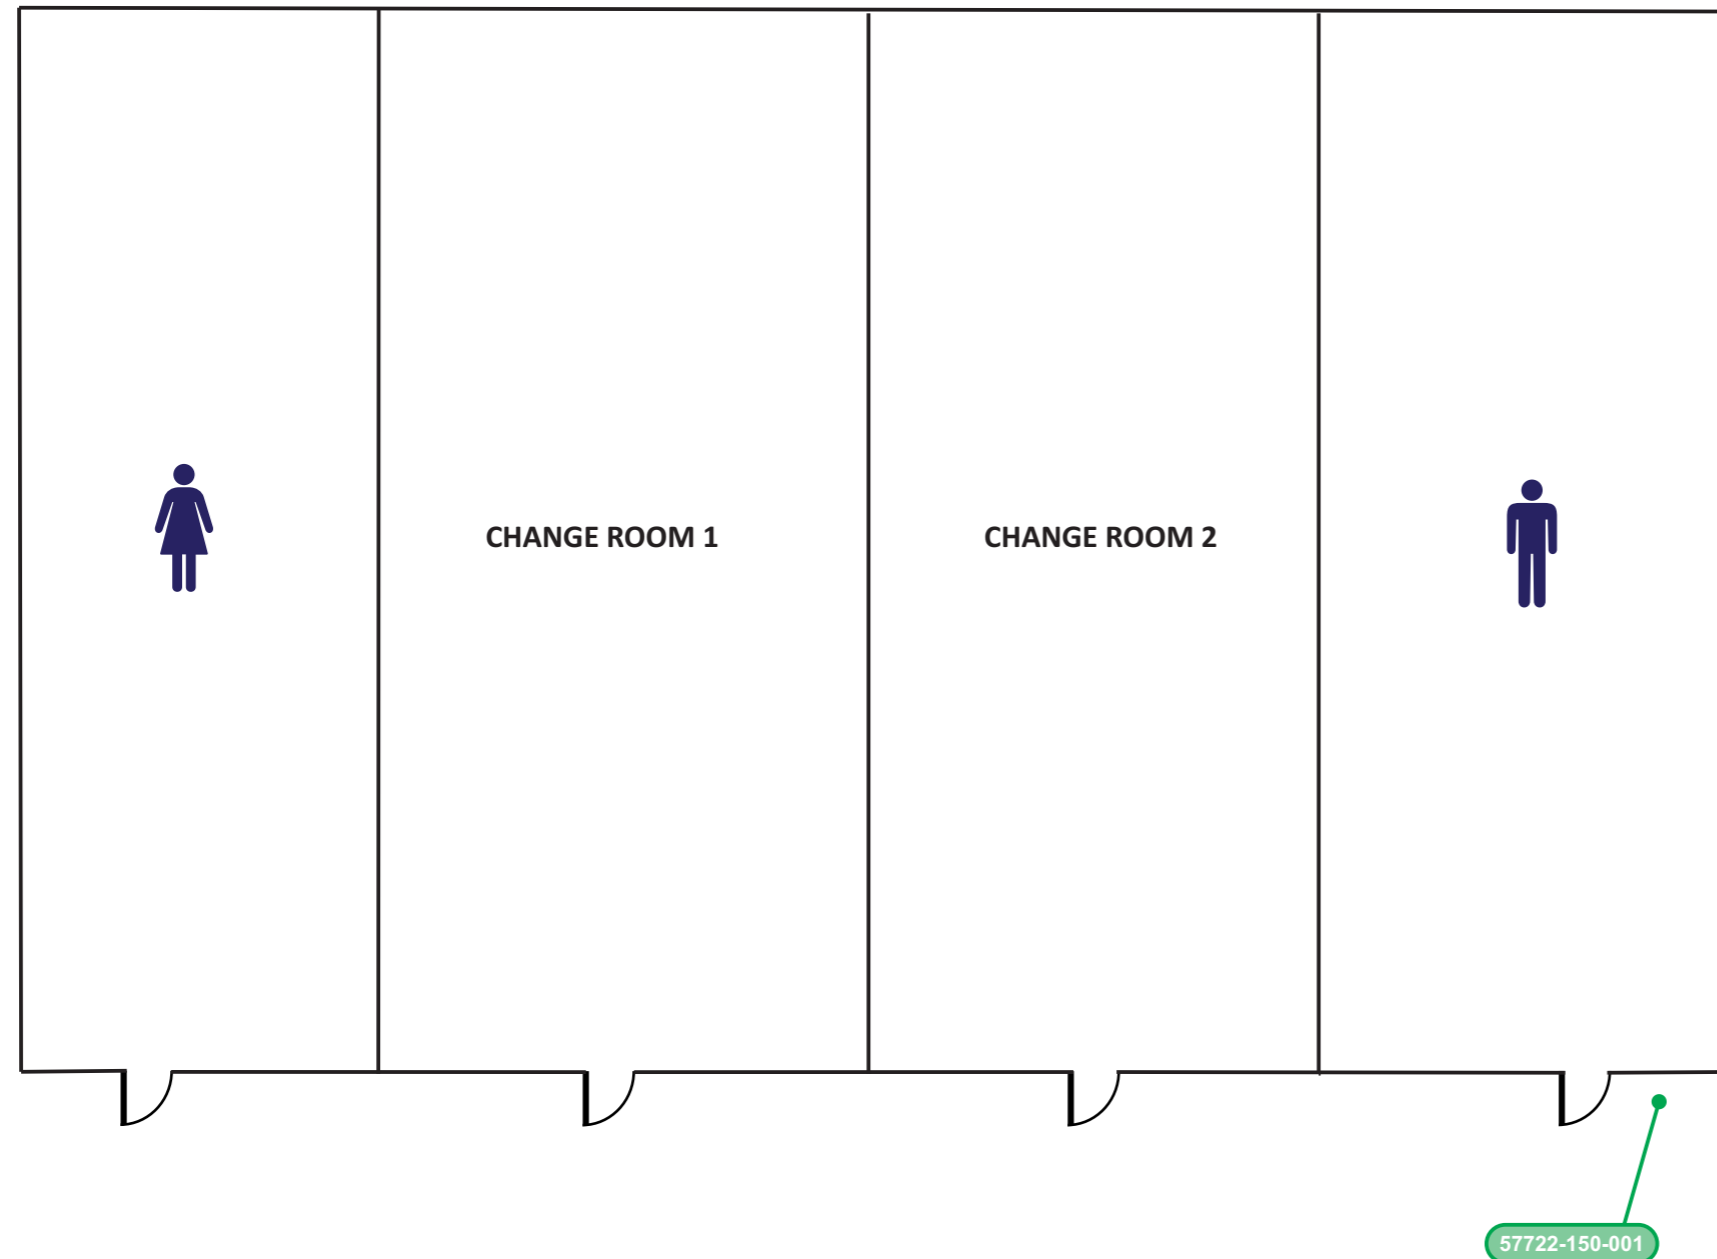
Leichhardt Oval No. 2 Toilet Block/ Change rooms Lilyfield-Ground Level

*Only asbestos-containing materials (ACM) have been labelled on the attached site plan to prevent confusion and ensure that these materials are given priority for action. Therefore, other hazardous materials may be present within the building and the register attached in **Section 1** should be consulted prior to work commencing.*
