# Hazardous Building Materials Assessment Leichhardt Oval No.1 Amenities (Female) Mary Street, Lilyfield NSW 2040

Inner West Council  
April 2018

Prensa Pty Ltd (Prensa) was engaged by Inner West Council (IWC) to conduct a Hazardous Building Materials Assessment (Assessment) of Leichhardt Oval No.1 - Amenities (Female) located at Mary Street, Lilyfield NSW 2040 (the site). Mackenzie Morrison, Andrew Pittaway and Jessica Wood of Prensa conducted the Assessment on 27<sup>th</sup> February 2018 at the request of Rick Jarvis of IWC.

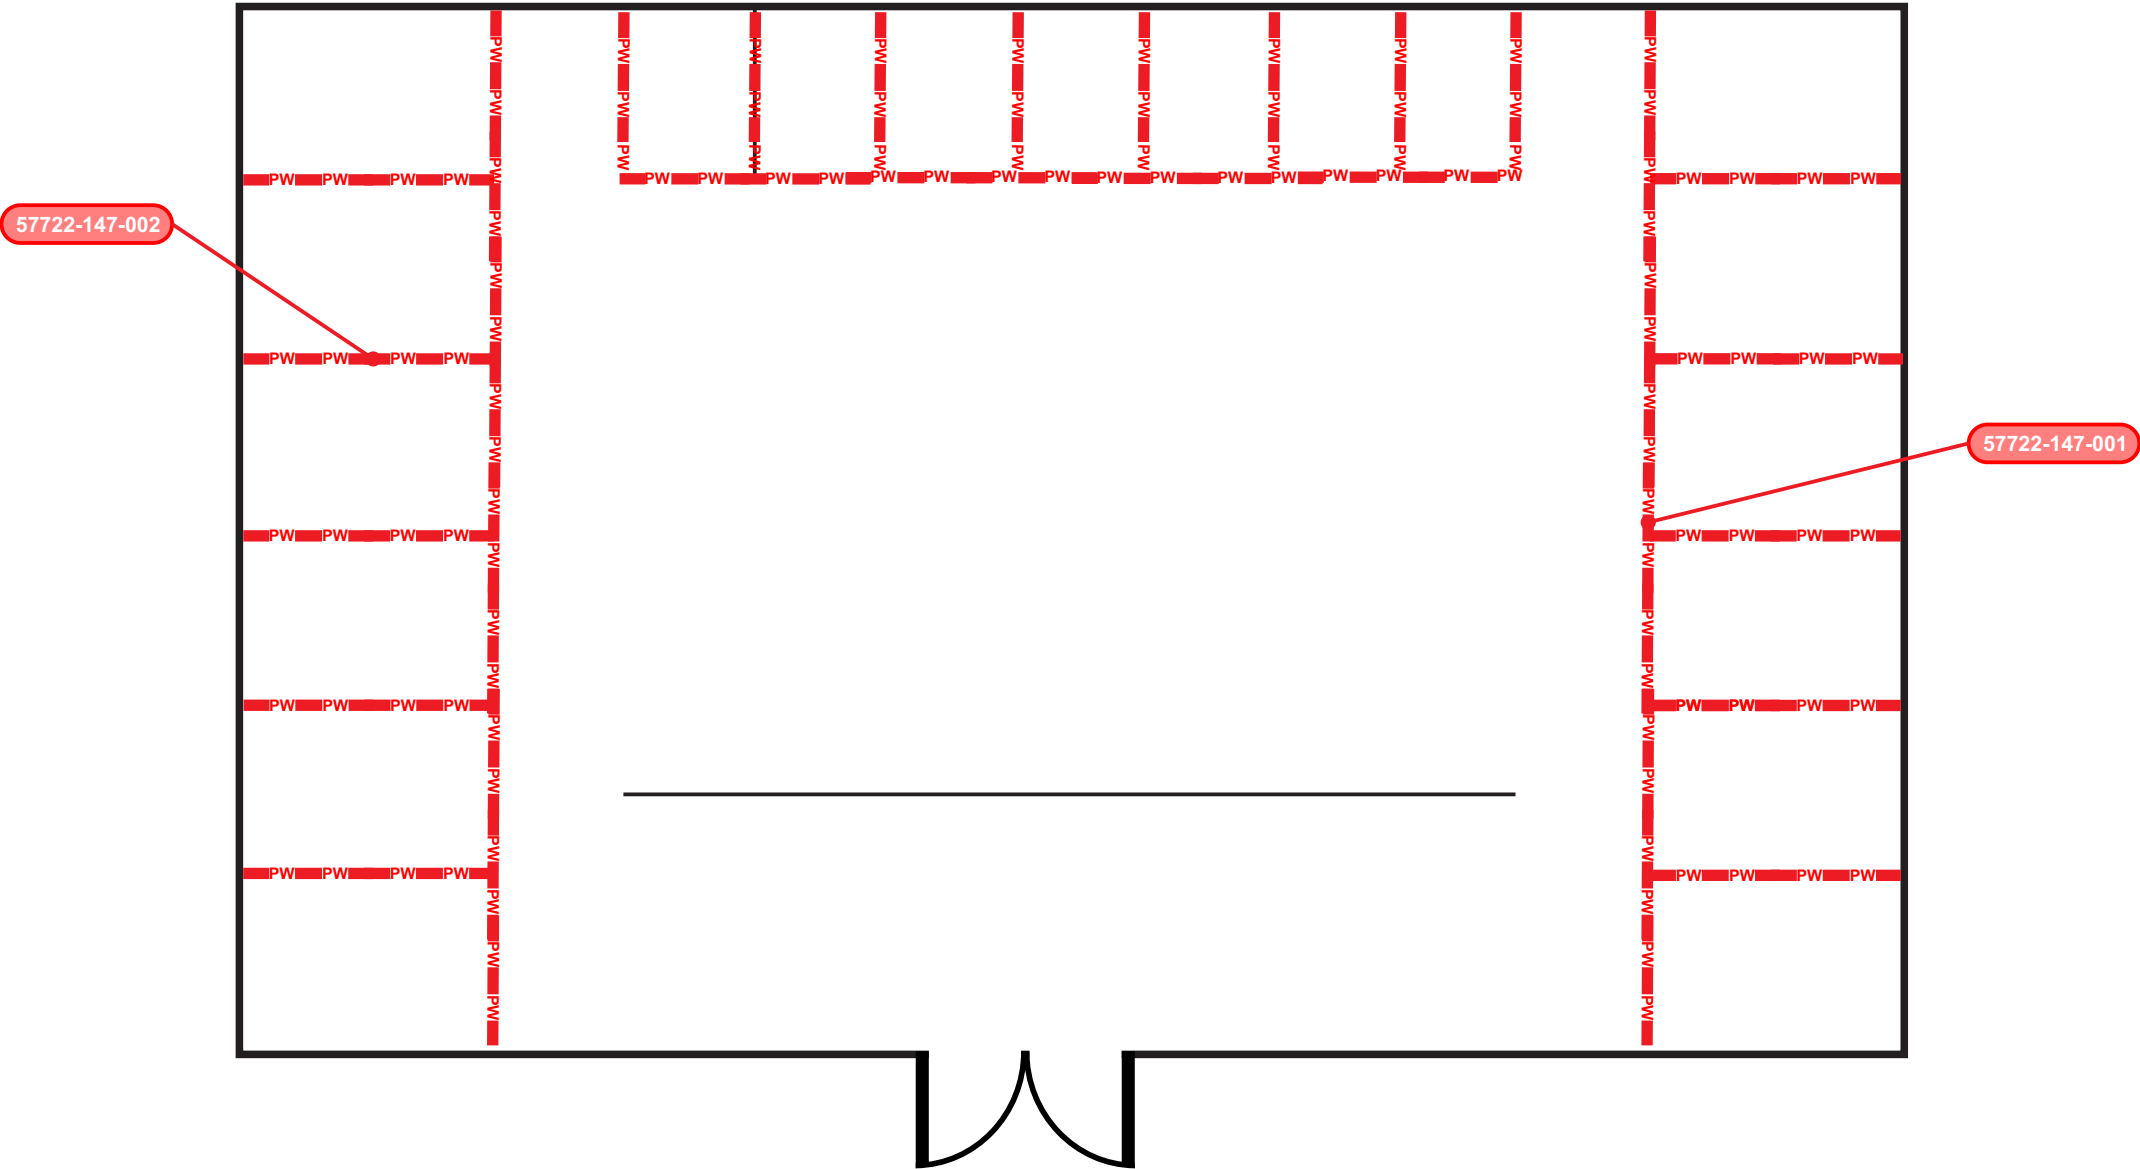
Drawn by: SL	Date: 10/04/2018
Checked by: MM	Date: 10/04/2018
Figure number: 1	Revision: 3
File name: 57722-147 - Rev 3

*Only asbestos-containing materials (ACM) have been labelled on the attached site plan to prevent confusion and ensure that these materials are given priority for action. Therefore, other hazardous materials may be present within the building and the register attached in **Section 1** should be consulted prior to work commencing.*
