Hazardous Building Materials Assessment Leichhardt Oval No.1 Pump Room (East) Mary Street Lilyfield NSW 2040

Inner West Council
April 2018

Job No.: 57722-058

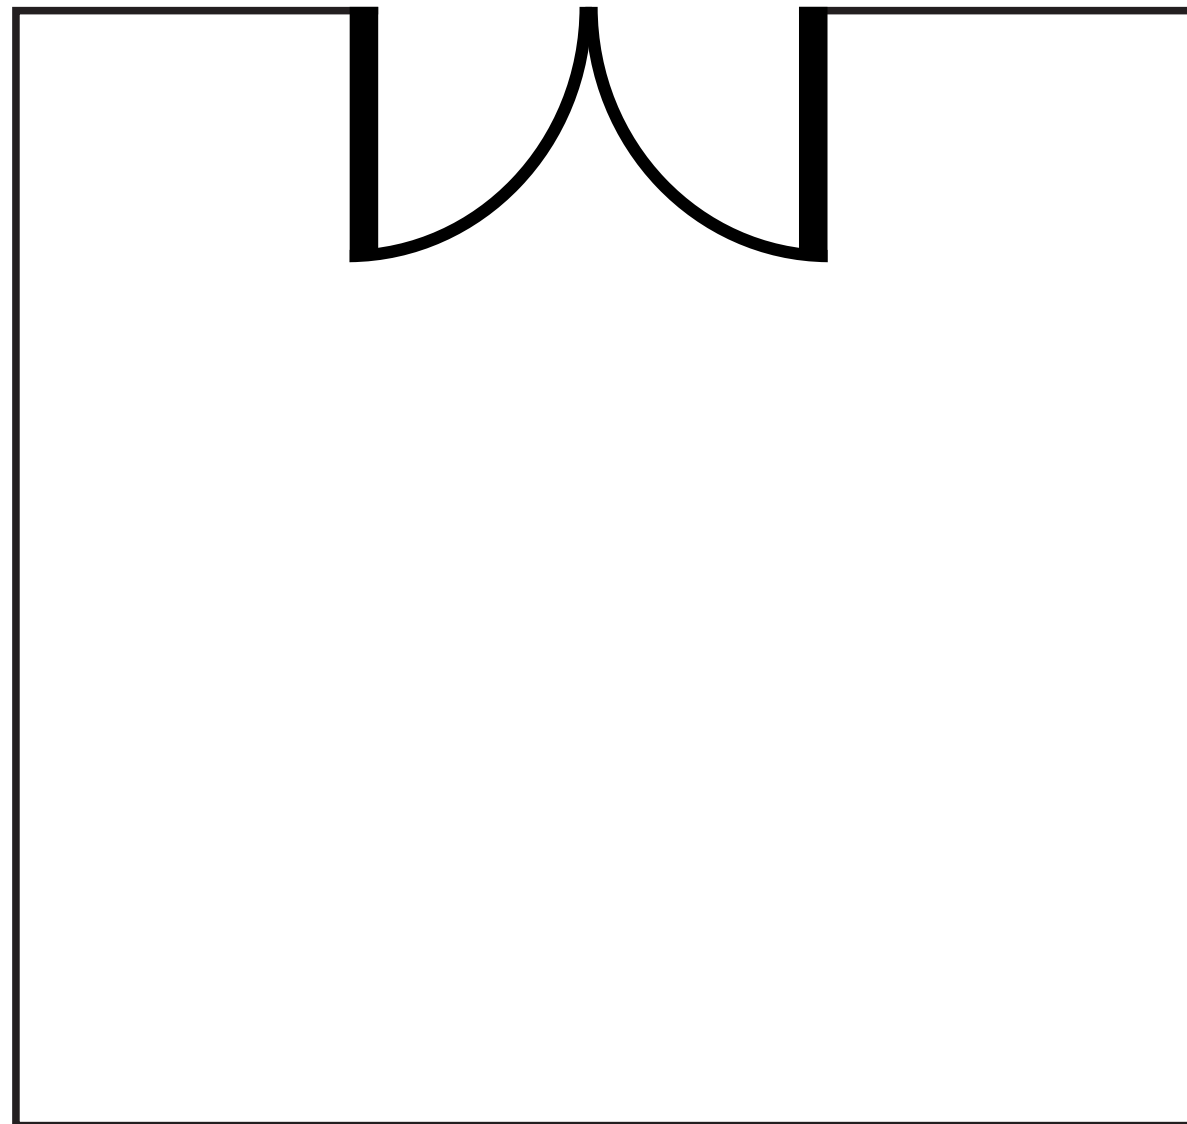
Leichhardt Oval No.1 Pump House, Lilyfield - Ground Level

*Only asbestos-containing materials (ACM) have been labelled on the attached site plan to prevent confusion and ensure that these materials are given priority for action. Therefore, other hazardous materials may be present within the building and the register attached in **Section 1** should be consulted prior to work commencing.*
