Hazardous Building Materials Assessment Leichhardt Oval No.1 - Scoreboard & Kiosk Mary Street Lilyfield NSW 2040

Inner West Council
April 2018

Job No.: 57722-055

Count ID: CID: 216

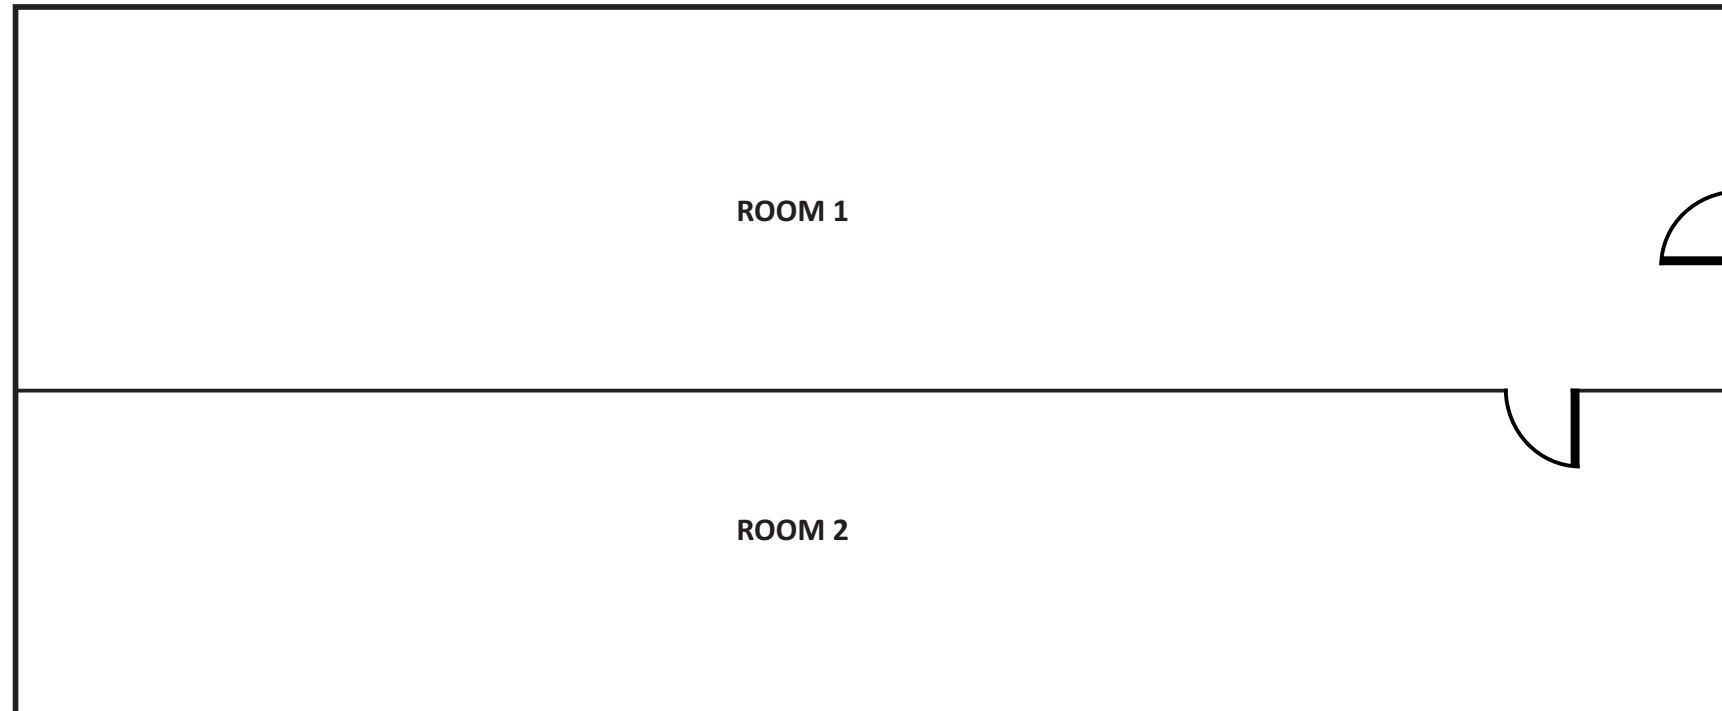
Leichhardt Oval No. 1 Scoreboard/Kiosk Lilyfield - Ground Level

*Only asbestos-containing materials (ACM) have been labelled on the attached site plan to prevent confusion and ensure that these materials are given priority for action. Therefore, other hazardous materials may be present within the building and the register attached in **Section 1** should be consulted prior to work commencing.*

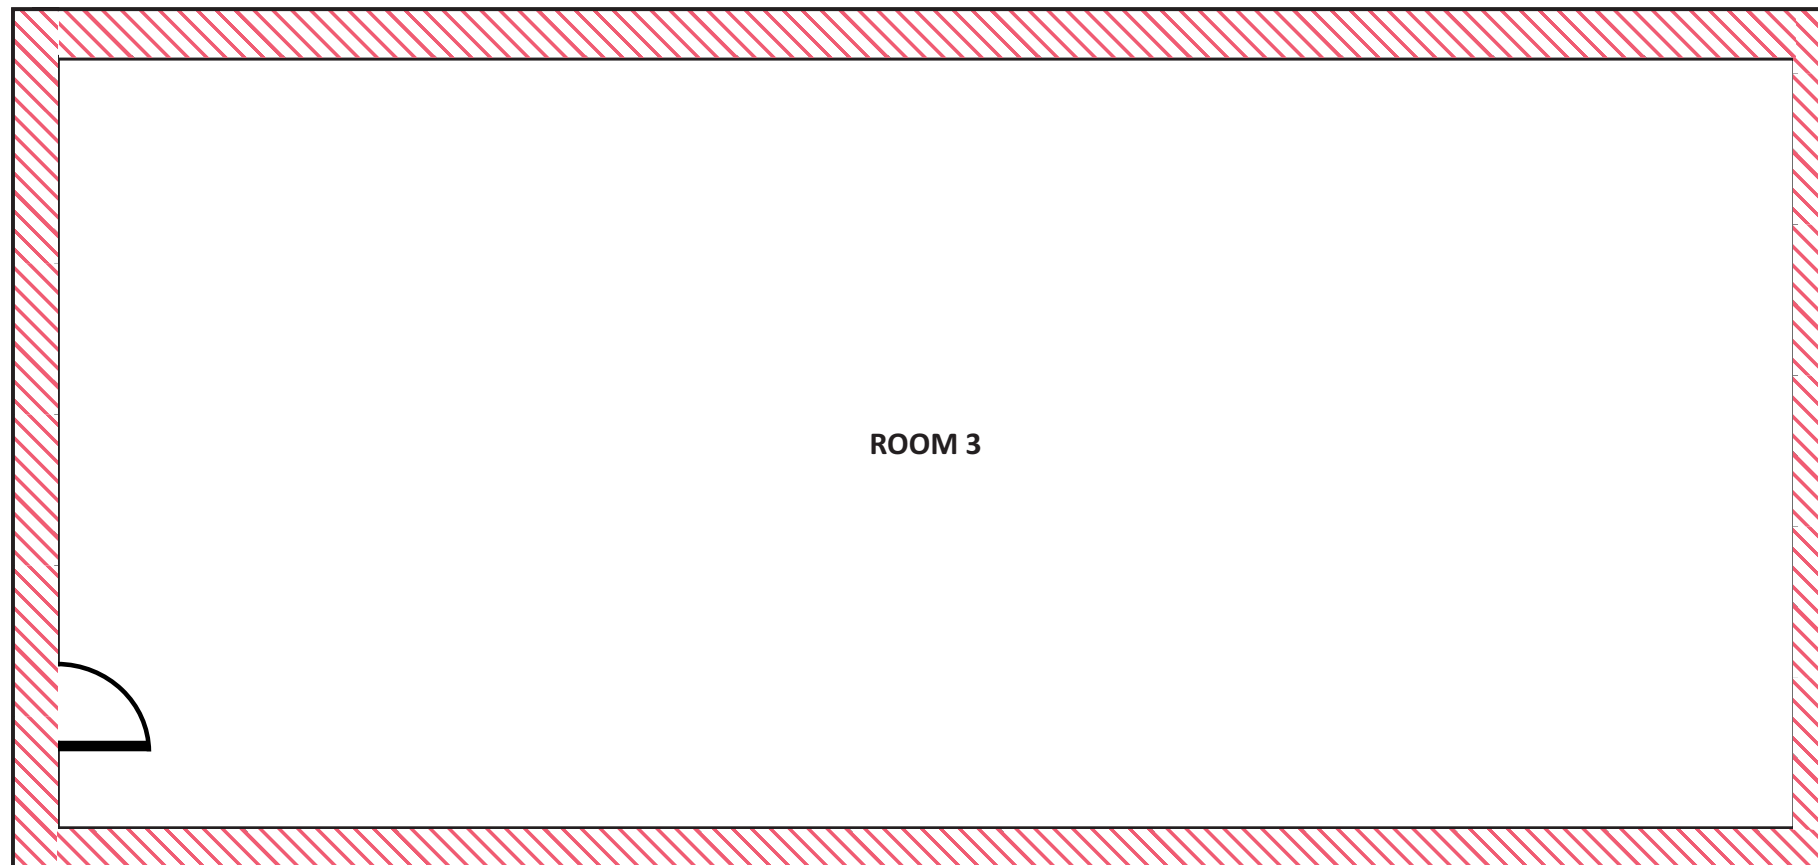
Leichhardt Oval No. 1 Scoreboard/Kiosk Lilyfield - Level 1

Eaves
