Hazardous Building Materials Assessment Leichhardt Oval No.1 - Turnstiles (Mary St) Mary Street, Lilyfield NSW 2040

Inner West Council
April 2018

Job No.: 57722-146

Executive Summary

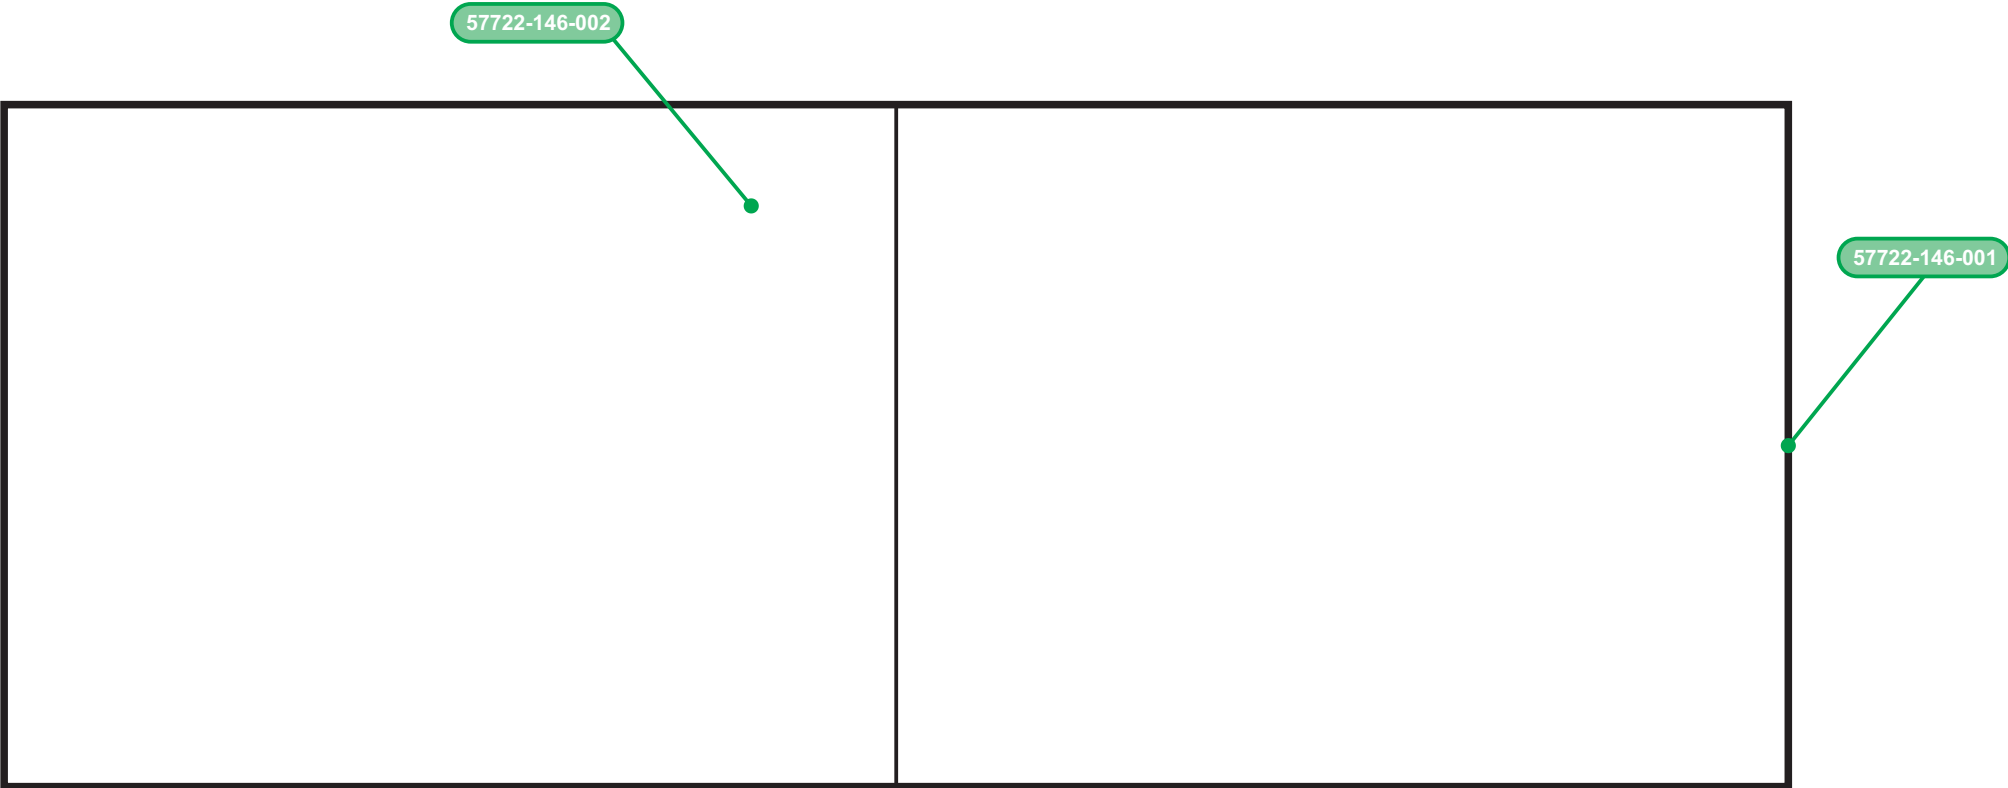
Leichhardt Oval No.1 Turnstiles (Mary St) Lilyfield - Ground Level

*Only asbestos-containing materials (ACM) have been labelled on the attached site plan to prevent confusion and ensure that these materials are given priority for action. Therefore, other hazardous materials may be present within the building and the register attached in **Section 1** should be consulted prior to work commencing.*
