Hazardous Building Materials Assessment Leichhardt Oval No.1 – Underground Toilets Mary Street, Lilyfield NSW 2040

Inner West Council
April 2018

Prensa Pty Ltd (Prensa) was engaged by Inner West Council (IWC) to conduct a Hazardous Building Materials Assessment (Assessment) of Leichhardt Oval No.1 – Underground Toilets located at Mary Street, Lilyfield NSW 2040 (the site). Mackenzie Morrison, Charly Golding and Jessica Wood of Prensa conducted the Assessment on 27th February 2018 at the request of Rick Jarvis of IWC.

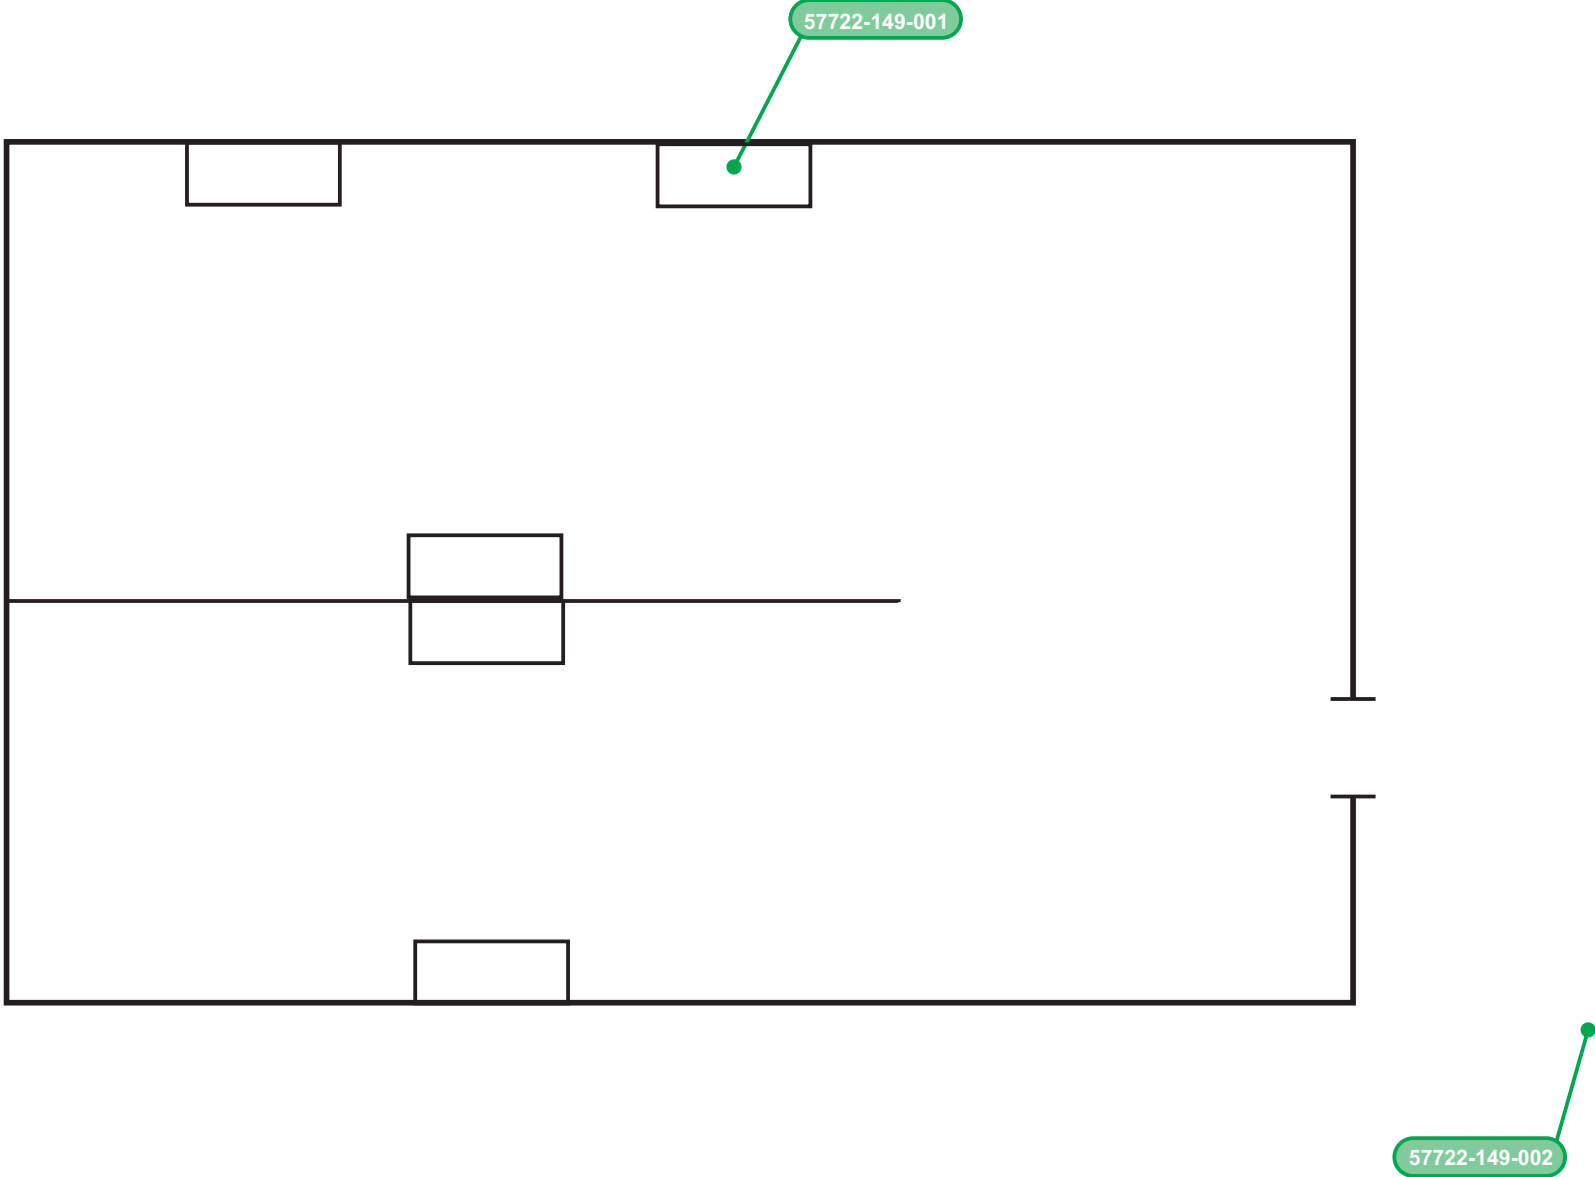
Drawn by: TME	Date: 10/04/2018
Checked by: MM	Date: 10/04/2018
Figure number: 1	Revision: 3
File name: 57722-149 - Rev 3

*Only asbestos-containing materials (ACM) have been labelled on the attached site plan to prevent confusion and ensure that these materials are given priority for action. Therefore, other hazardous materials may be present within the building and the register attached in **Section 1** should be consulted prior to work commencing.*
