Hazardous Building Materials Assessment

Enmore Resource Centre

Enmore & Victoria Roads

Inner West Council
April 2018

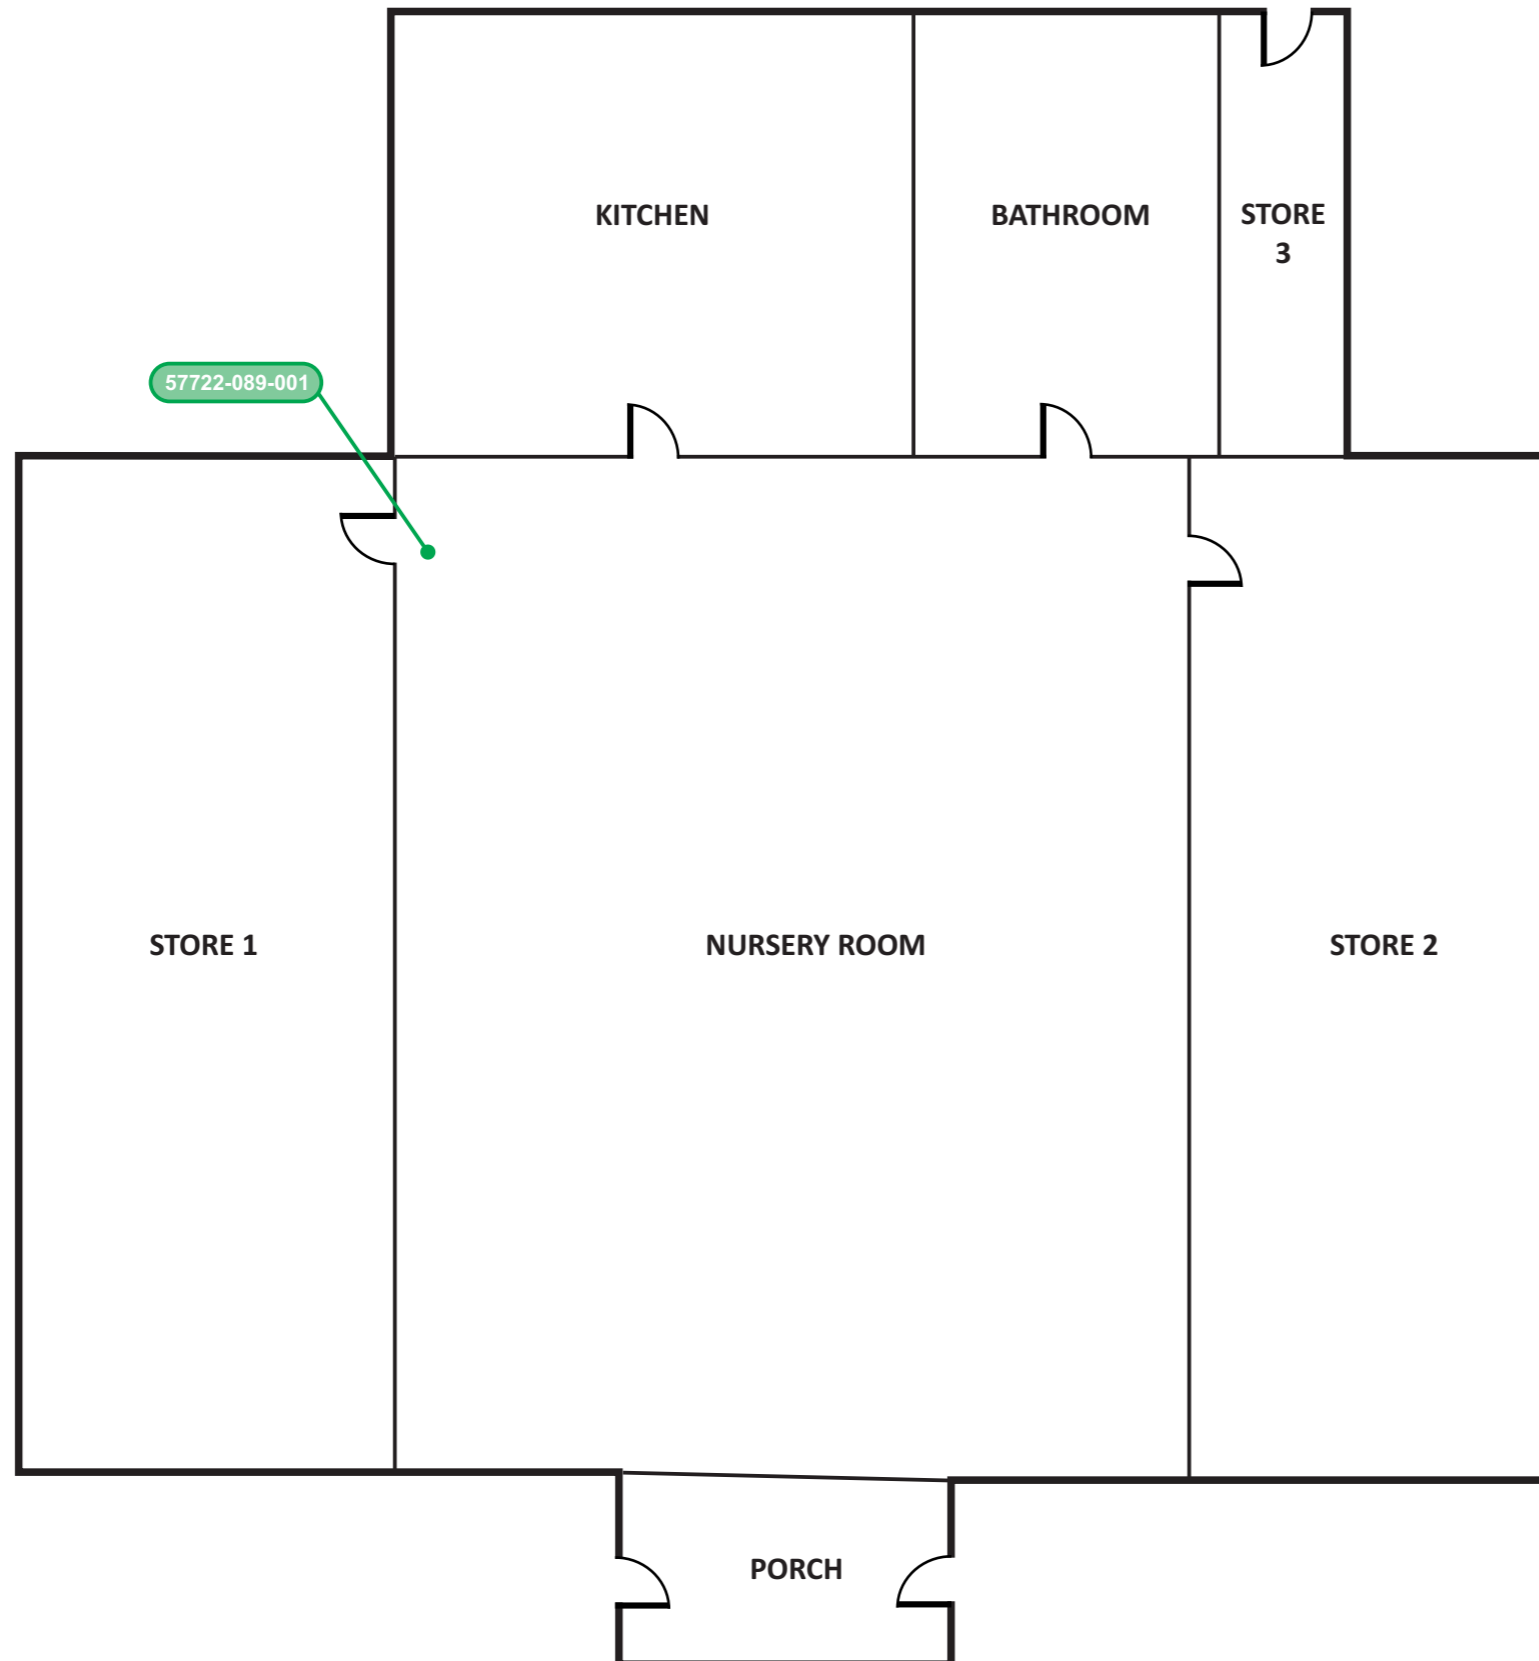
Enmore Resource Centre Marrickville- Ground Level

*Only asbestos-containing materials (ACM) have been labelled on the attached site plan to prevent confusion and ensure that these materials are given priority for action. Therefore, other hazardous materials may be present within the building and the register attached in **Section 1** should be consulted prior to work commencing.*
