Hazardous Building Materials Assessment Marrickville Park Croquet Club Fraser Street and Lawson Avenue Marrickville NSW 2204

Inner West Council
April 2018

Job No.: 57722-127

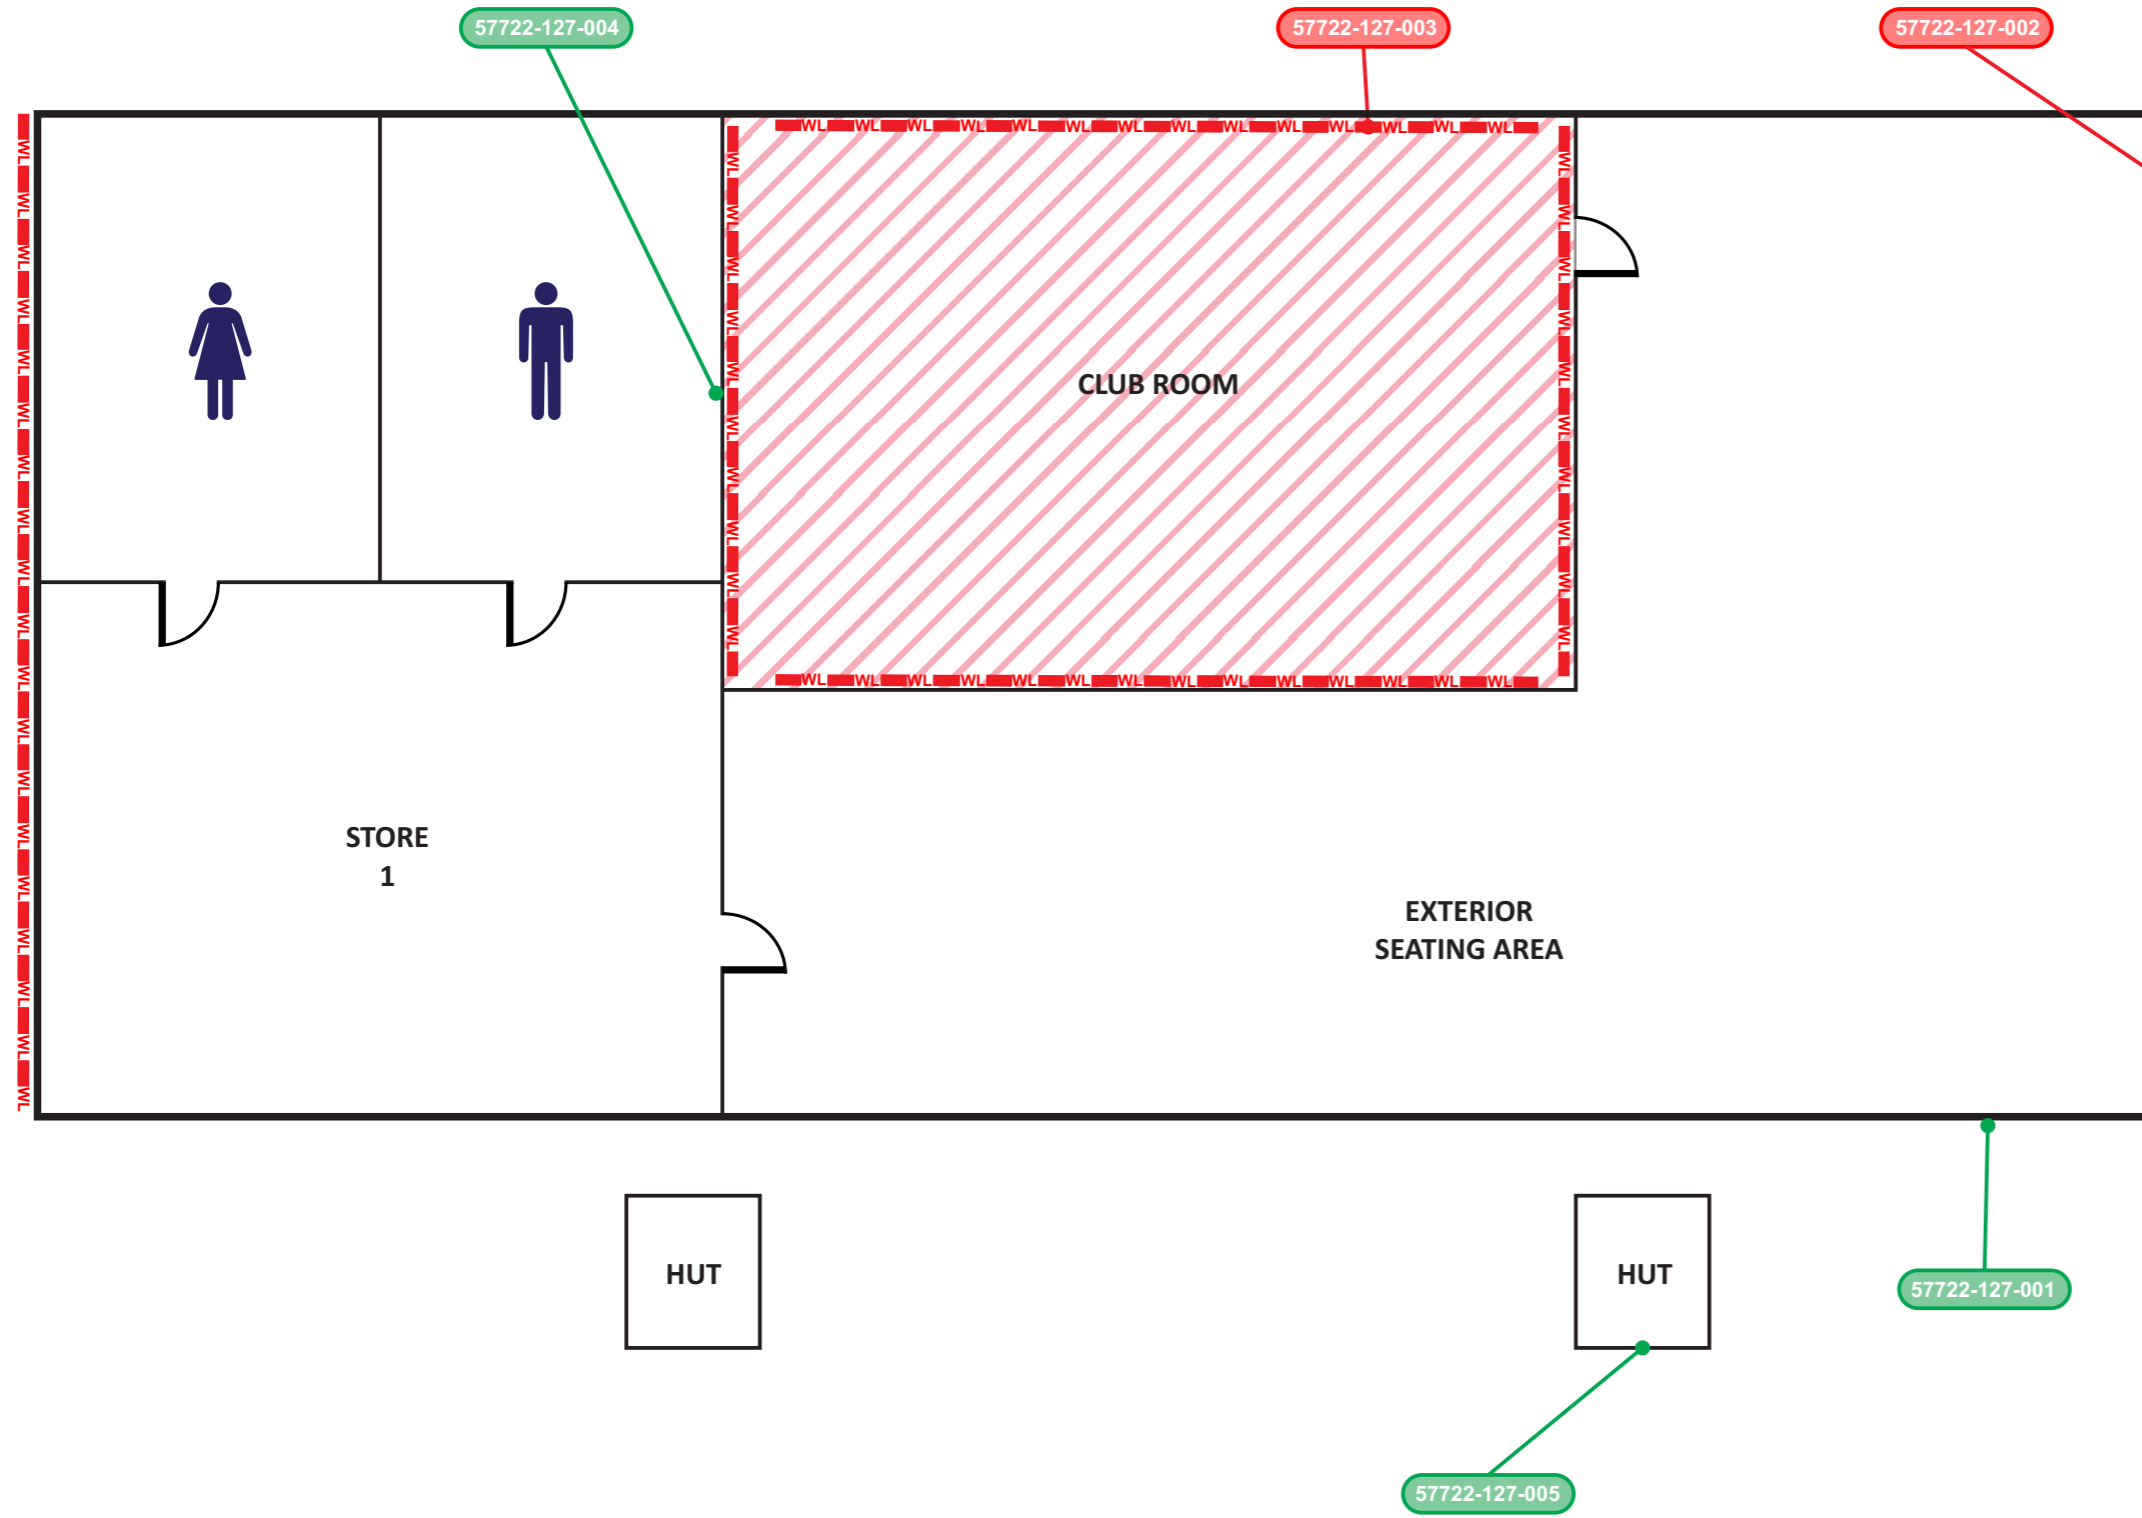
Marrickville Park Croquet Club - Ground Level

*Only asbestos-containing materials (ACM) have been labelled on the attached site plan to prevent confusion and ensure that these materials are given priority for action. Therefore, other hazardous materials may be present within the building and the register attached in **Section 1** should be consulted prior to work commencing.*
