Hazardous Building Materials Assessment

Marrickville Legal Centre

338 Illawarra Road
Marrickville NSW 2204

Inner West Council
April 2018

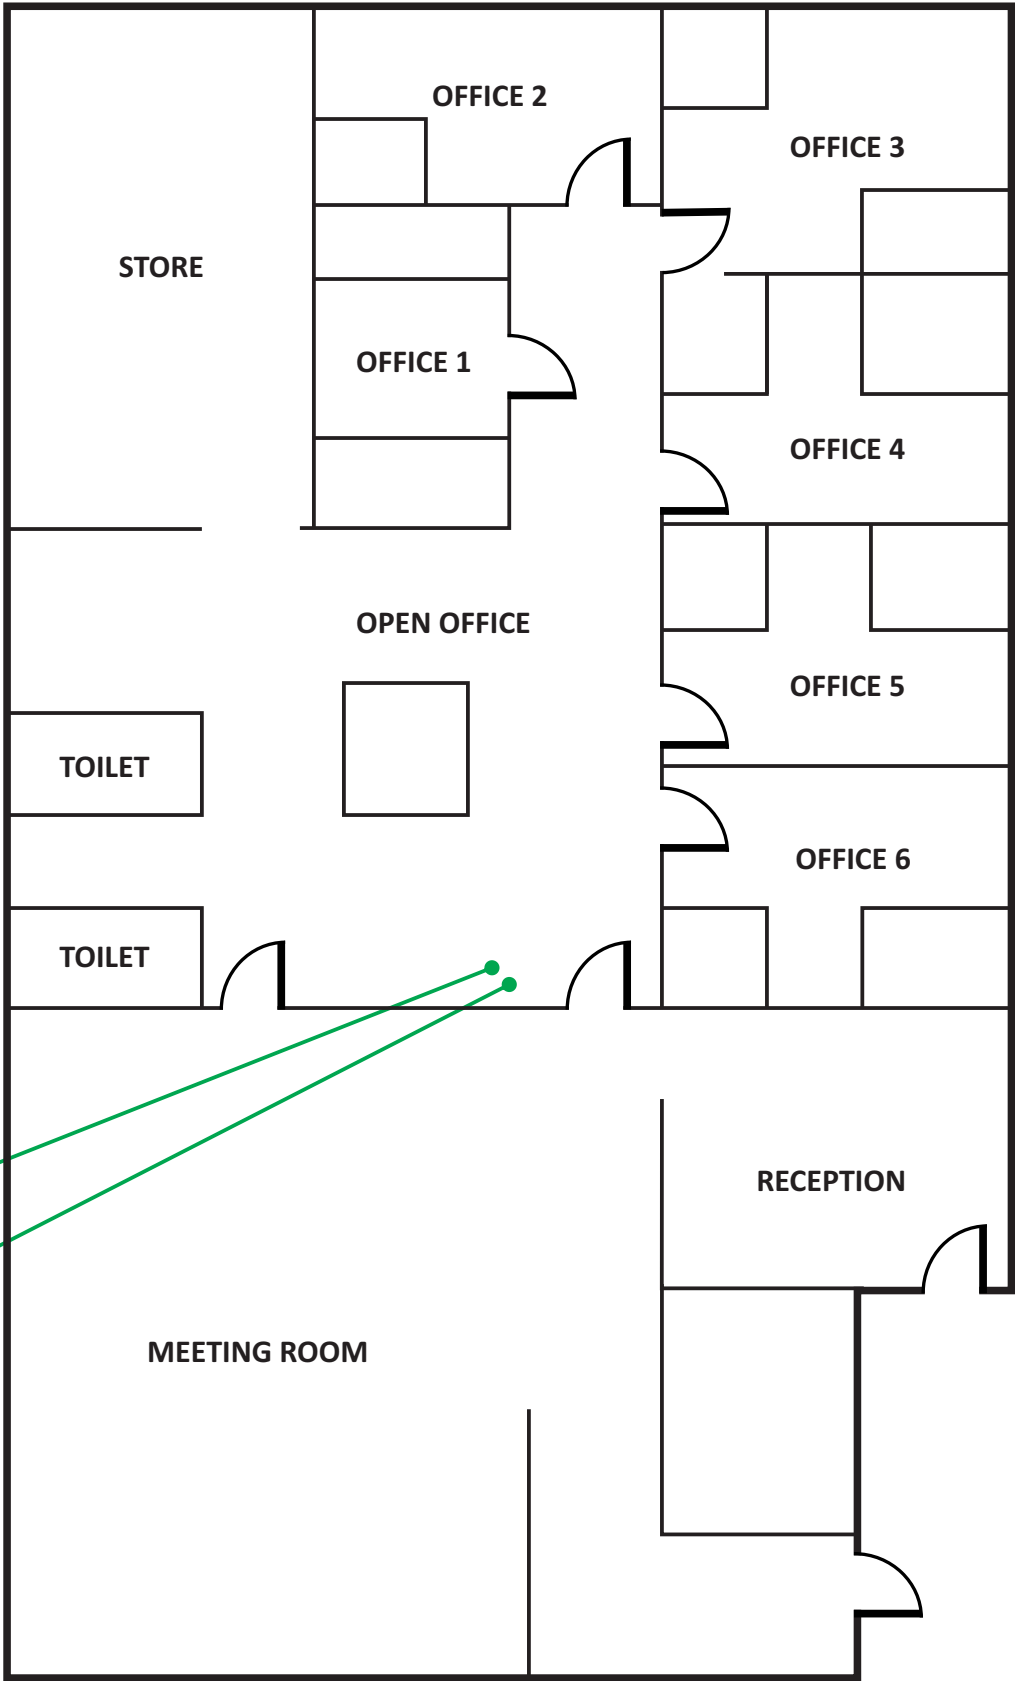
Client:	Inner West Council
Project:	Hazardous Building Materials Assessment
Address:	338 Illawarra Road, Marrickville NSW 2204
Drawing Title:	Marrickville Legal Centre
Job No.:	57722-057
Client No.:	S0149
IWC Code:	CID 259

*Only asbestos-containing materials (ACM) have been labelled on the attached site plan to prevent confusion and ensure that these materials are given priority for action. Therefore, other hazardous materials may be present within the building and the register attached in **Section 1** should be consulted prior to work commencing.*
