Hazardous Building Materials Assessment HJ Mahoney Memorial Reserve 531-565 Illawarra Road Marrickville NSW 2204

Inner West Council
April 2018

Job No.: 57722-123

Count ID: CID: 155

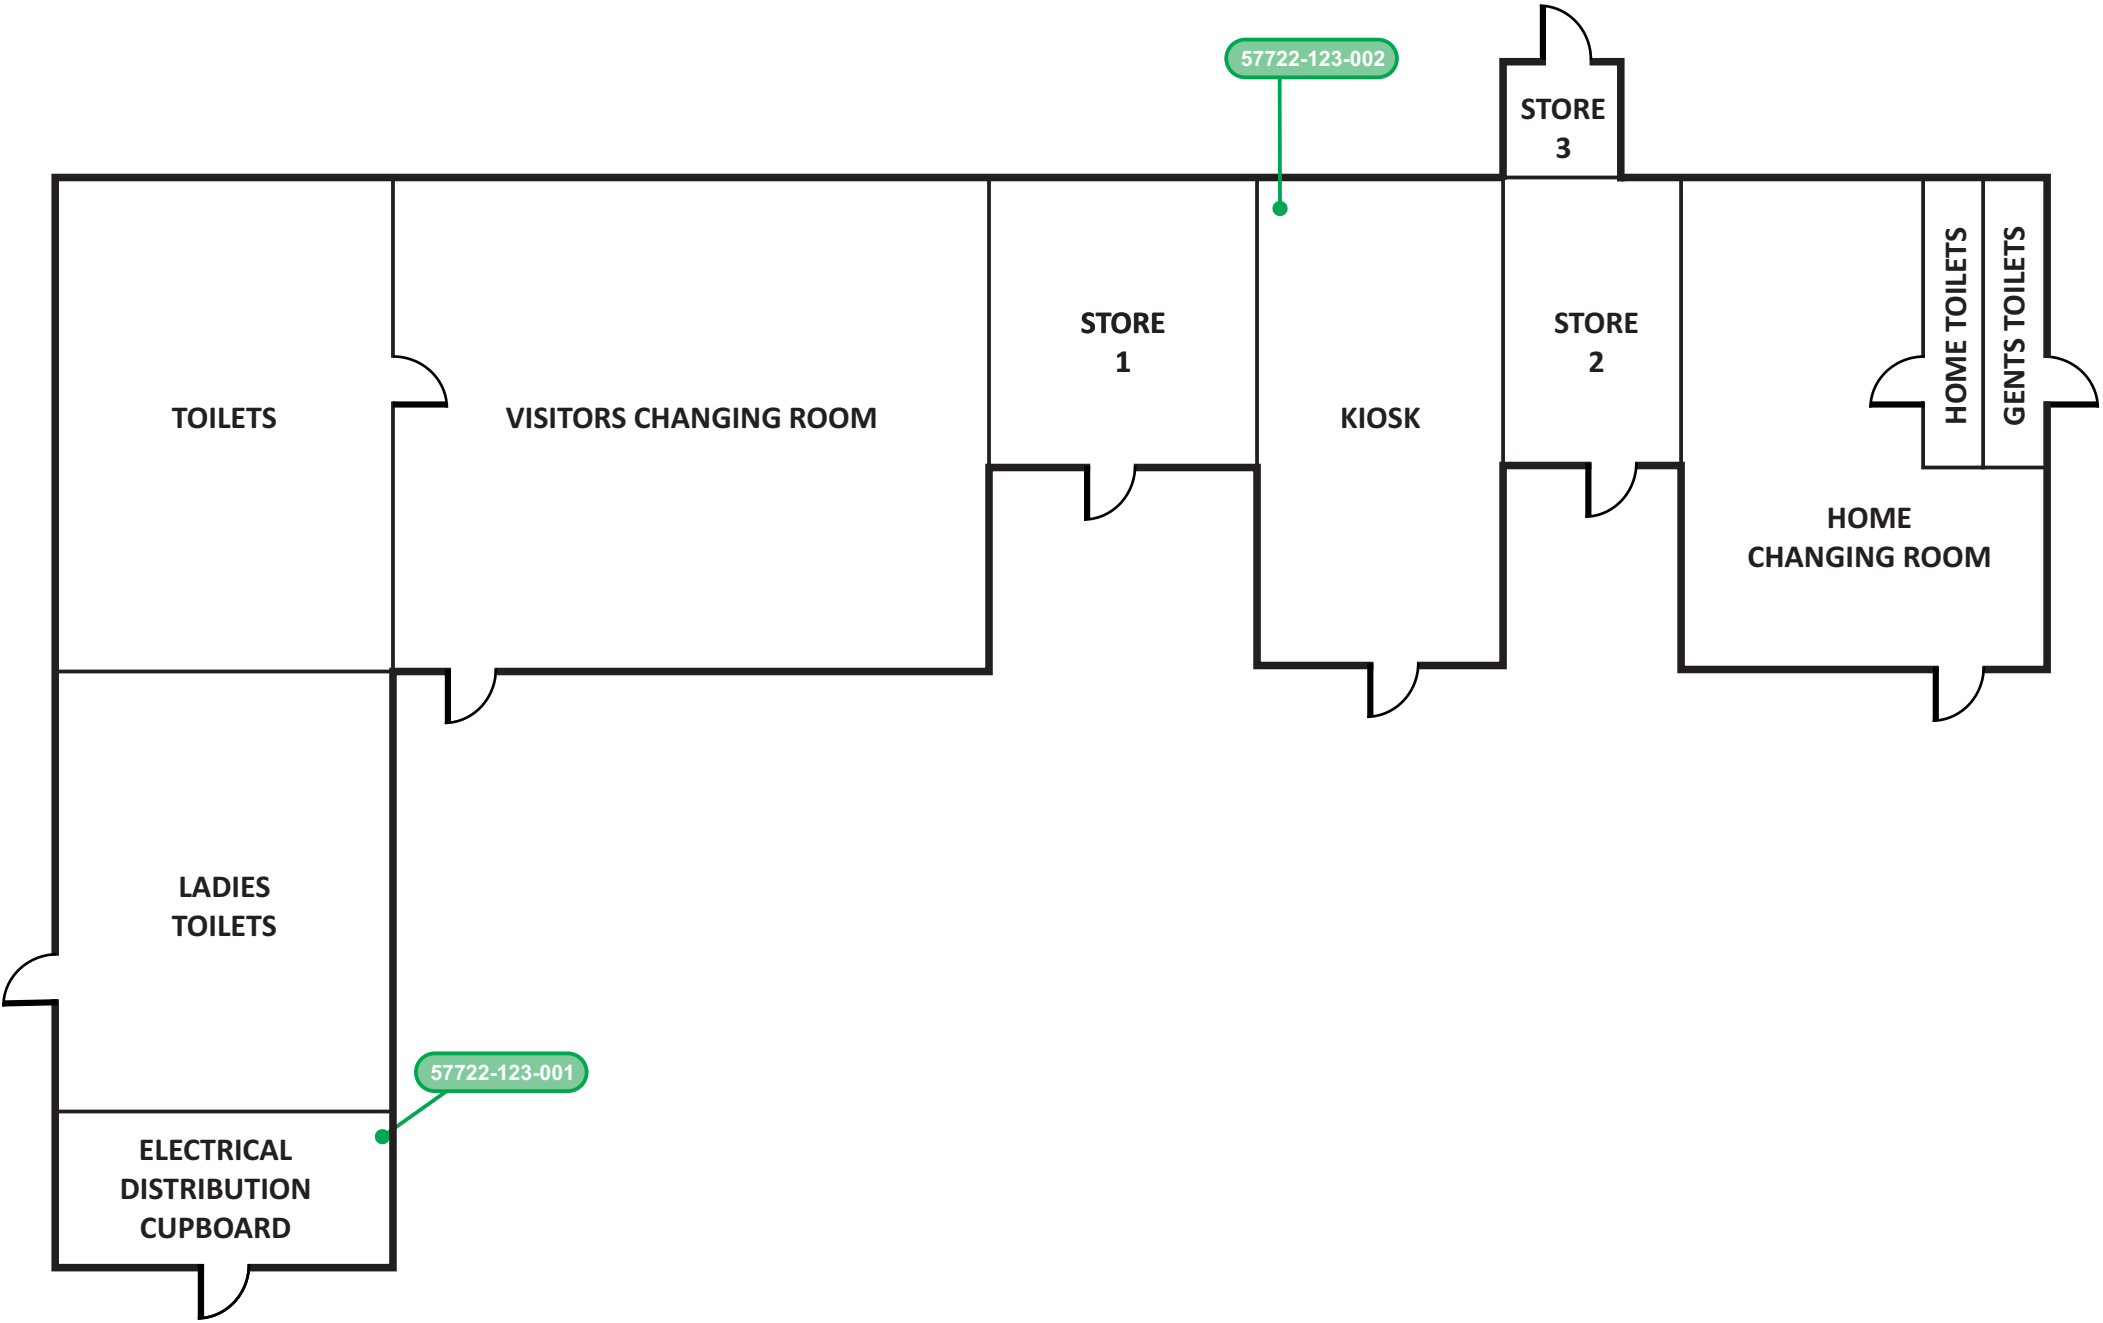
*Only asbestos-containing materials (ACM) have been labelled on the attached site plan to prevent confusion and ensure that these materials are given priority for action. Therefore, other hazardous materials may be present within the building and the register attached in **Section 1** should be consulted prior to work commencing.*
