Hazardous Building Materials Assessment Marrickville Park Tennis Club Livingstone Road Marrickville NSW 2204

Inner West Council
April 2018

Job No.: 57722-133

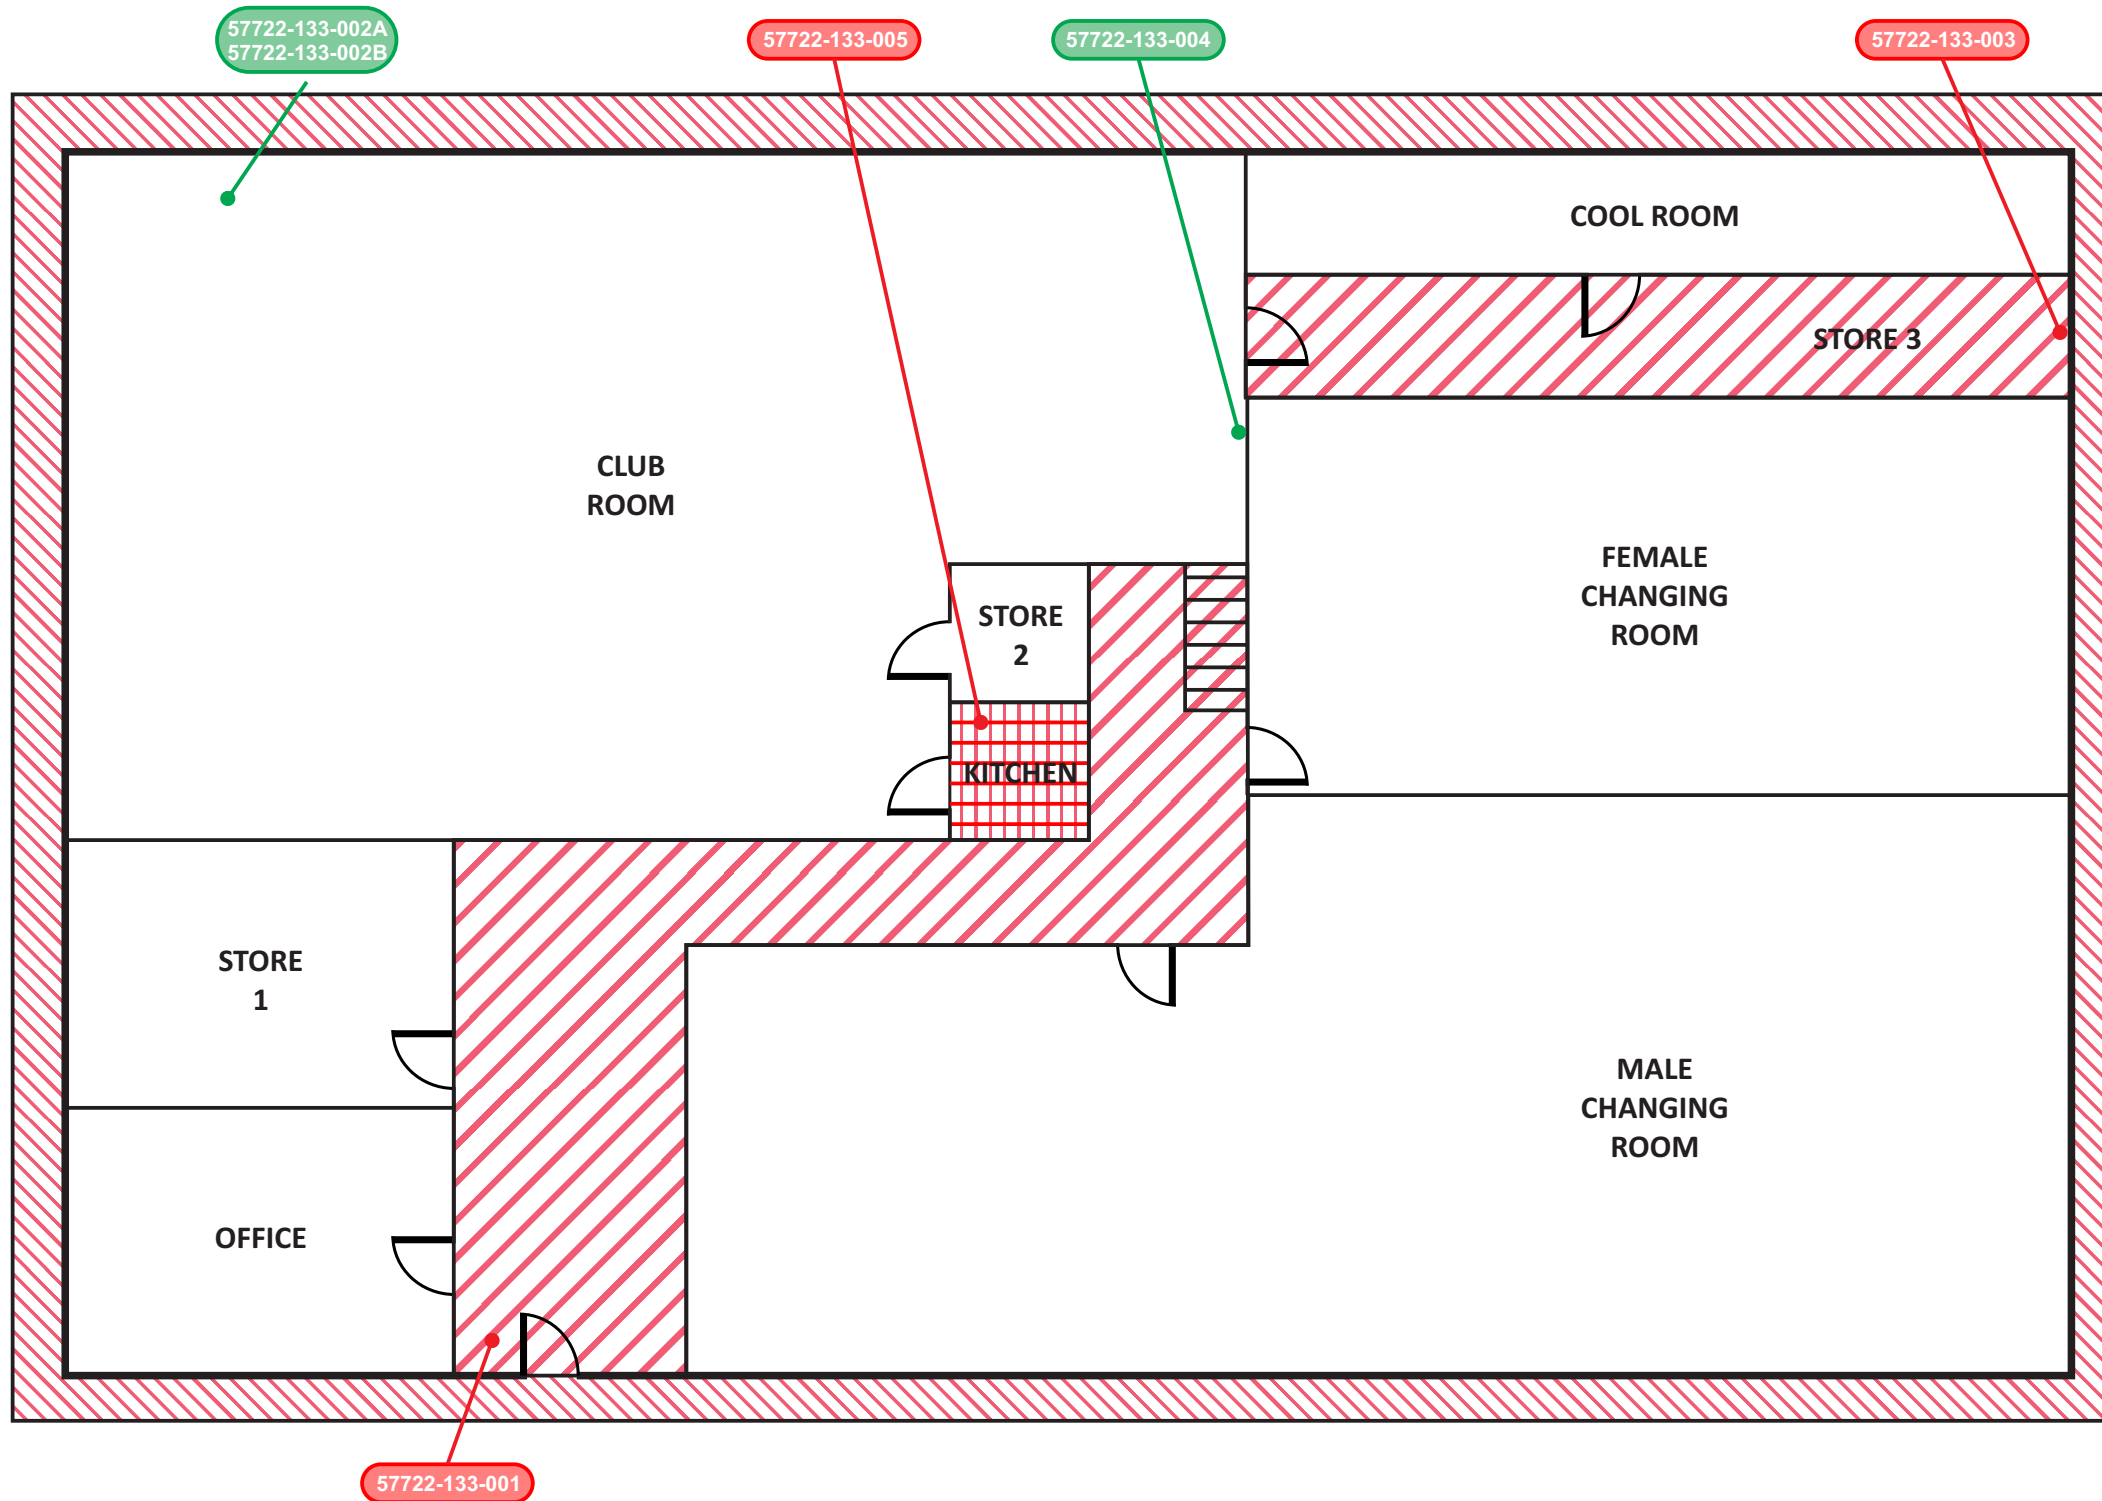
Marrickville Park Tennis Club House - Ground Level

*Only asbestos-containing materials (ACM) have been labelled on the attached site plan to prevent confusion and ensure that these materials are given priority for action. Therefore, other hazardous materials may be present within the building and the register attached in **Section 1** should be consulted prior to work commencing.*
