Hazardous Building Materials Assessment

May Murray Early Learning Centre

35 Premier Street
Marrickville NSW 2204

Inner West Council
April 2018

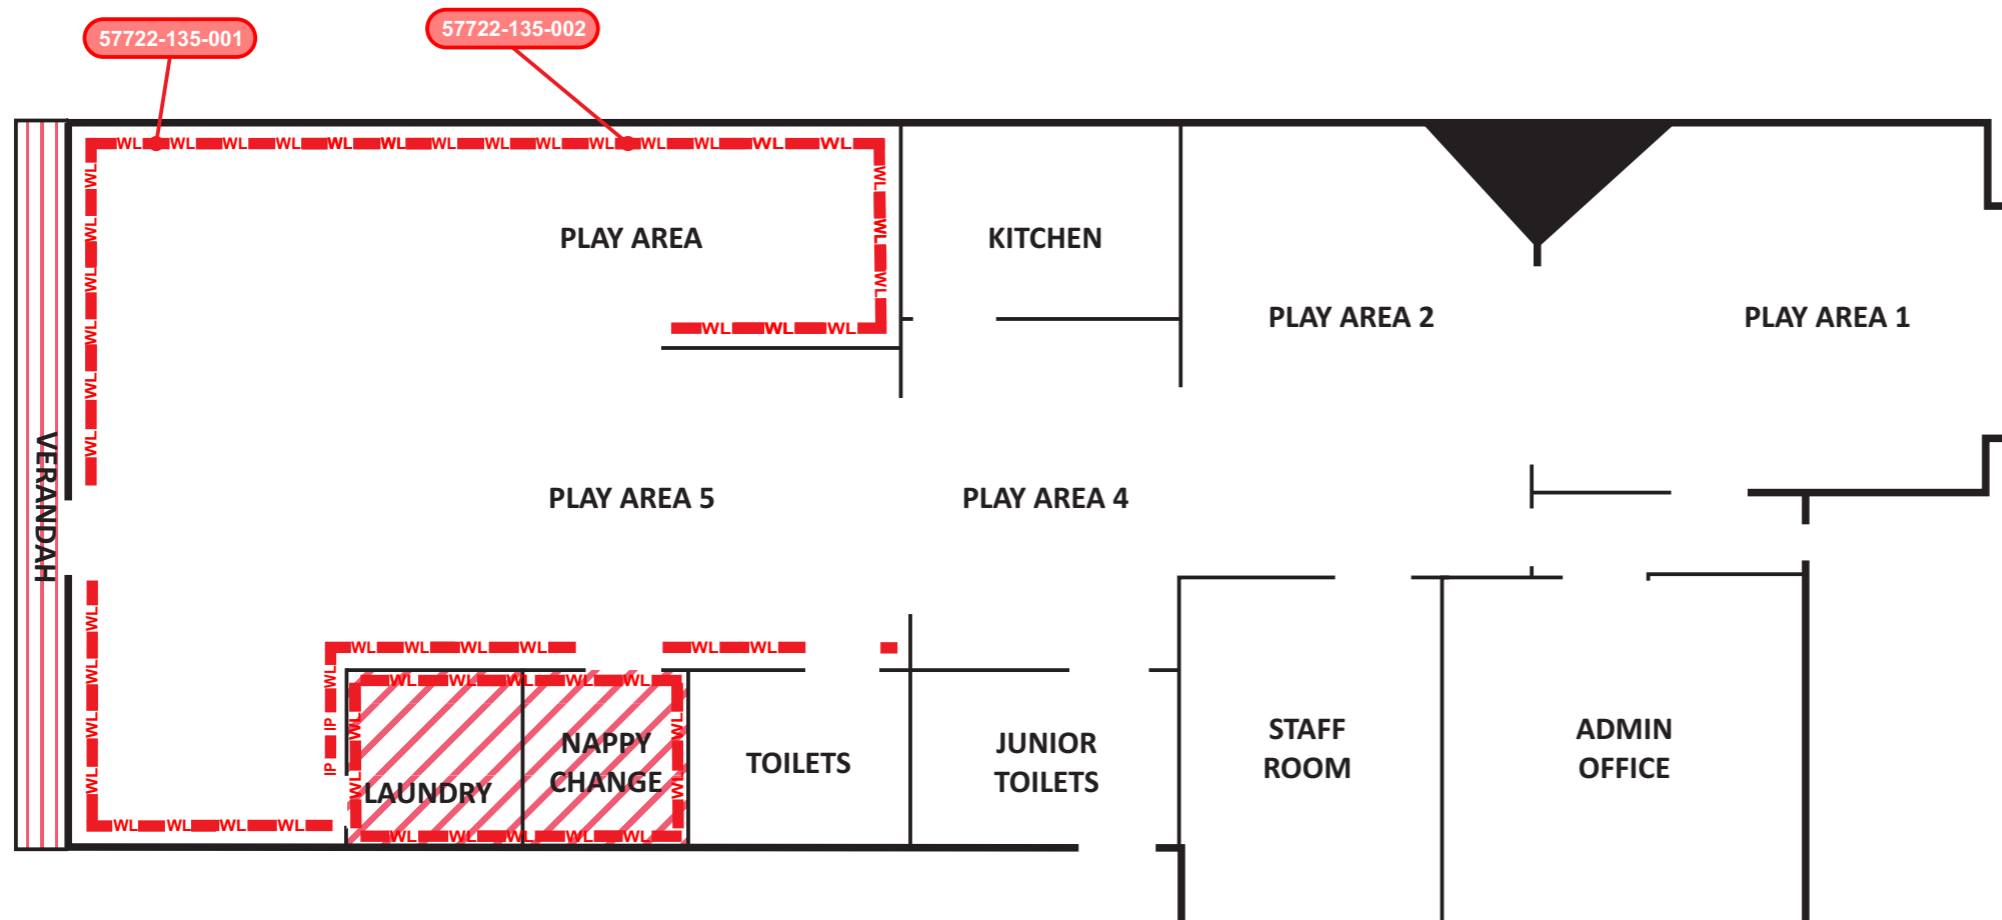
Drawn by: SL	Date: 17/05/2018
Checked by: MM	Date: 17/05/2018
Figure number: 1	Revision: 3
File name: 57722-135 - Rev 3

Infill Panel
