Hazardous Building Materials Assessment

Mackey Park Bowling Club

91 Sydenham Road
Marrickville NSW 2204

Inner West Council
April 2018

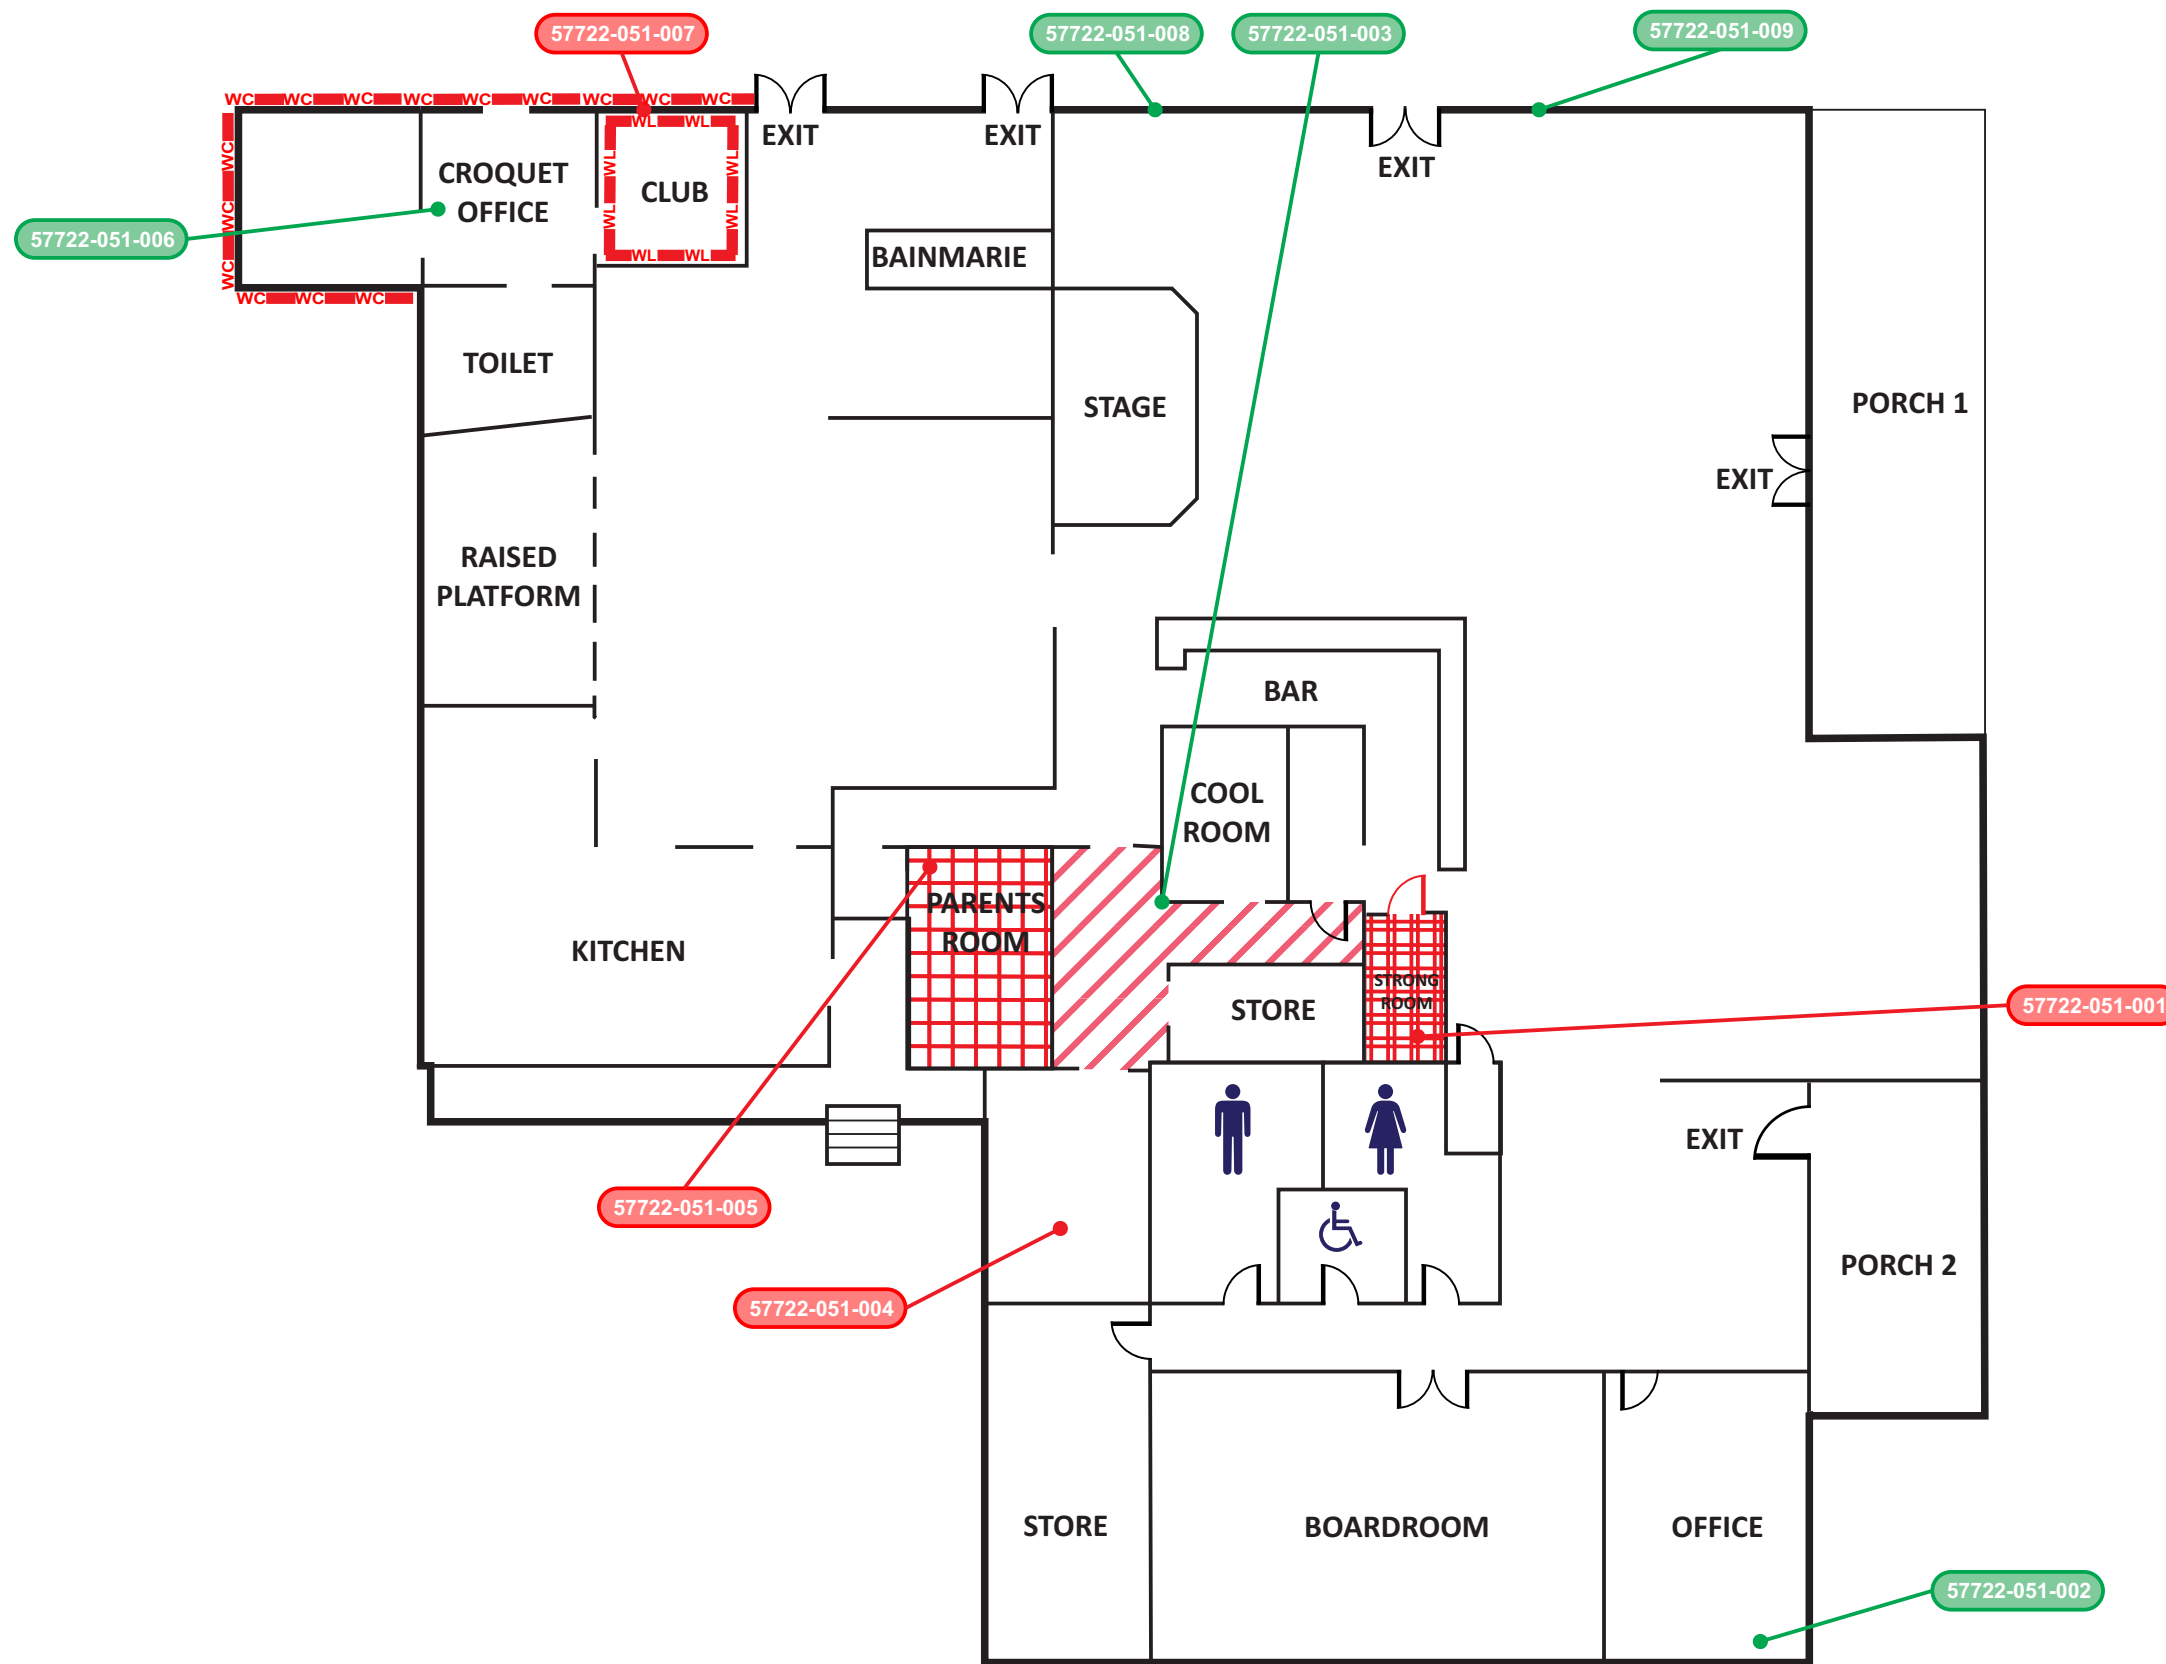
Mackey Park Bowling Club, Marrickville- Ground Level

*Only asbestos-containing materials (ACM) have been labelled on the attached site plan to prevent confusion and ensure that these materials are given priority for action. Therefore, other hazardous materials may be present within the building and the register attached in **Section 1** should be consulted prior to work commencing.*
