Hazardous Building Materials Assessment

Henson Park Male Toilets on Hill

Inner West Council

April 2018

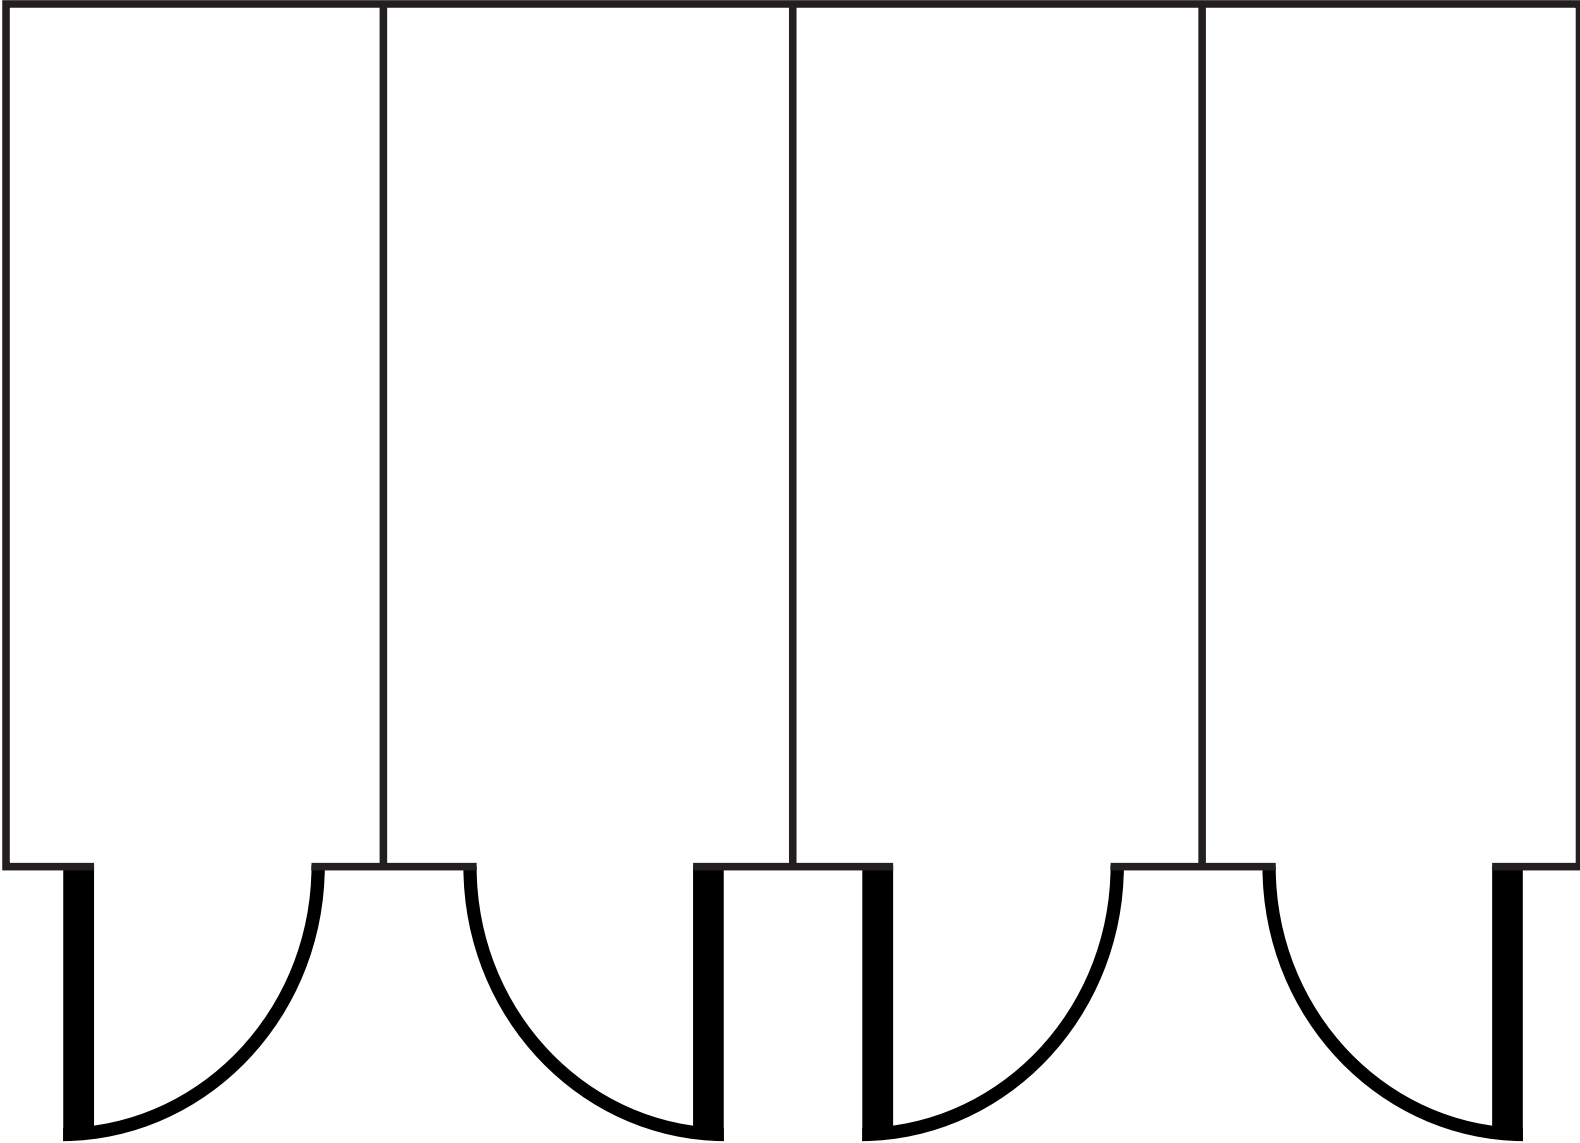
Henson Park, Male Toilets On Hill Marrickville - Ground Level

*Only asbestos-containing materials (ACM) have been labelled on the attached site plan to prevent confusion and ensure that these materials are given priority for action. Therefore, other hazardous materials may be present within the building and the register attached in **Section 1** should be consulted prior to work commencing.*
