Hazardous Building Materials Assessment Henson Park Turnstyle & Female Toilets Sydenham Road Marrickville NSW 2204

Inner West Council
April 2018

Job No.: 57722-161

Count ID: CID: 172

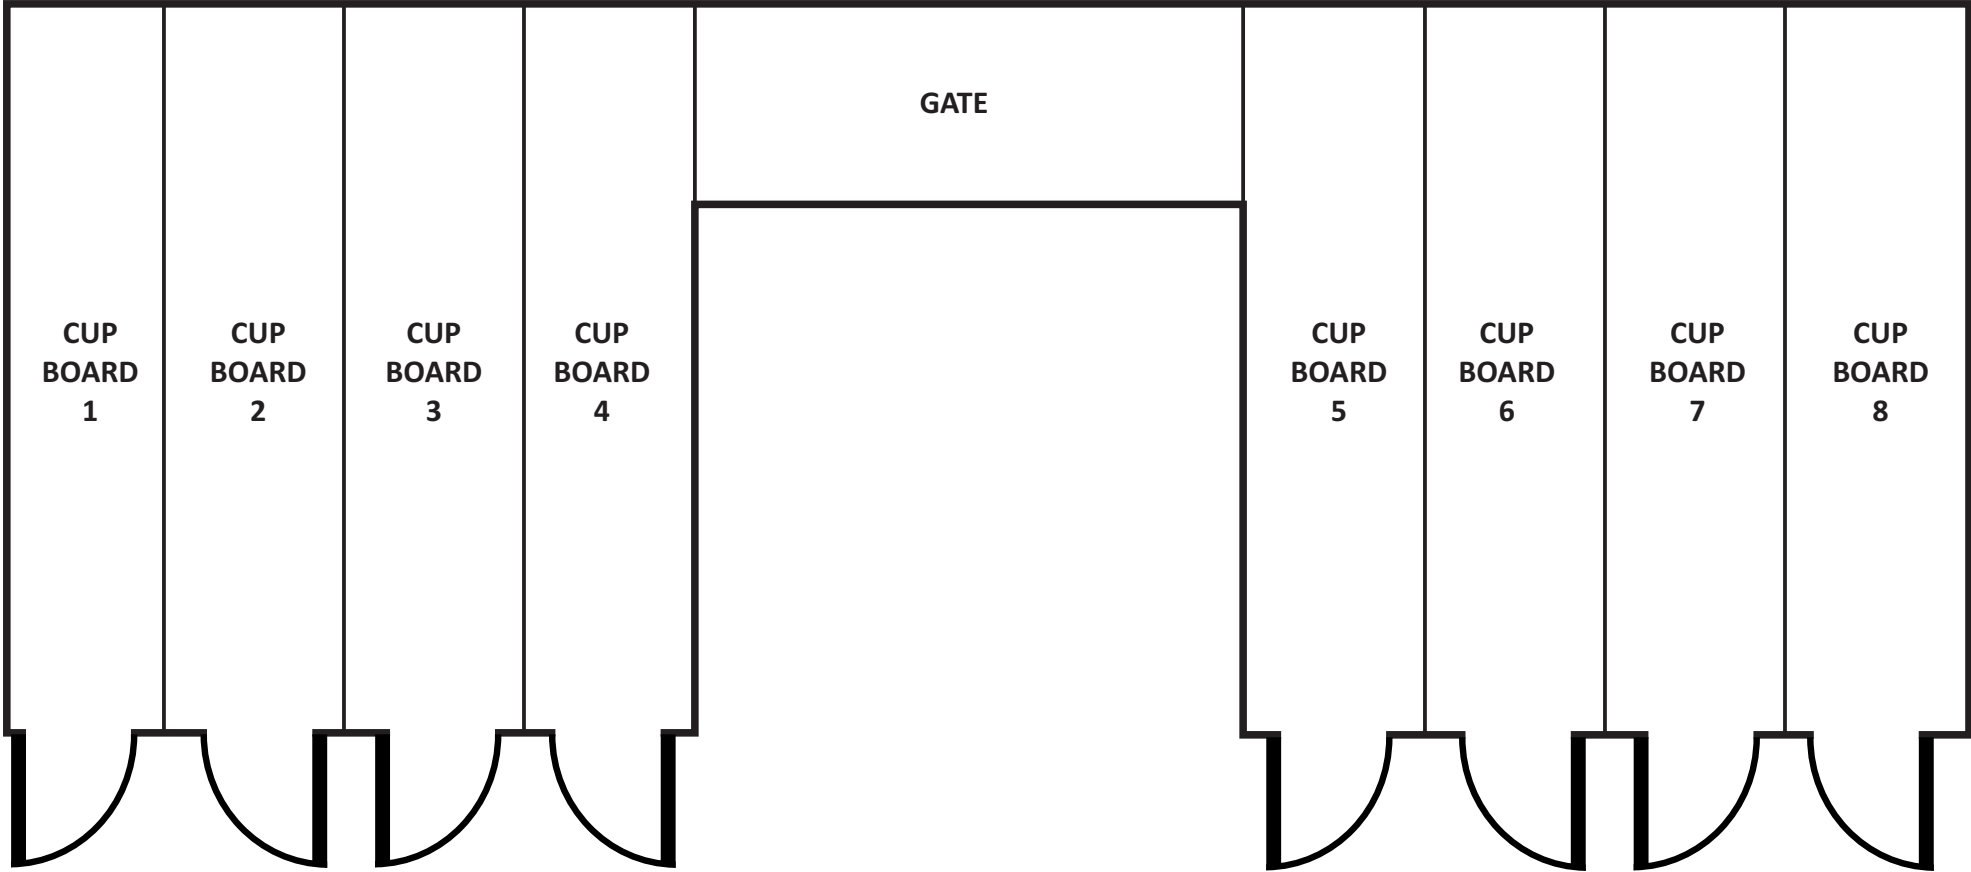
Figure number: 1 Revision: 2

*Only asbestos-containing materials (ACM) have been labelled on the attached site plan to prevent confusion and ensure that these materials are given priority for action. Therefore, other hazardous materials may be present within the building and the register attached in **Section 1** should be consulted prior to work commencing.*
