Hazardous Building Materials Assessment Marrickville Golf Course Garage Wharf Street Marrickville NSW 2204

Inner West Council
April 2018

Job No.: 57722-166

Count ID: CID: 255

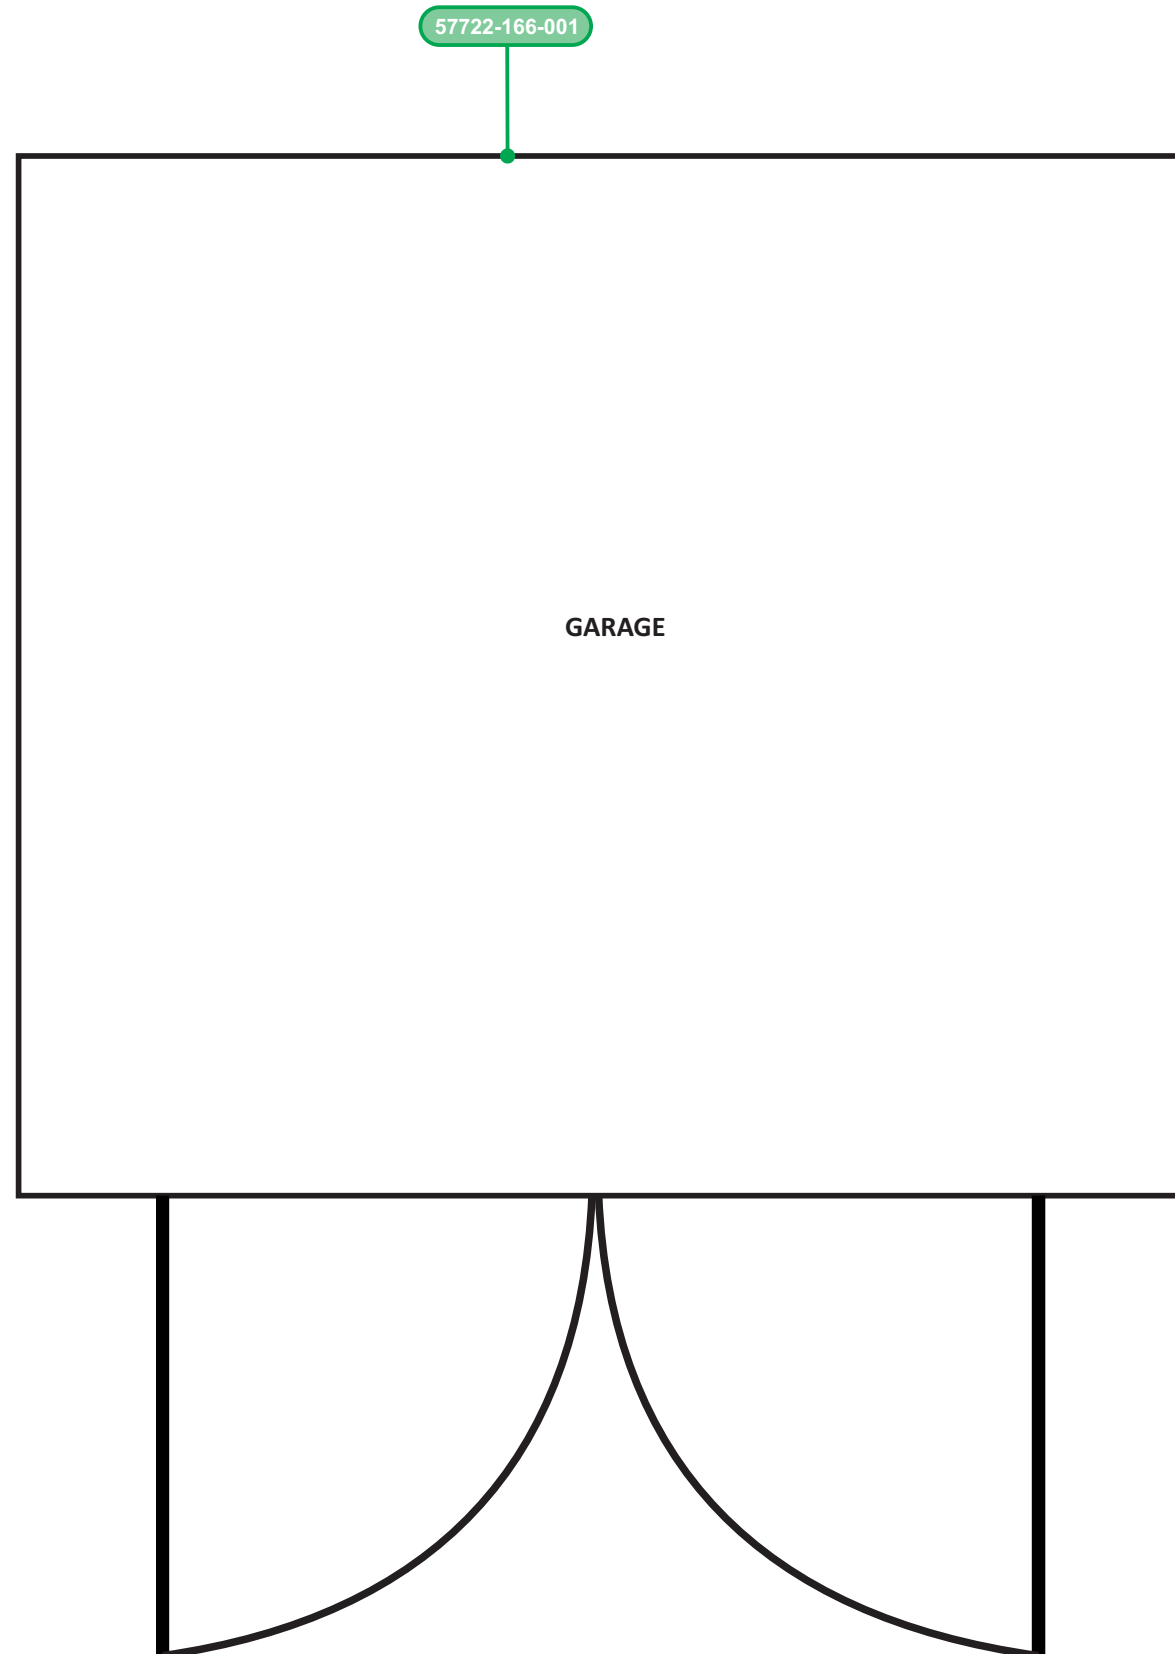
Marrickville - Ground Level

*Only asbestos-containing materials (ACM) have been labelled on the attached site plan to prevent confusion and ensure that these materials are given priority for action. Therefore, other hazardous materials may be present within the building and the register attached in **Section 1** should be consulted prior to work commencing.*
