Hazardous Building Materials Assessment Newtown Town Hall - Beach Burrito 1a Bedford Street, Newtown NSW 2042

Inner West Council
April 2018

Job No.: 57722-114

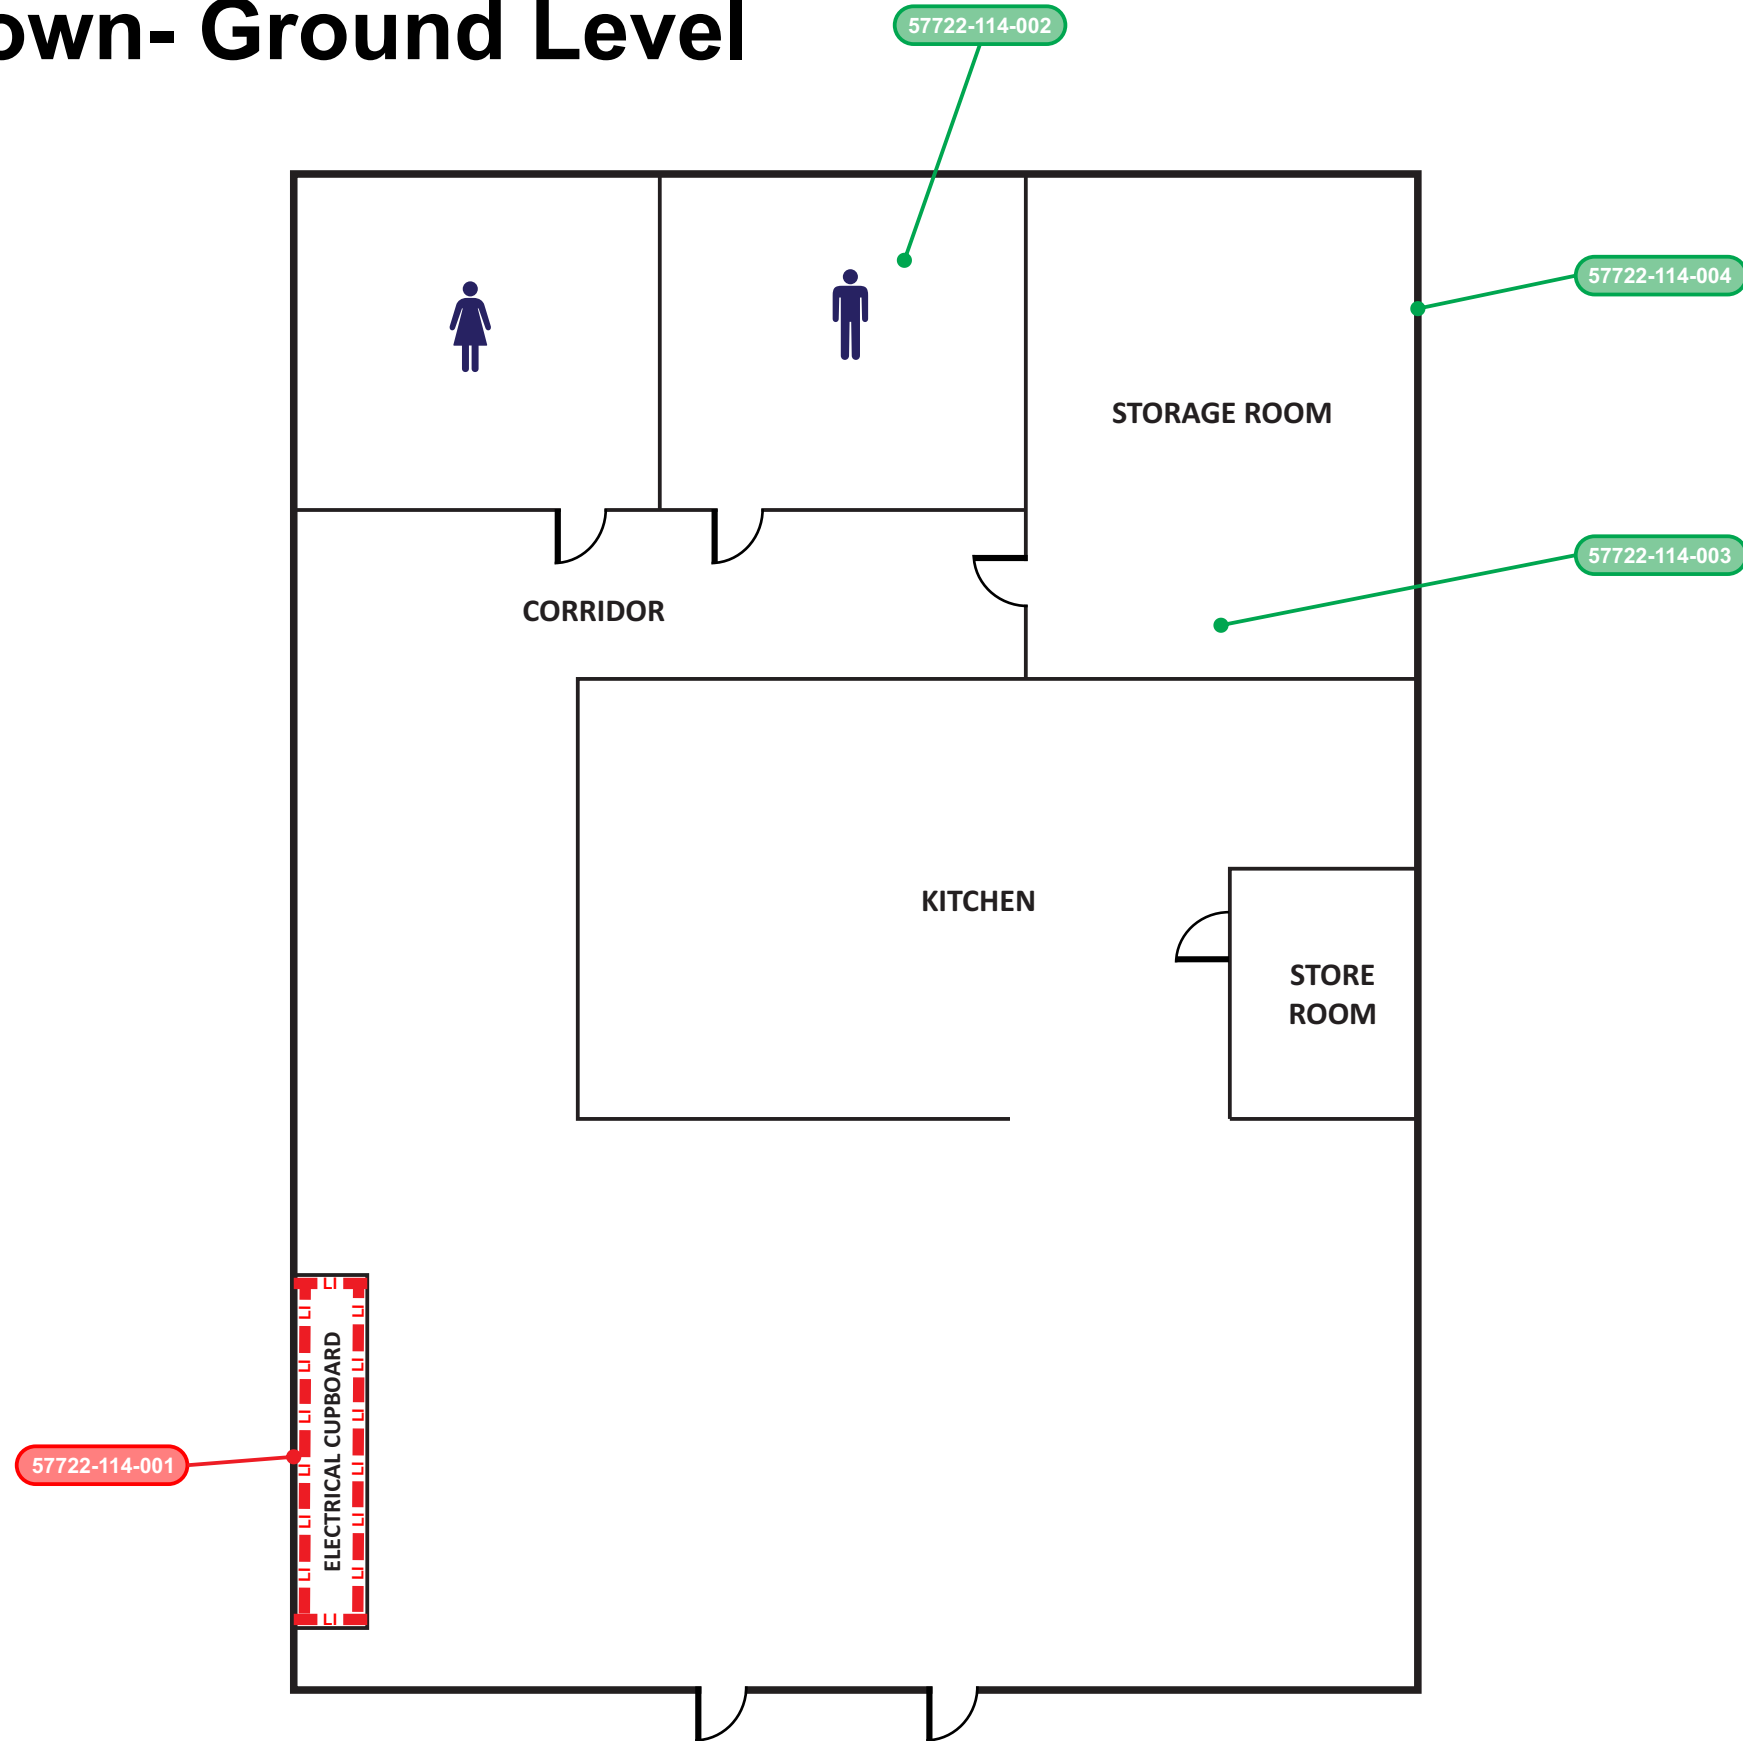
Beach Burrito, Newtown- Ground Level

*Only asbestos-containing materials (ACM) have been labelled on the attached site plan to prevent confusion and ensure that these materials are given priority for action. Therefore, other hazardous materials may be present within the building and the register attached in **Section 1** should be consulted prior to work commencing.*
