# Hazardous Building Materials Assessment Petersham Park - Grandstand Brighton and West Streets Petersham NSW 2049

Inner West Council

April 2018

Job No.: 57722-022

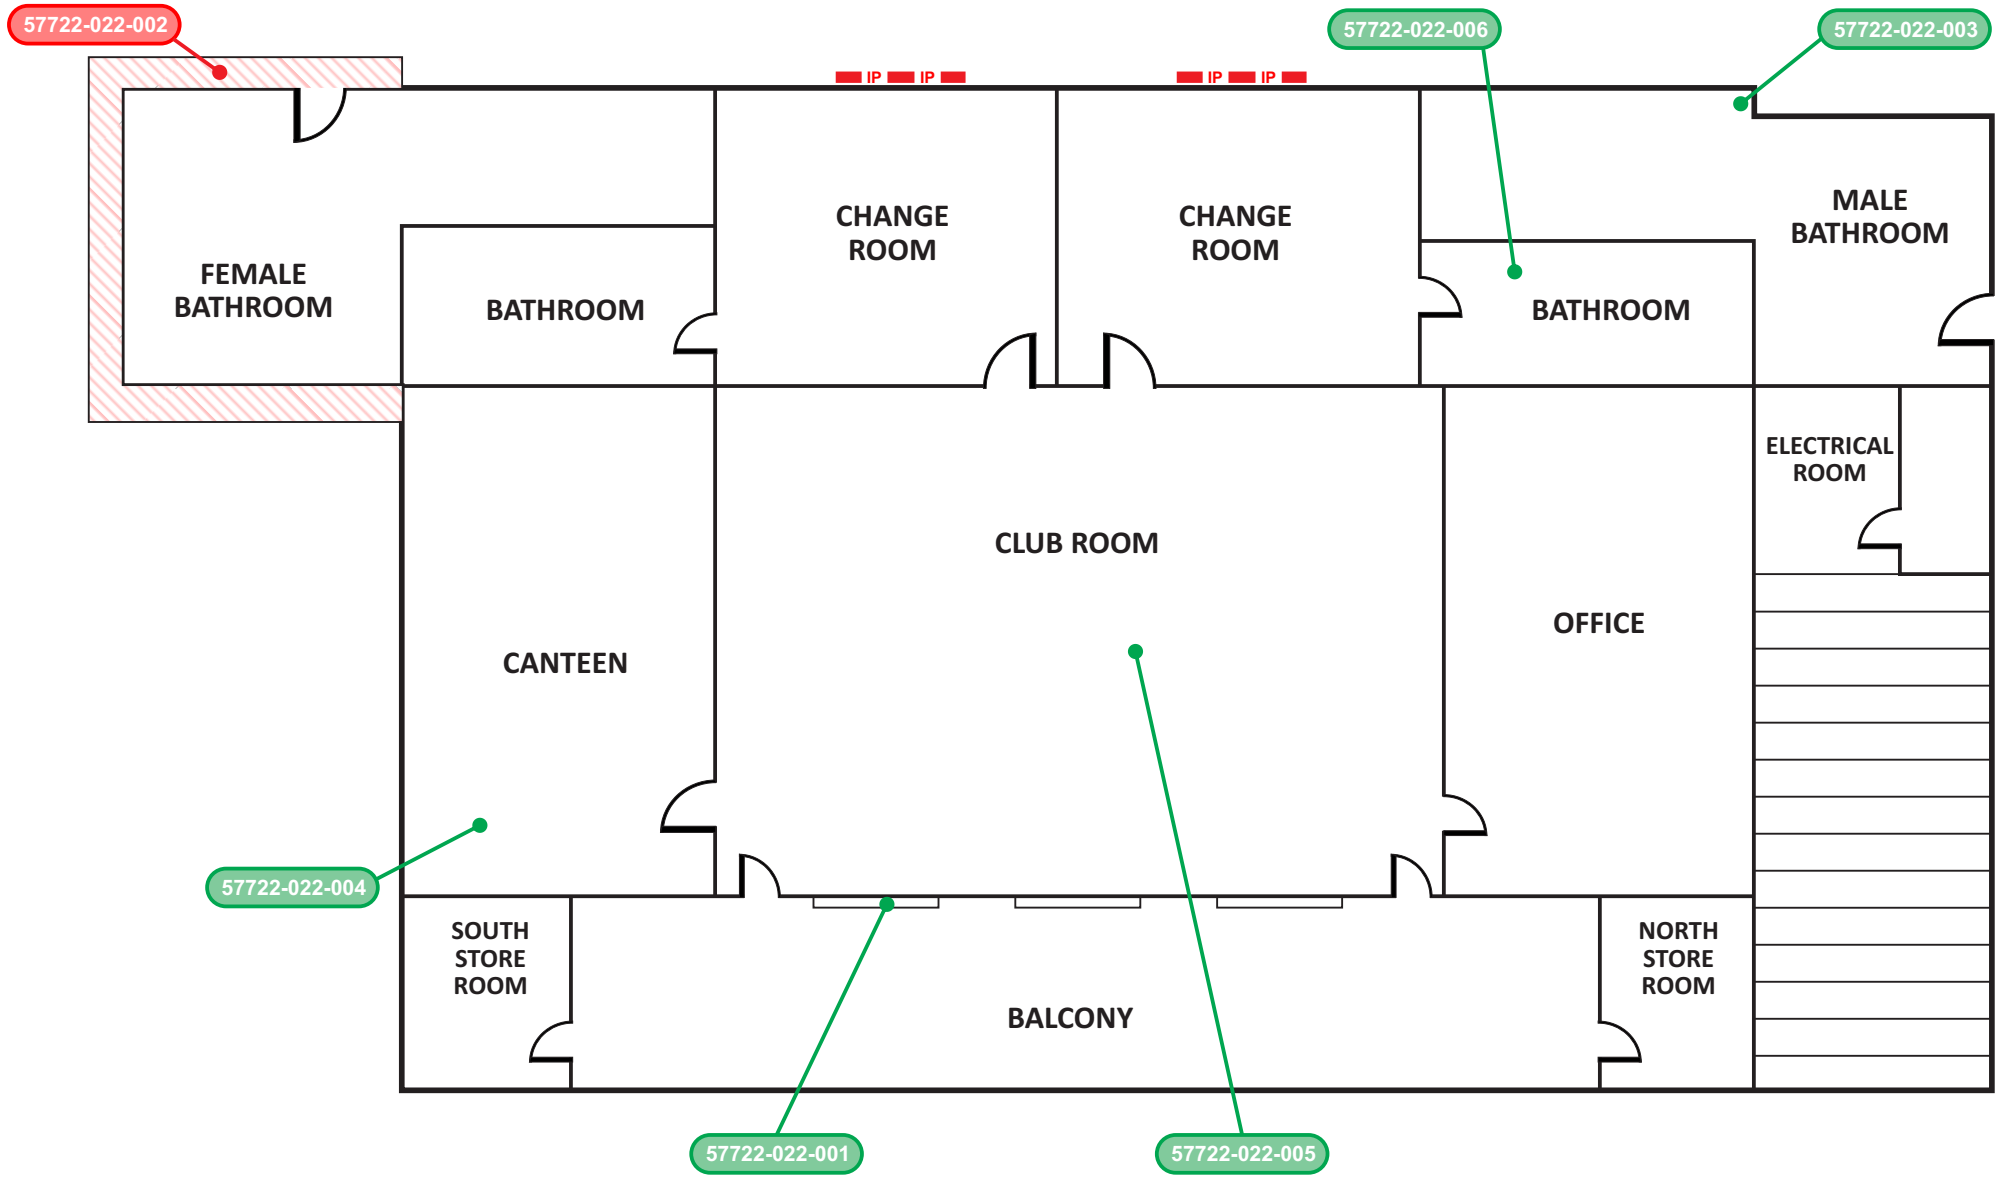
# Petersham Park Grandstand/Change/Kiosk Ground Level

*Only asbestos-containing materials (ACM) have been labelled on the attached site plan to prevent confusion and ensure that these materials are given priority for action. Therefore, other hazardous materials may be present within the building and the register attached in **Section 1** should be consulted prior to work commencing.*
