Hazardous Building Materials Assessment Tempe Reserve – Blue Amenities / Change Rooms Holbeach Avenue, Tempe NSW 2044

Inner West Council
April 2018

Job No.: 57722-116

Count ID: CID: 370

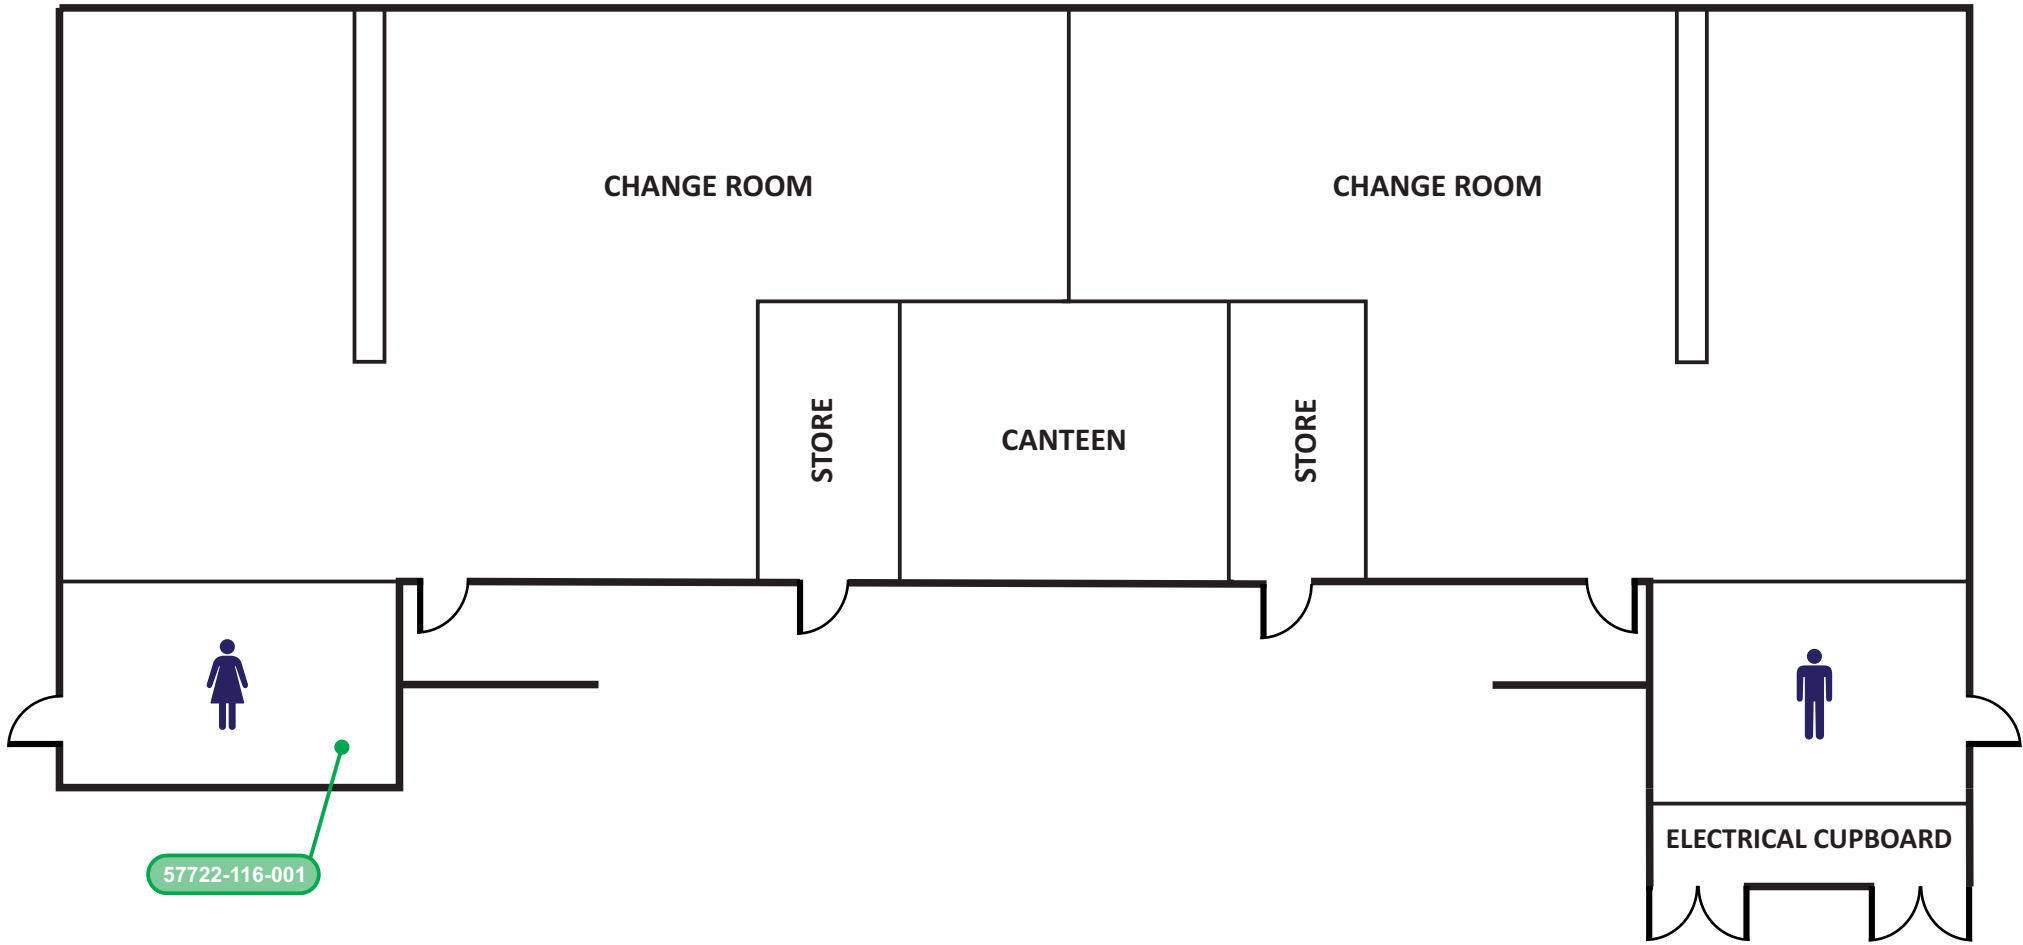
Drawn by: SL	Date: 14/03/2018
Checked by: MM	Date: 05/02/2018
Figure number: 1	Revision: 2
File name: 57722-116 - Rev 2

*Only asbestos-containing materials (ACM) have been labelled on the attached site plan to prevent confusion and ensure that these materials are given priority for action. Therefore, other hazardous materials may be present within the building and the register attached in **Section 1** should be consulted prior to work commencing.*
