Hazardous Building Materials Assessment Tempe Reserve – Robyn Webster Building Holbeach Avenue, Tempe NSW 2044

Inner West Council
April 2018

Job No.: 57722-113

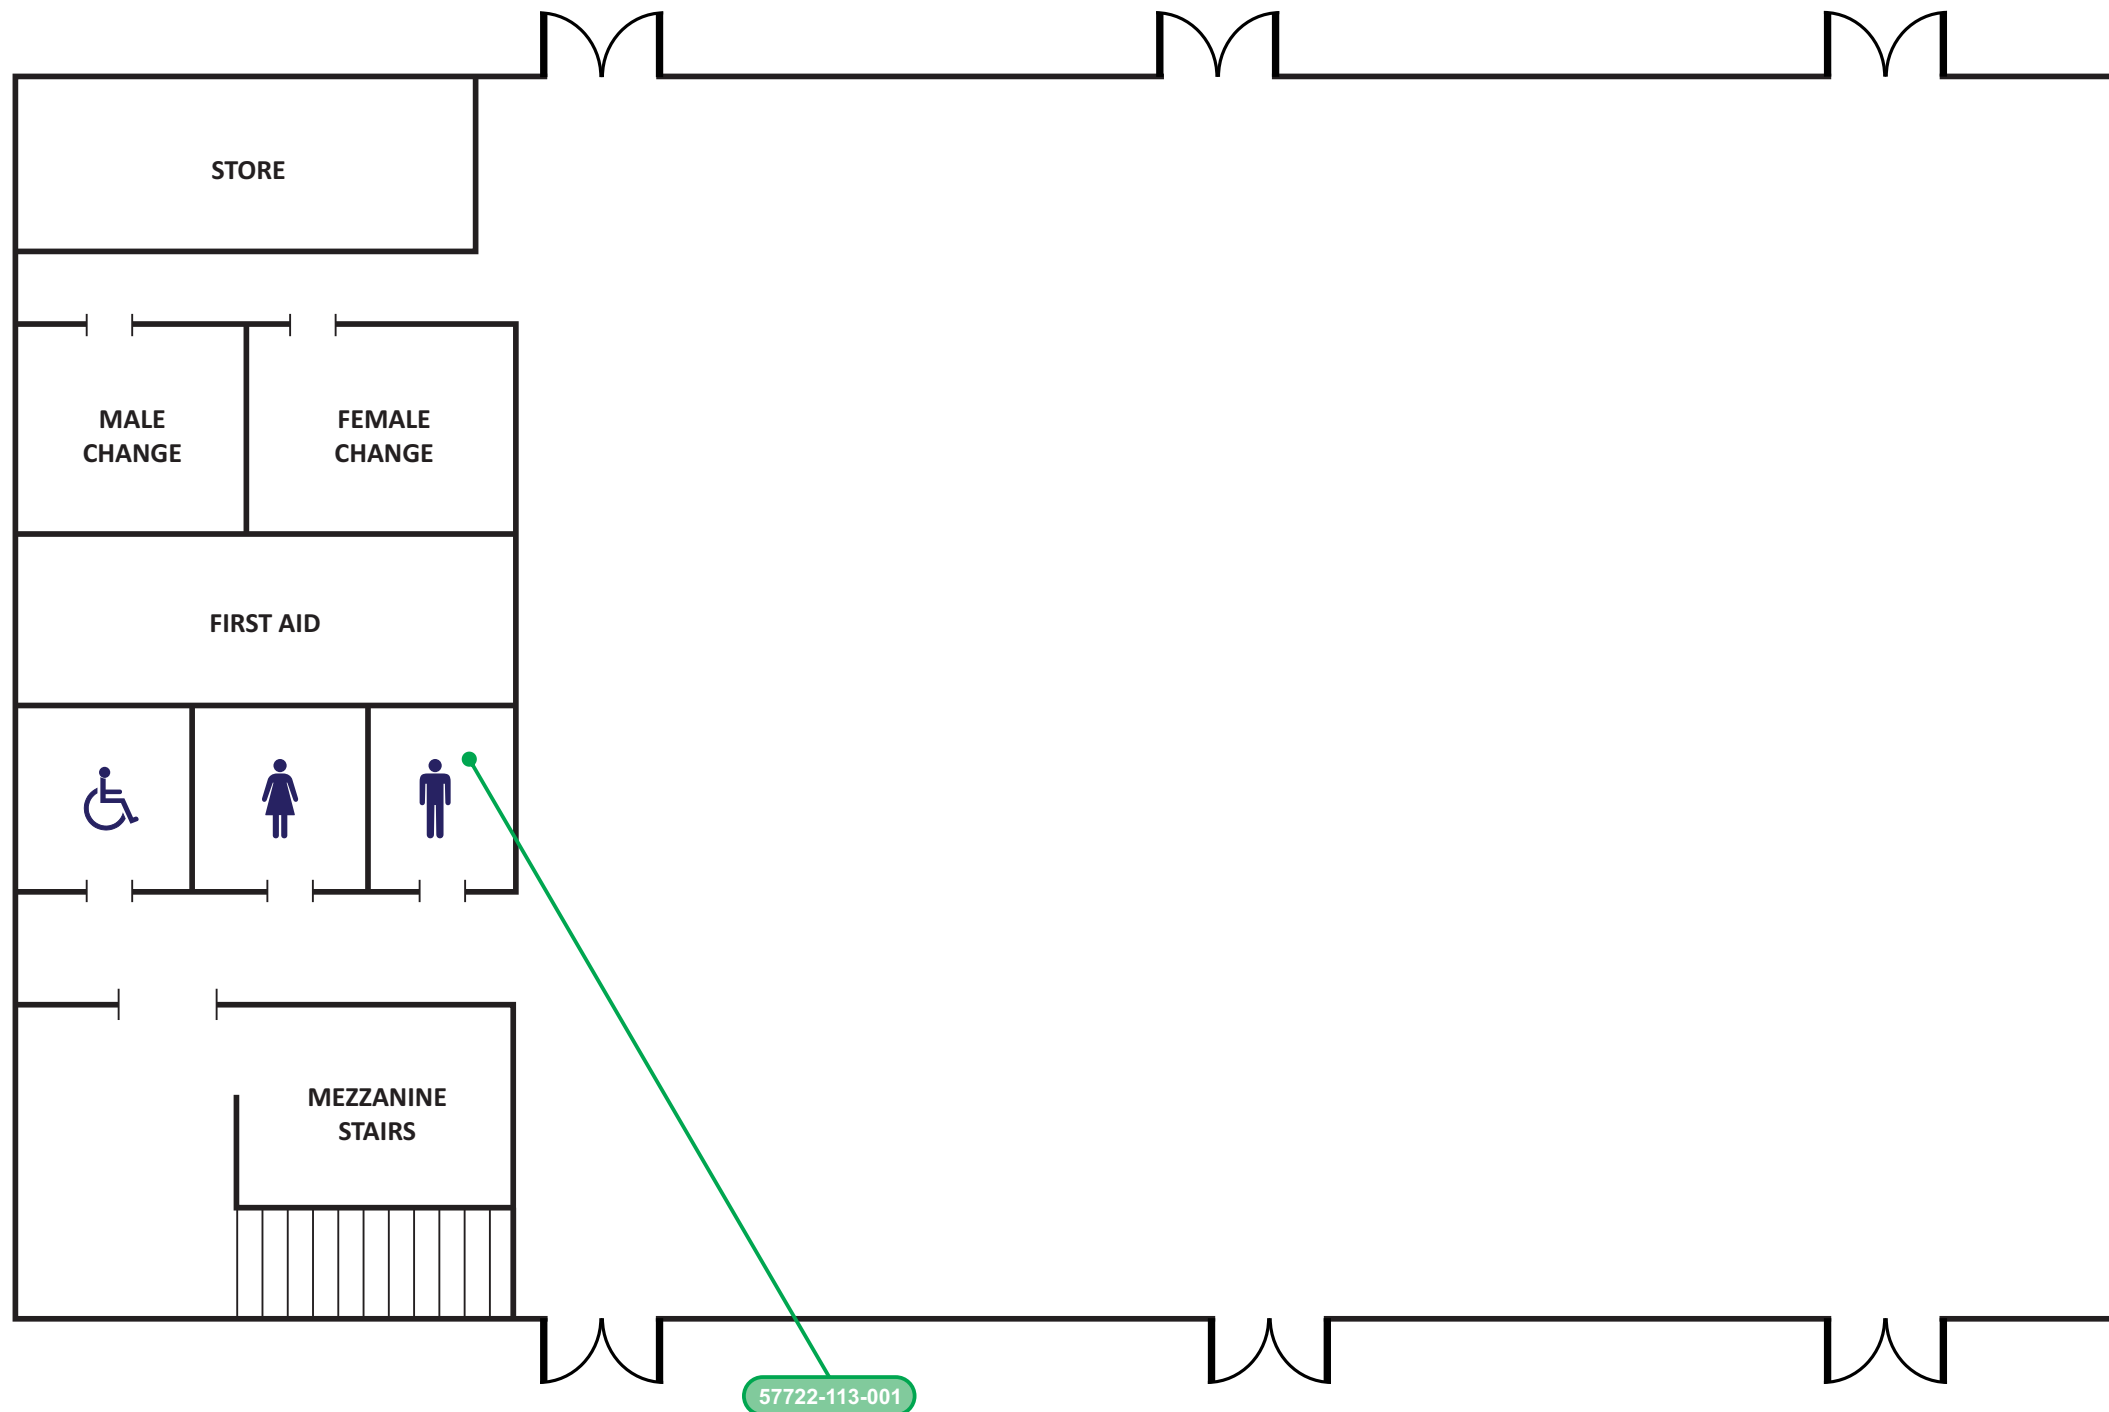
Tempe - Ground Level

*Only asbestos-containing materials (ACM) have been labelled on the attached site plan to prevent confusion and ensure that these materials are given priority for action. Therefore, other hazardous materials may be present within the building and the register attached in **Section 1** should be consulted prior to work commencing.*
