Hazardous Building Materials Assessment Tempe Golf Driving Range – Demountable 1 17 Swamp Road Tempe NSW 2044

Inner West Council
April 2018

Job No.: 57722-111

Count ID: CID: 362

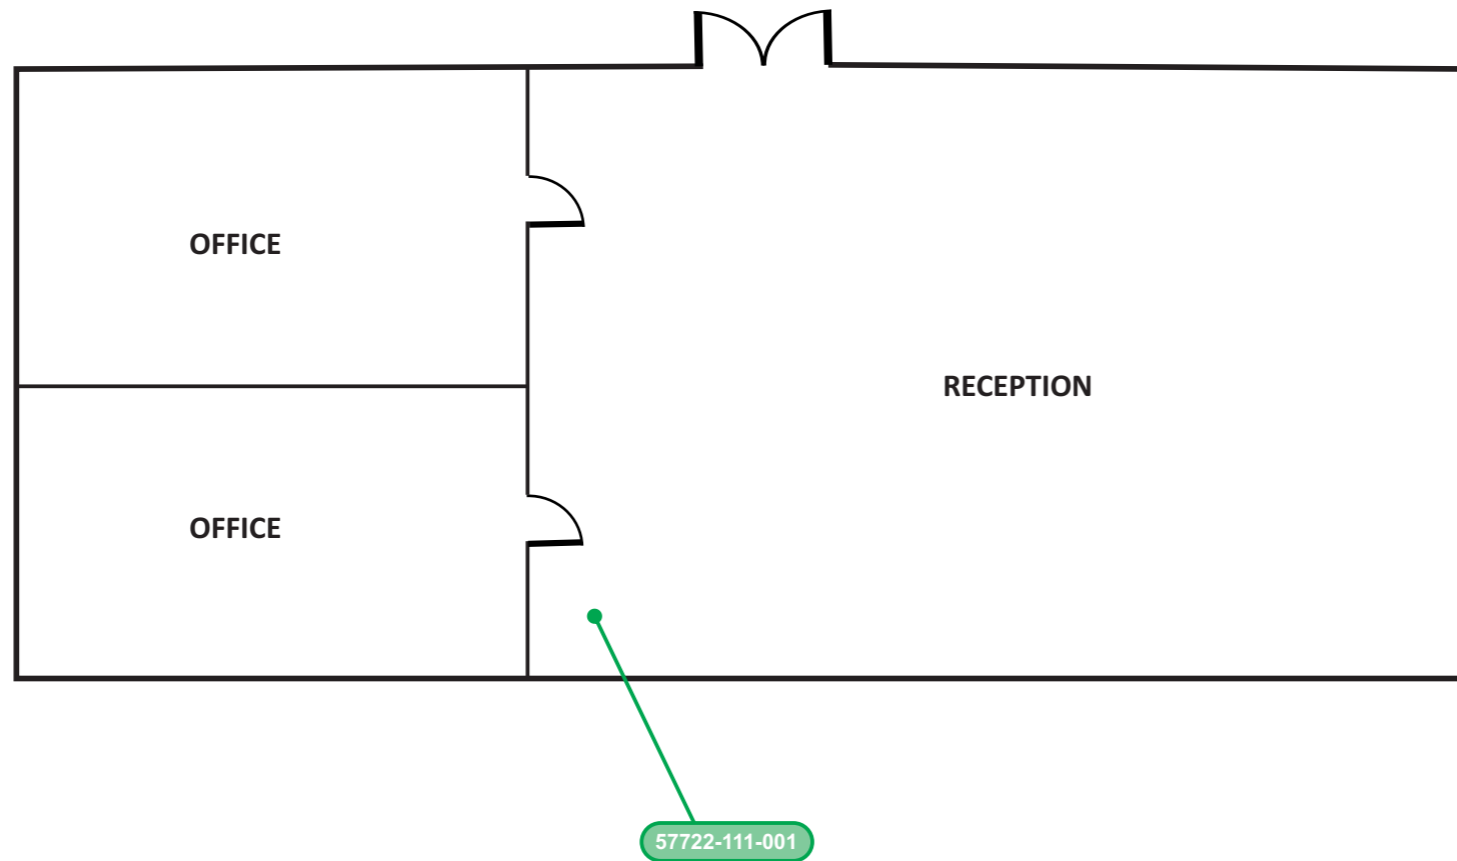
Tempe - Ground Level

*Only asbestos-containing materials (ACM) have been labelled on the attached site plan to prevent confusion and ensure that these materials are given priority for action. Therefore, other hazardous materials may be present within the building and the register attached in **Section 1** should be consulted prior to work commencing.*
