Hazardous Building Materials Assessment Tempe Golf Driving Range – Demountable 2 17 Swamp Road, Tempe NSW 2044

Inner West Council
April 2018

Job No.: 57722-118

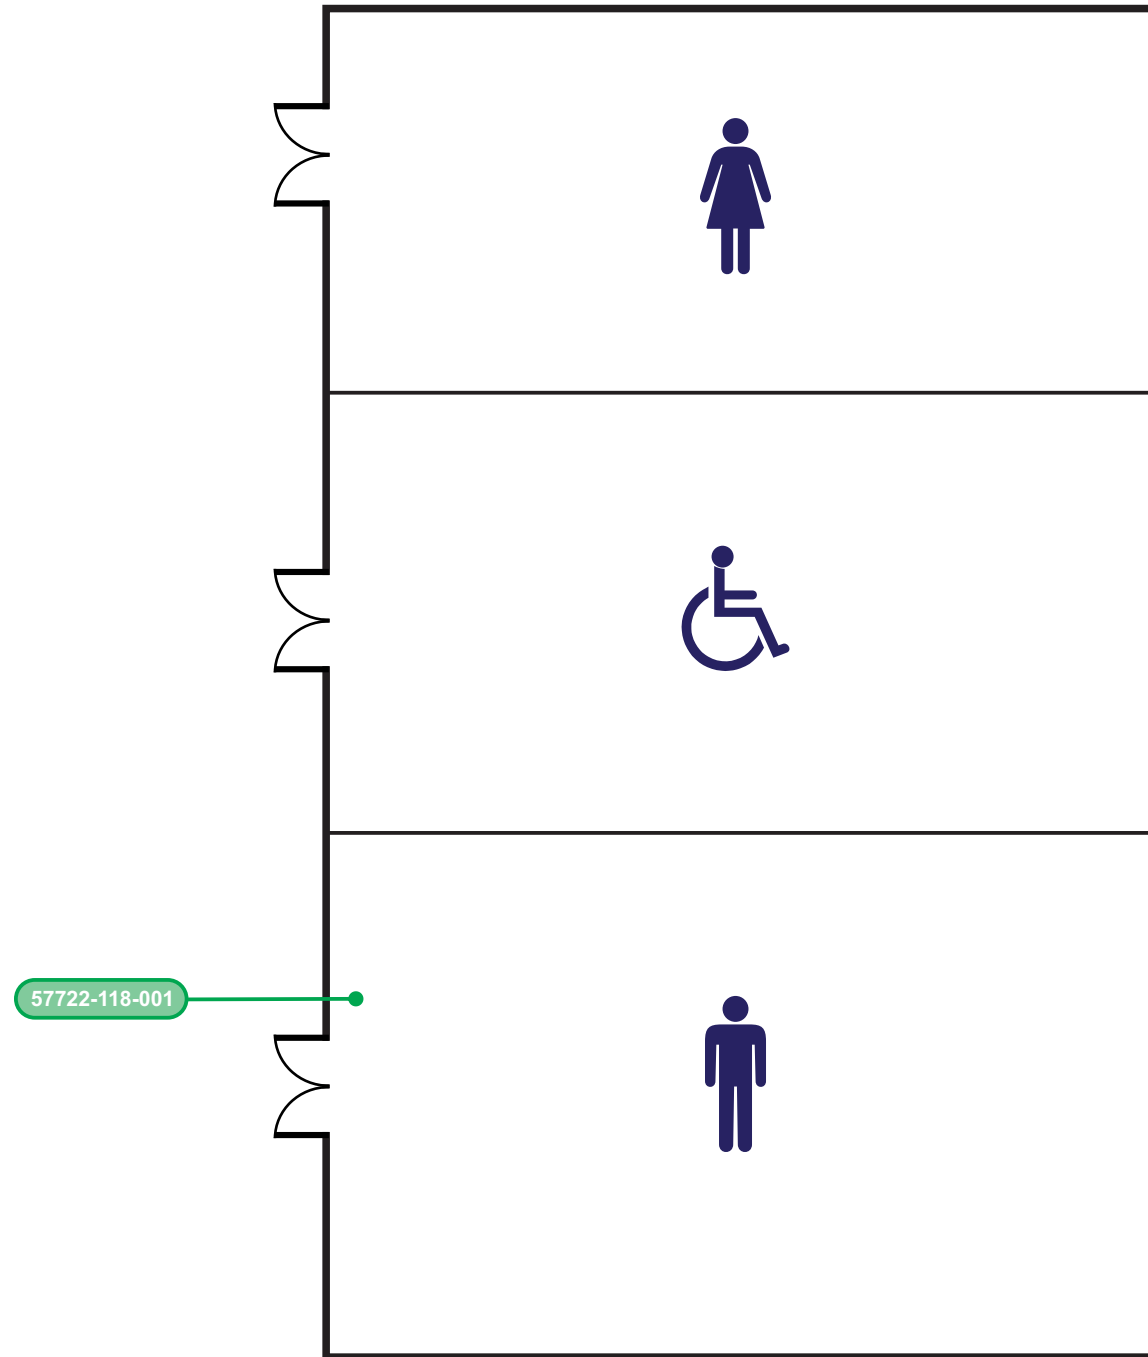
Tempe - Ground Level

*Only asbestos-containing materials (ACM) have been labelled on the attached site plan to prevent confusion and ensure that these materials are given priority for action. Therefore, other hazardous materials may be present within the building and the register attached in **Section 1** should be consulted prior to work commencing.*
