Hazardous Building Materials Assessment Tillman Park Early Learning Centre 79 Unwins Bridge Road, Tempe NSW 2044

Inner West Council
April 2018

Job No.: 57722-117

Count ID: CID: 376

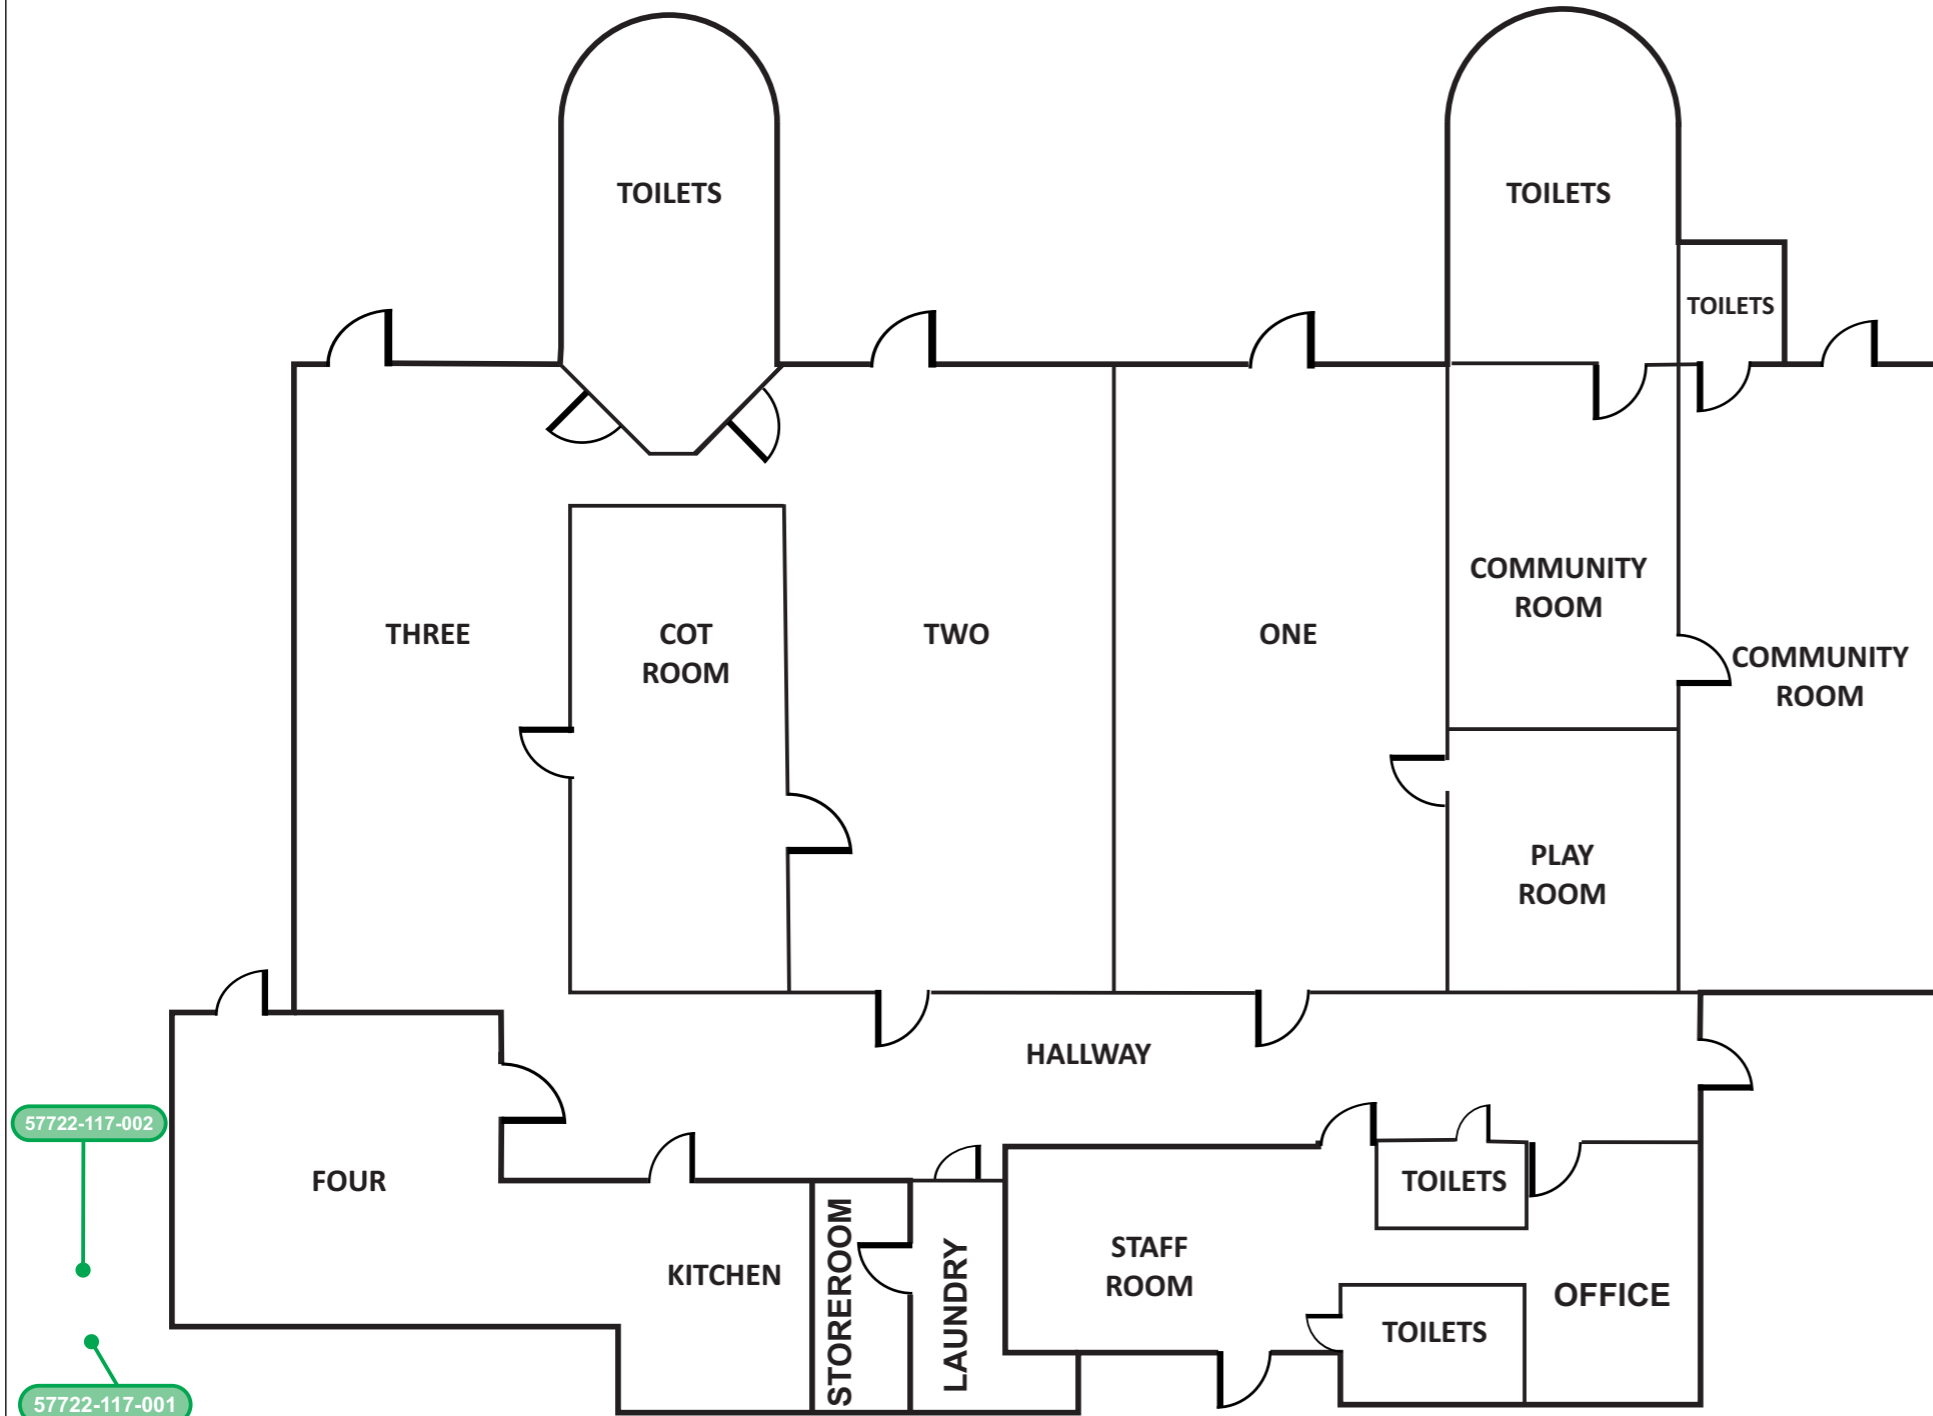
Tillman Park Early Learning Centre Tempe - Ground Level

*Only asbestos-containing materials (ACM) have been labelled on the attached site plan to prevent confusion and ensure that these materials are given priority for action. Therefore, other hazardous materials may be present within the building and the register attached in **Section 1** should be consulted prior to work commencing.*
