MARRICKVILLE COUNCIL

EC East Subcatchment Management Plan Volume 2 - Flood Study

Report Number. 097626003-008-Rev4-4000
(For Public Exhibition)

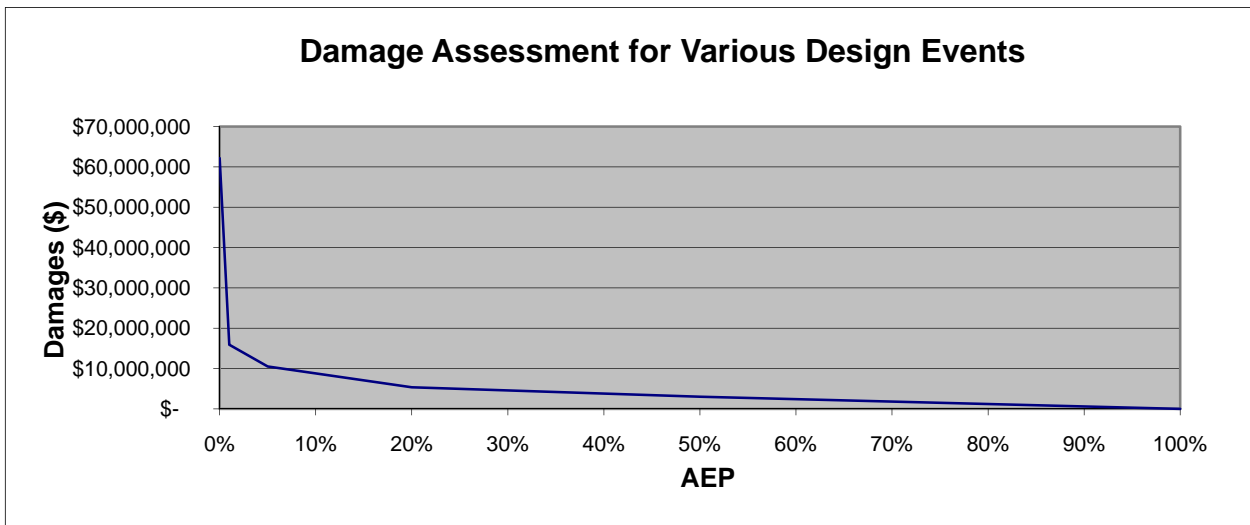
Figure 2: Damage-Probability relationship for various design flood events

The Annual Average Damage (AAD) provides a measure of the average cost of stormwater flooding to the community on annual basis. Damage cost for each design event is plotted against the probability of the design event to establish a damage-probability relationship, as shown in Figure 2.

The AAD is assessed by estimating the area under the damage-probability curve. For the EC East Subcatchment, the AAD is estimated to be \$4,117,613. Table 16 provides contribution of each design flood event to the AAD.

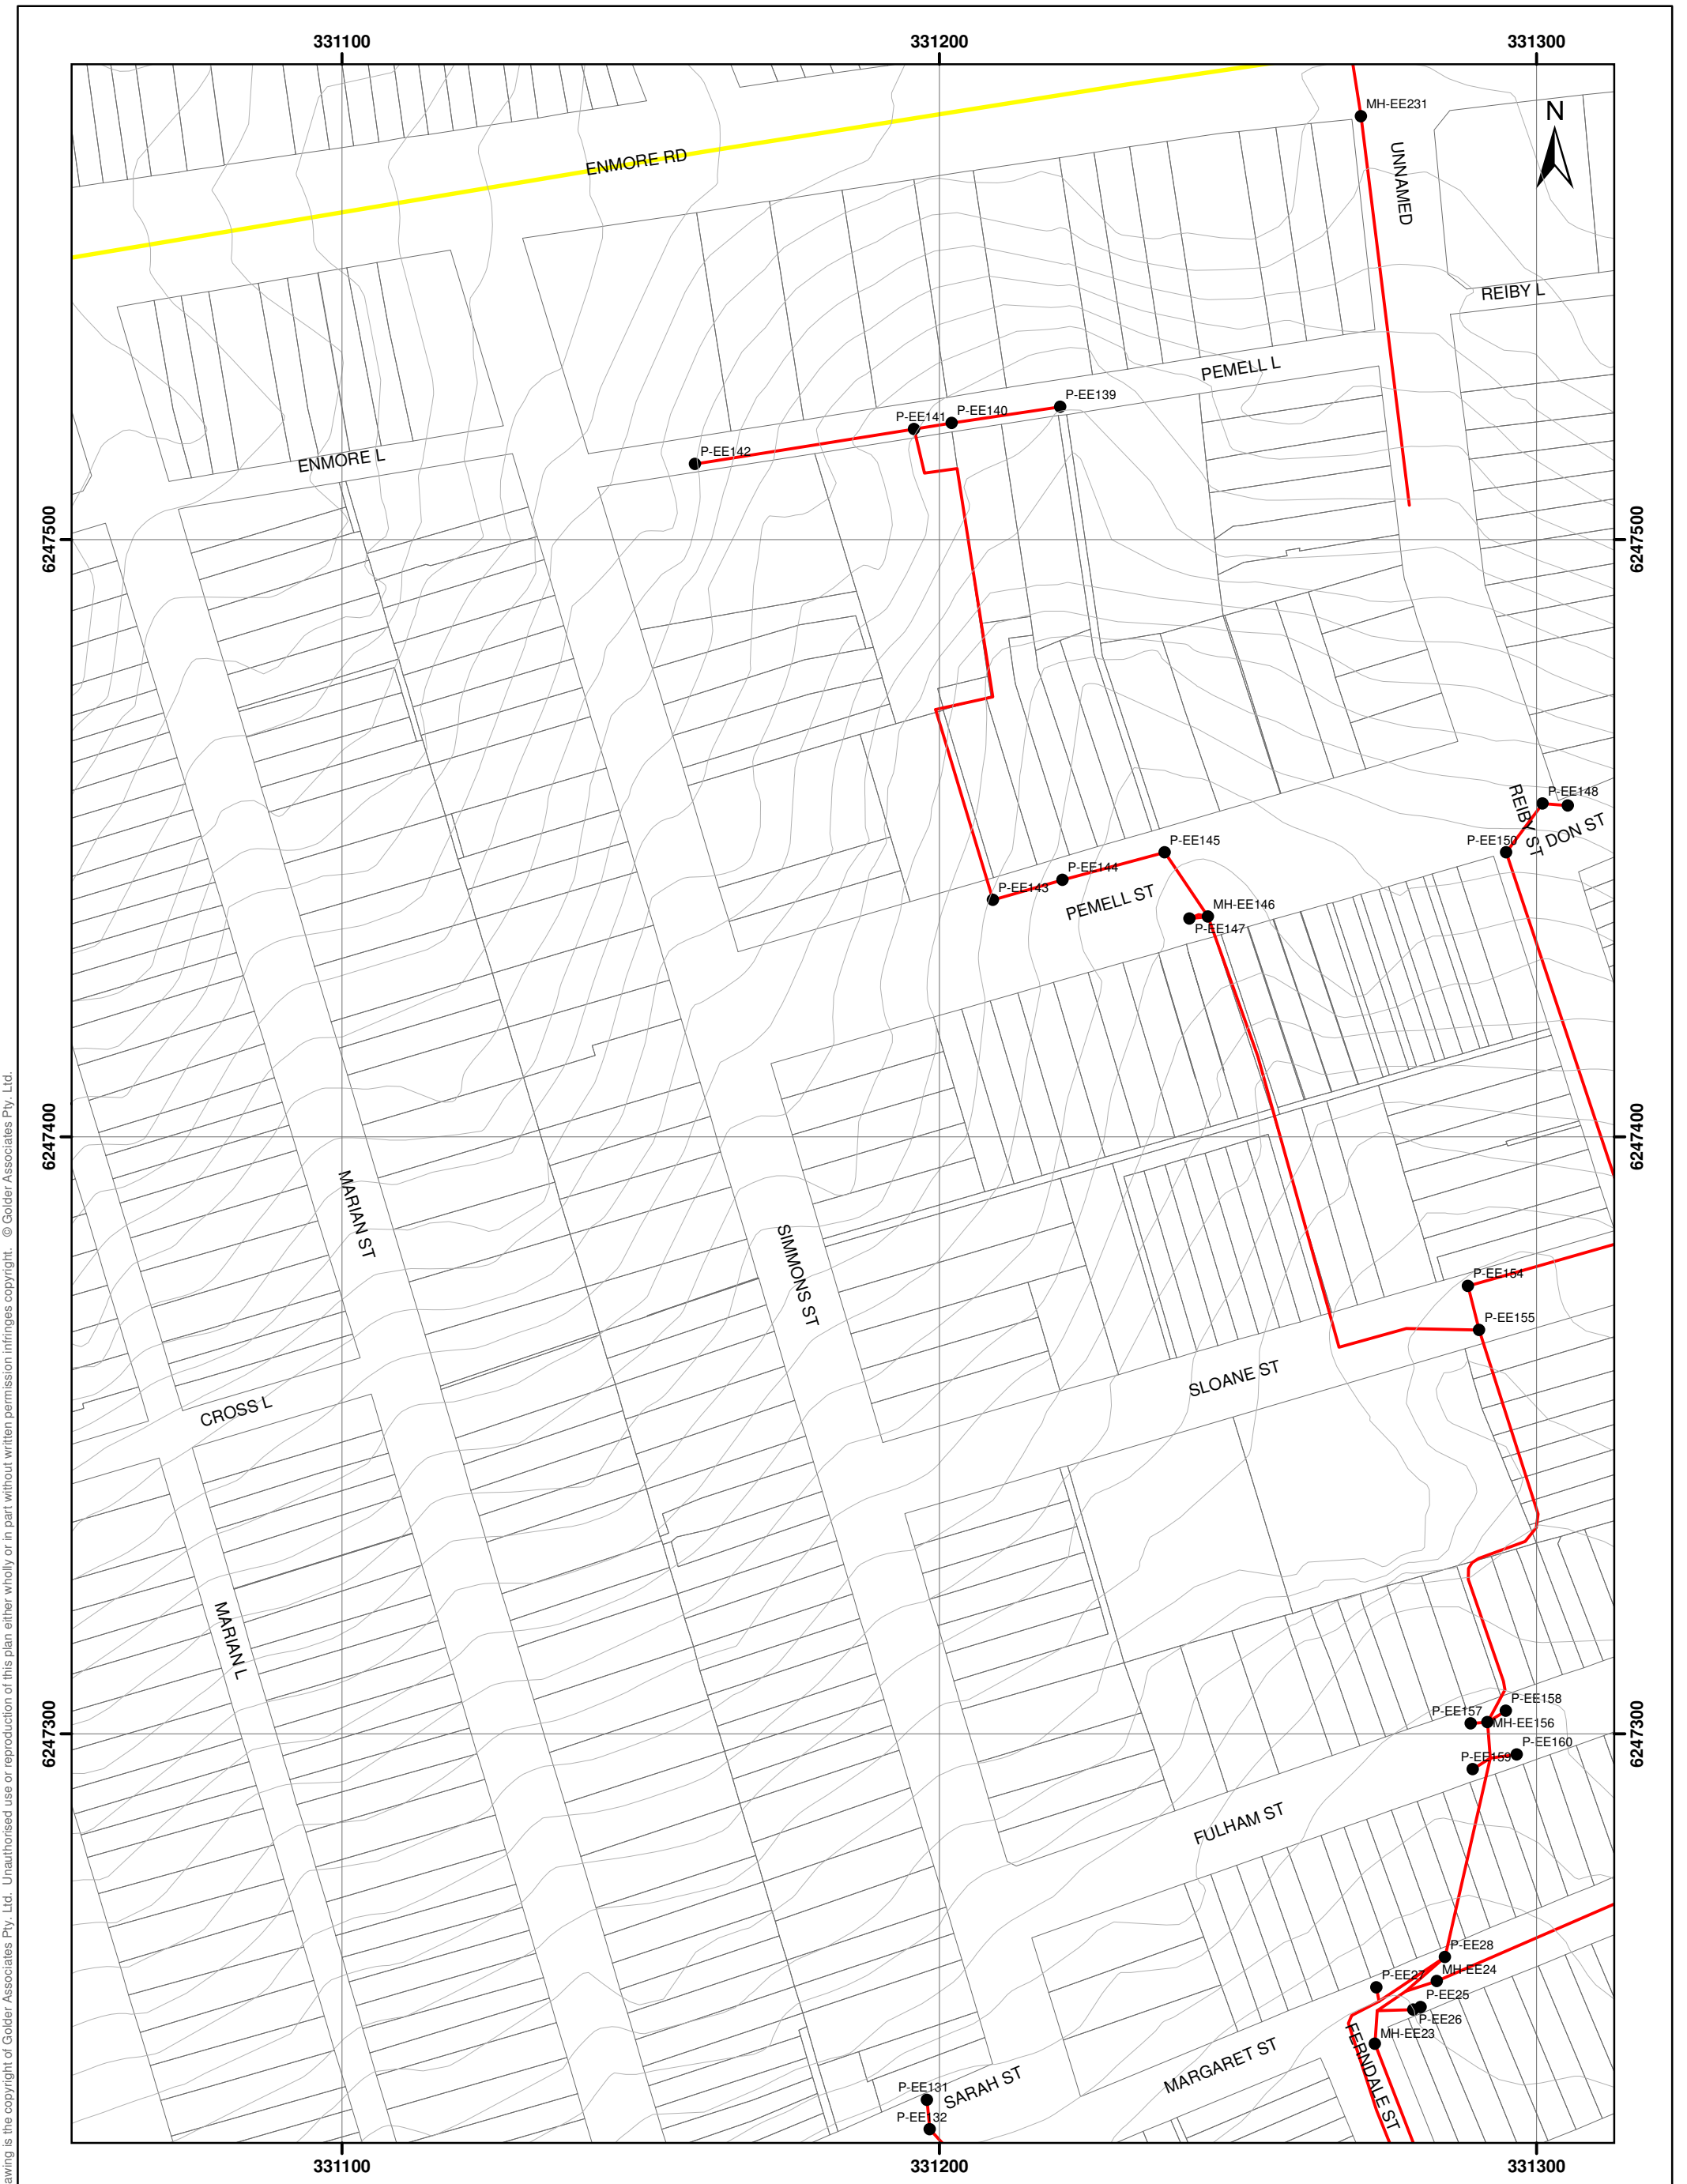
CLIENT Marrickville Council		PROJECT Eastern Channel East Flood Study	
DRAWN GSB	DATE 25-02-10	PIT/PIPE NETWORK	
CHECKED JRB	DATE 25-02-10		
SCALE 1:1,000		PROJECT No 097626003-008	FIGURE No A-2
		REV No 0	A3

A site visit to gather missing information was conducted on 11 August 2009. A number of observations were made during the site visit. A brief description is presented below. (See Figure A-1, A-2 and A-3 for pit numbers referred to in the following description).

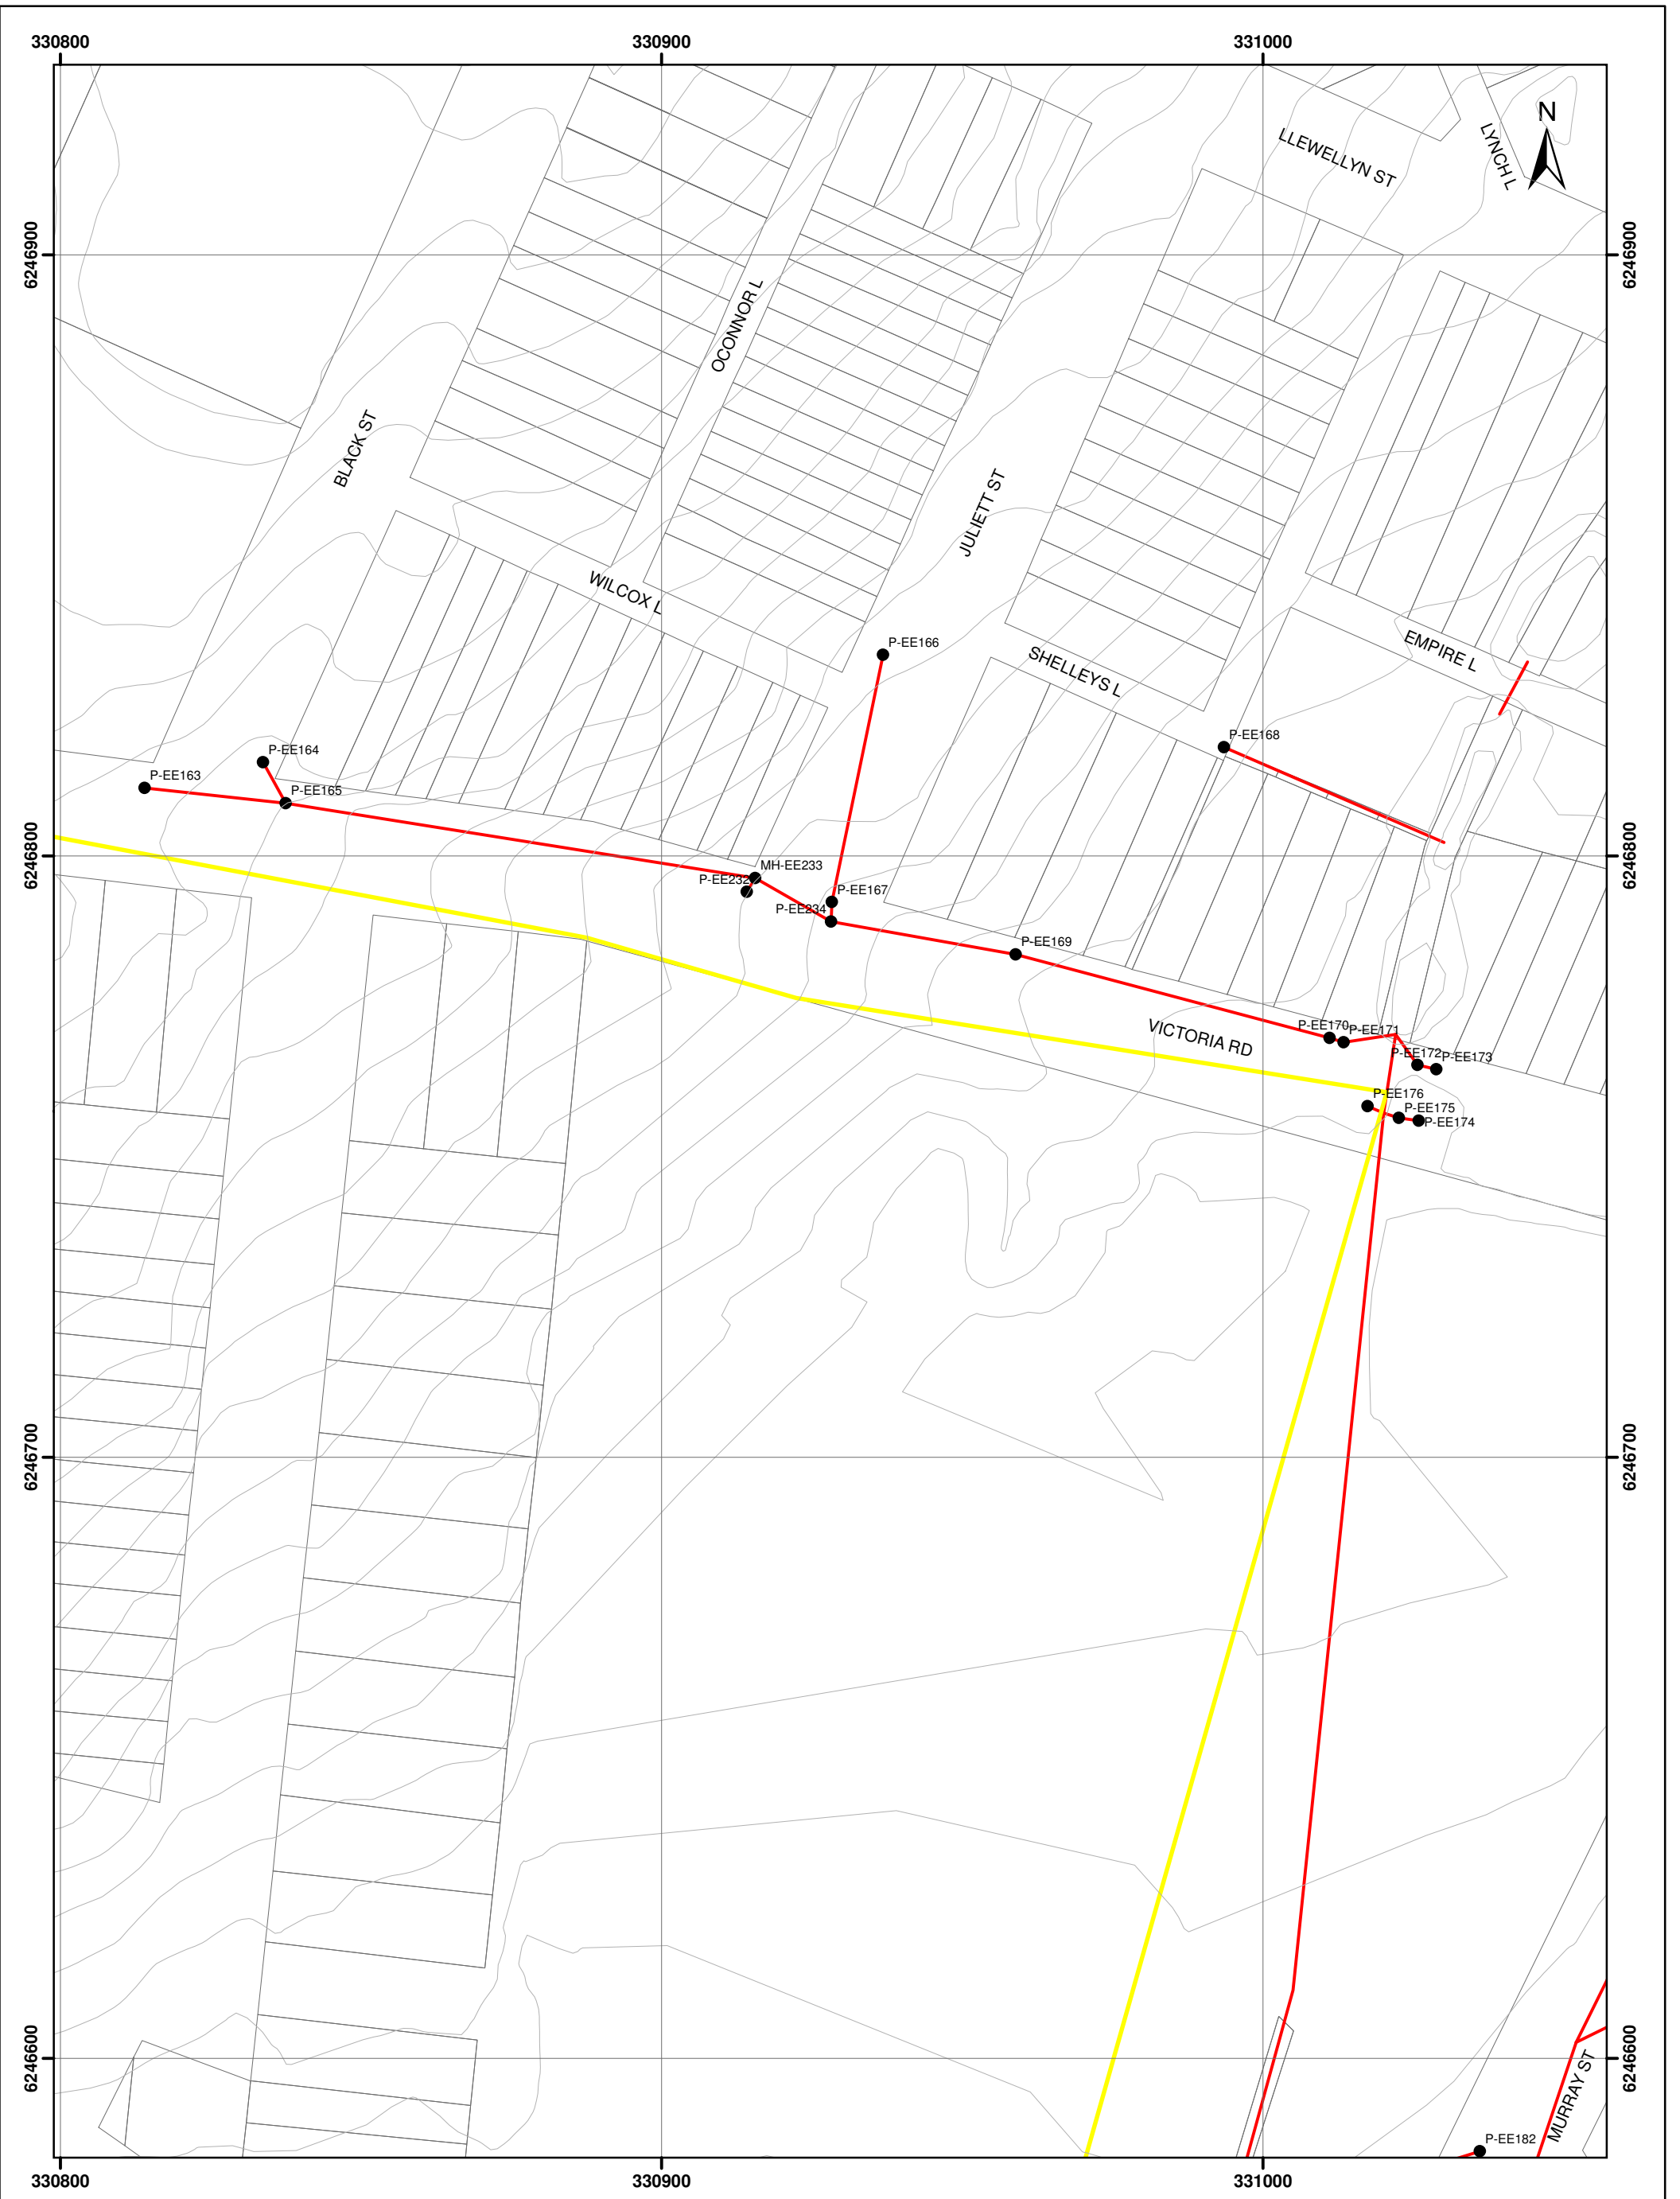
PROJECT Eastern Channel East Flood Study	
PIT/PIPE NETWORK	
PROJECT No 097626003-008	FIGURE No A-3
REV No 0	A3

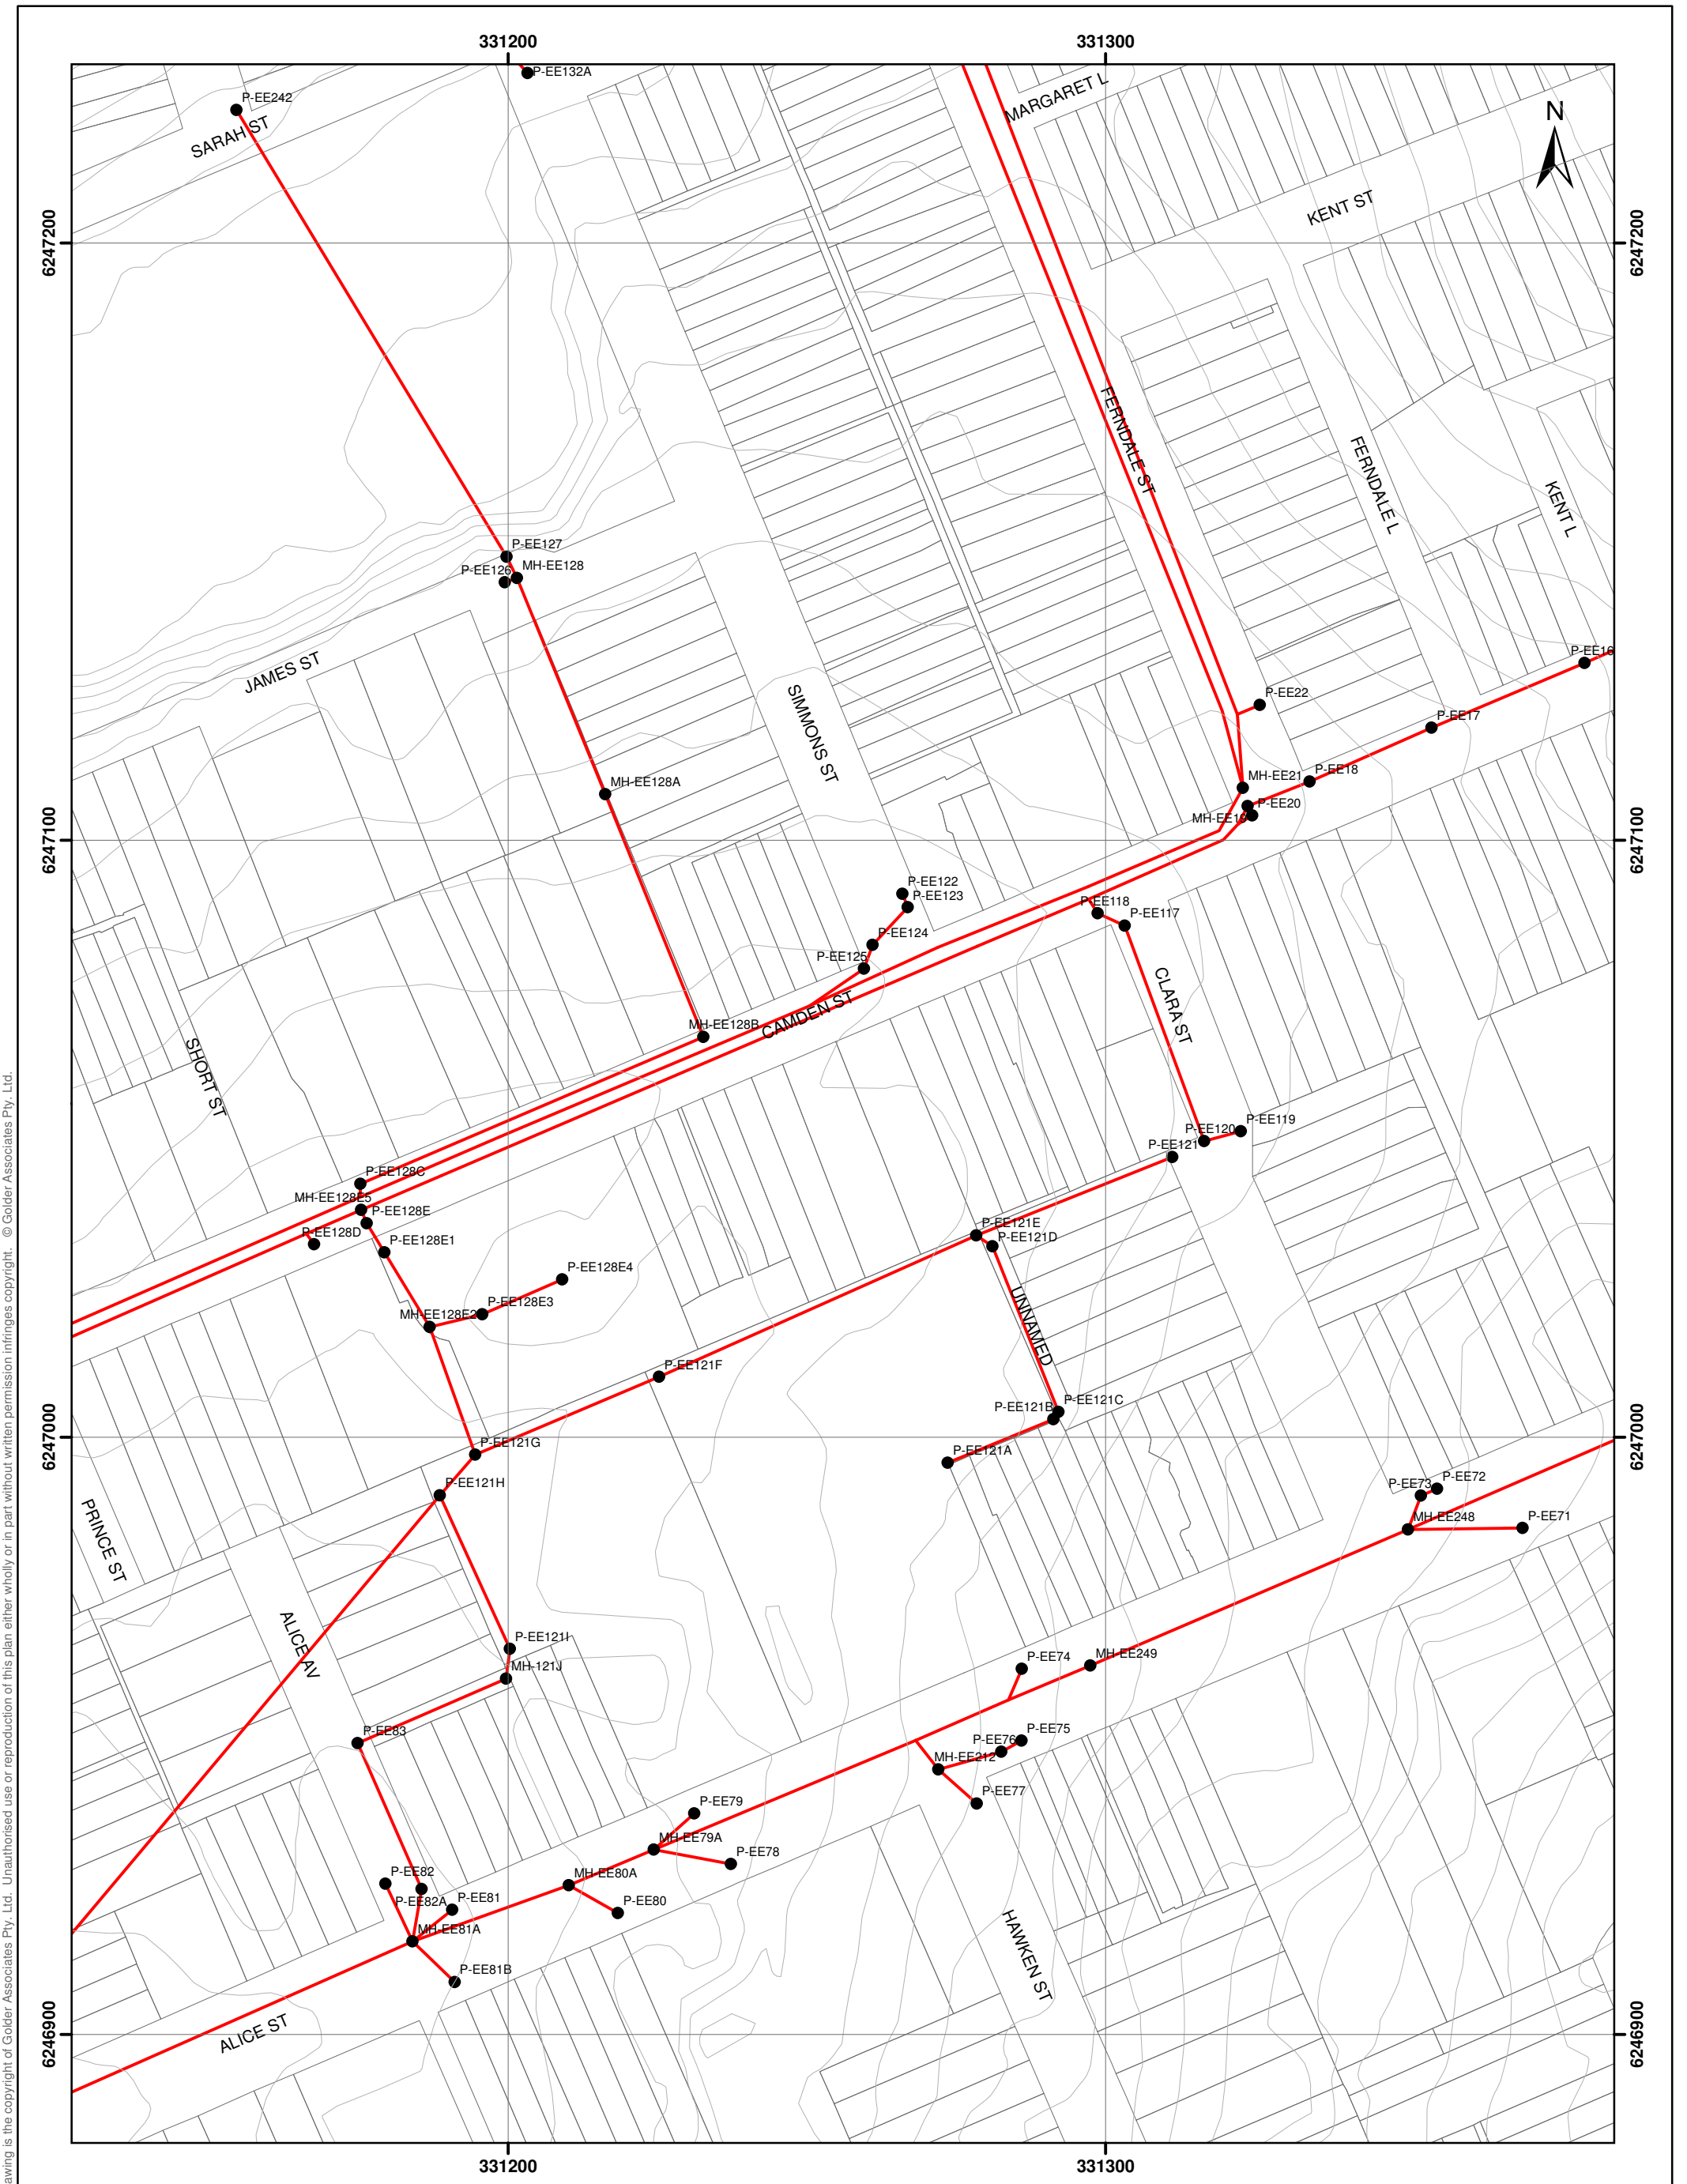
- Legend**
- ECE Catchment Boundary
 - Tuflow 1D Element Network
 - Tuflow 1D Element Network (pipes)

CLIENT Marrickville Council		PROJECT Eastern Channel East Flood Study	
DRAWN GSB	DATE 25-02-10	TITLE PIT/PIPE NETWORK	
CHECKED JRB	DATE 25-02-10	PROJECT No 097626003-008	
SCALE 1:1,000		FIGURE No A-5	REV No 0
		A3

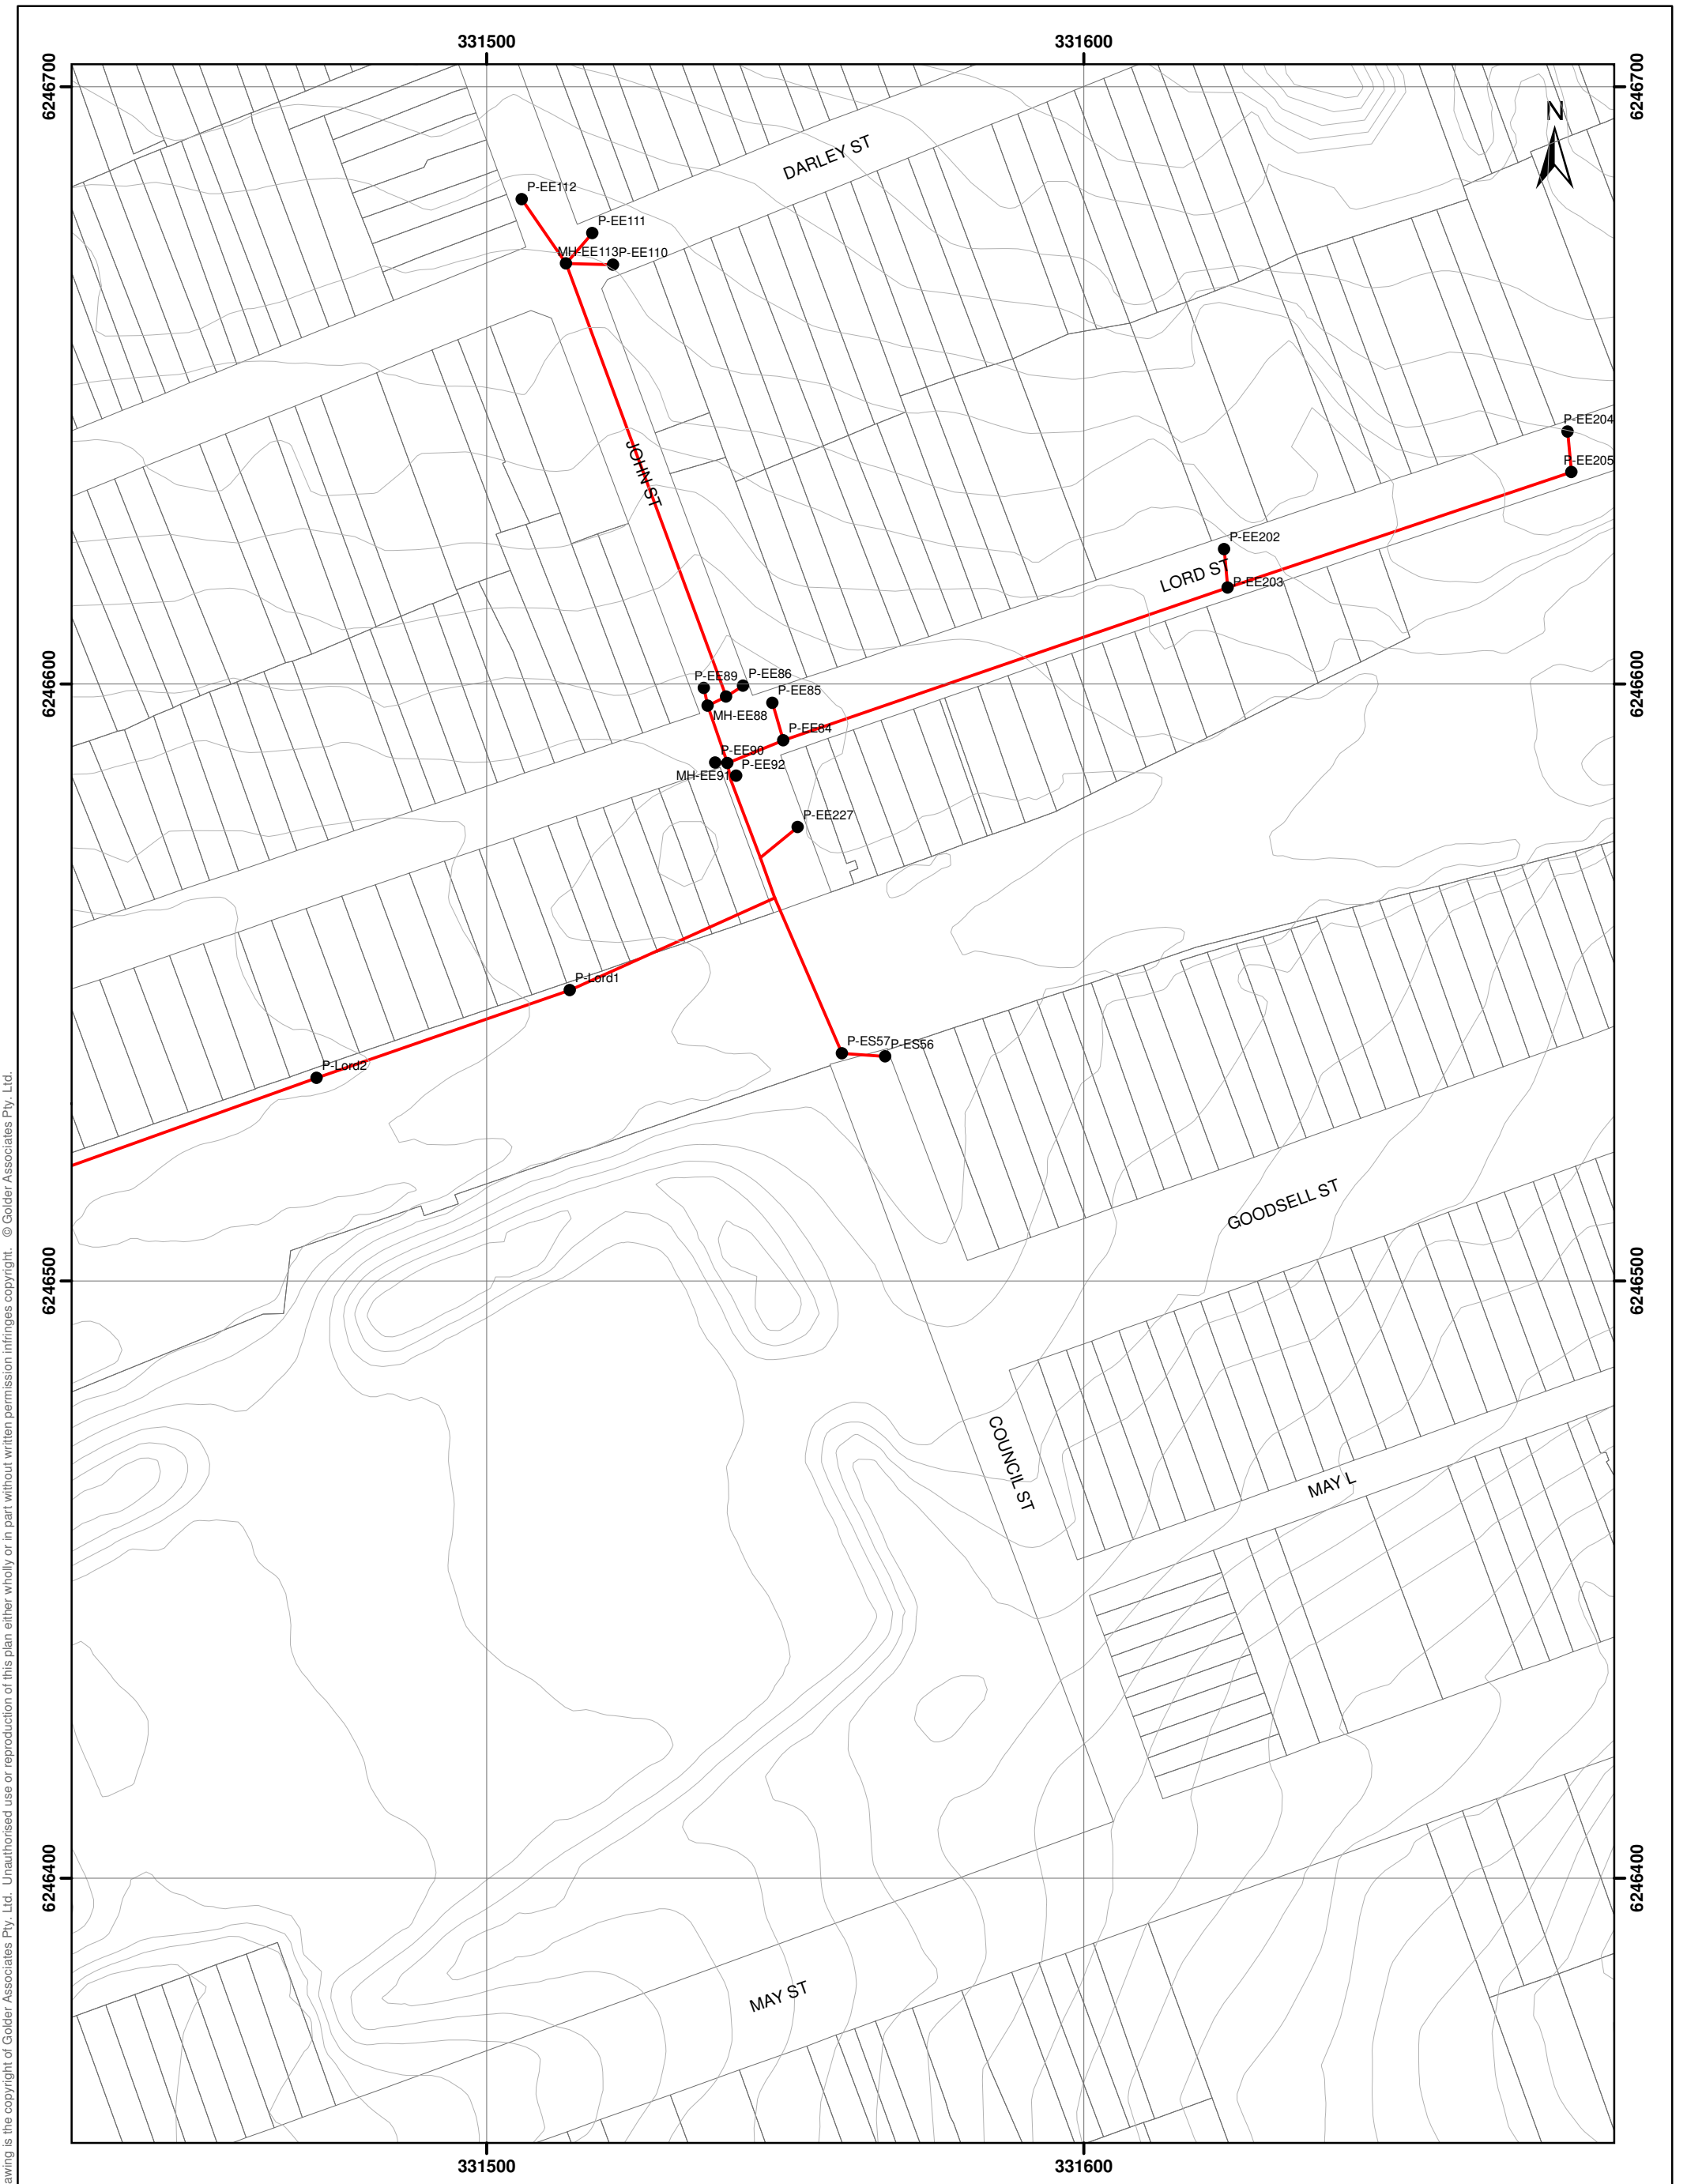
CLIENT Marrickville Council		PROJECT Eastern Channel East Flood Study	
DRAWN GSB	DATE 25-02-10	PIT/PIPE NETWORK	
CHECKED JRB	DATE 25-02-10		
SCALE 1:1,000		PROJECT No 097626003-008	FIGURE No A-7
		REV No 0	A3

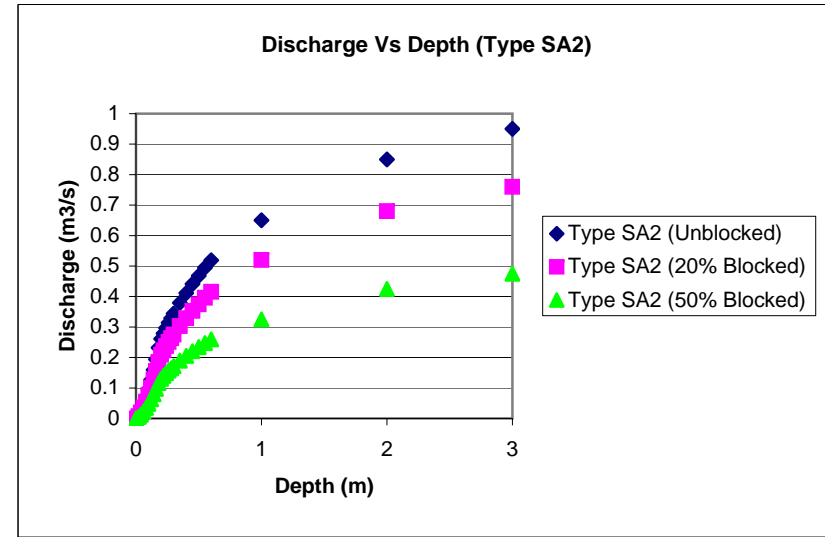
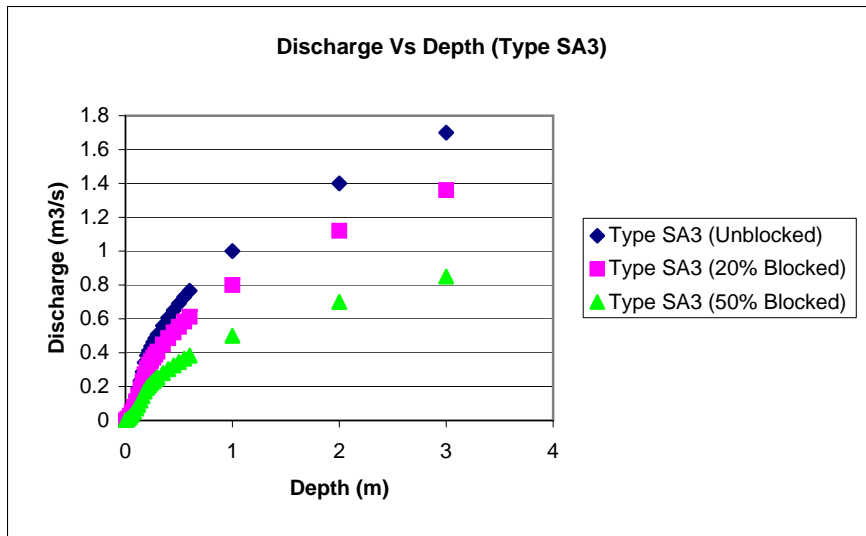
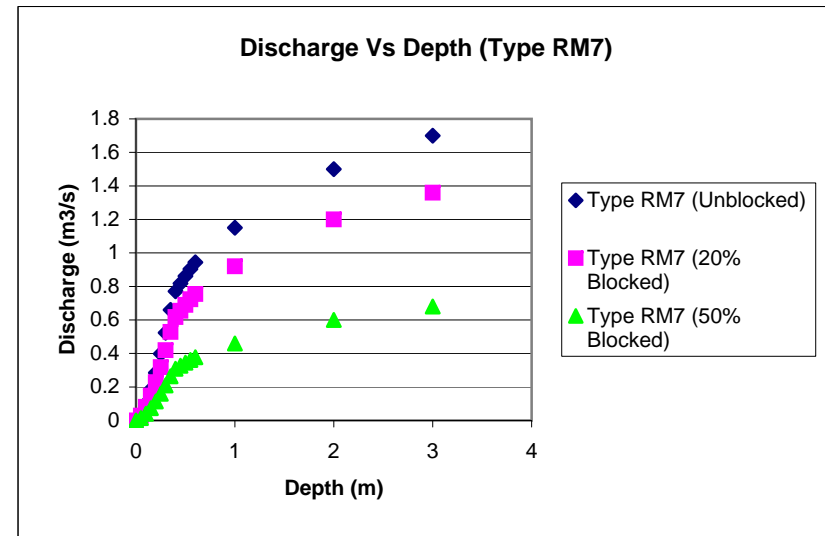
TUFLOW – Adopted Pit Hydraulic Characteristic Curves

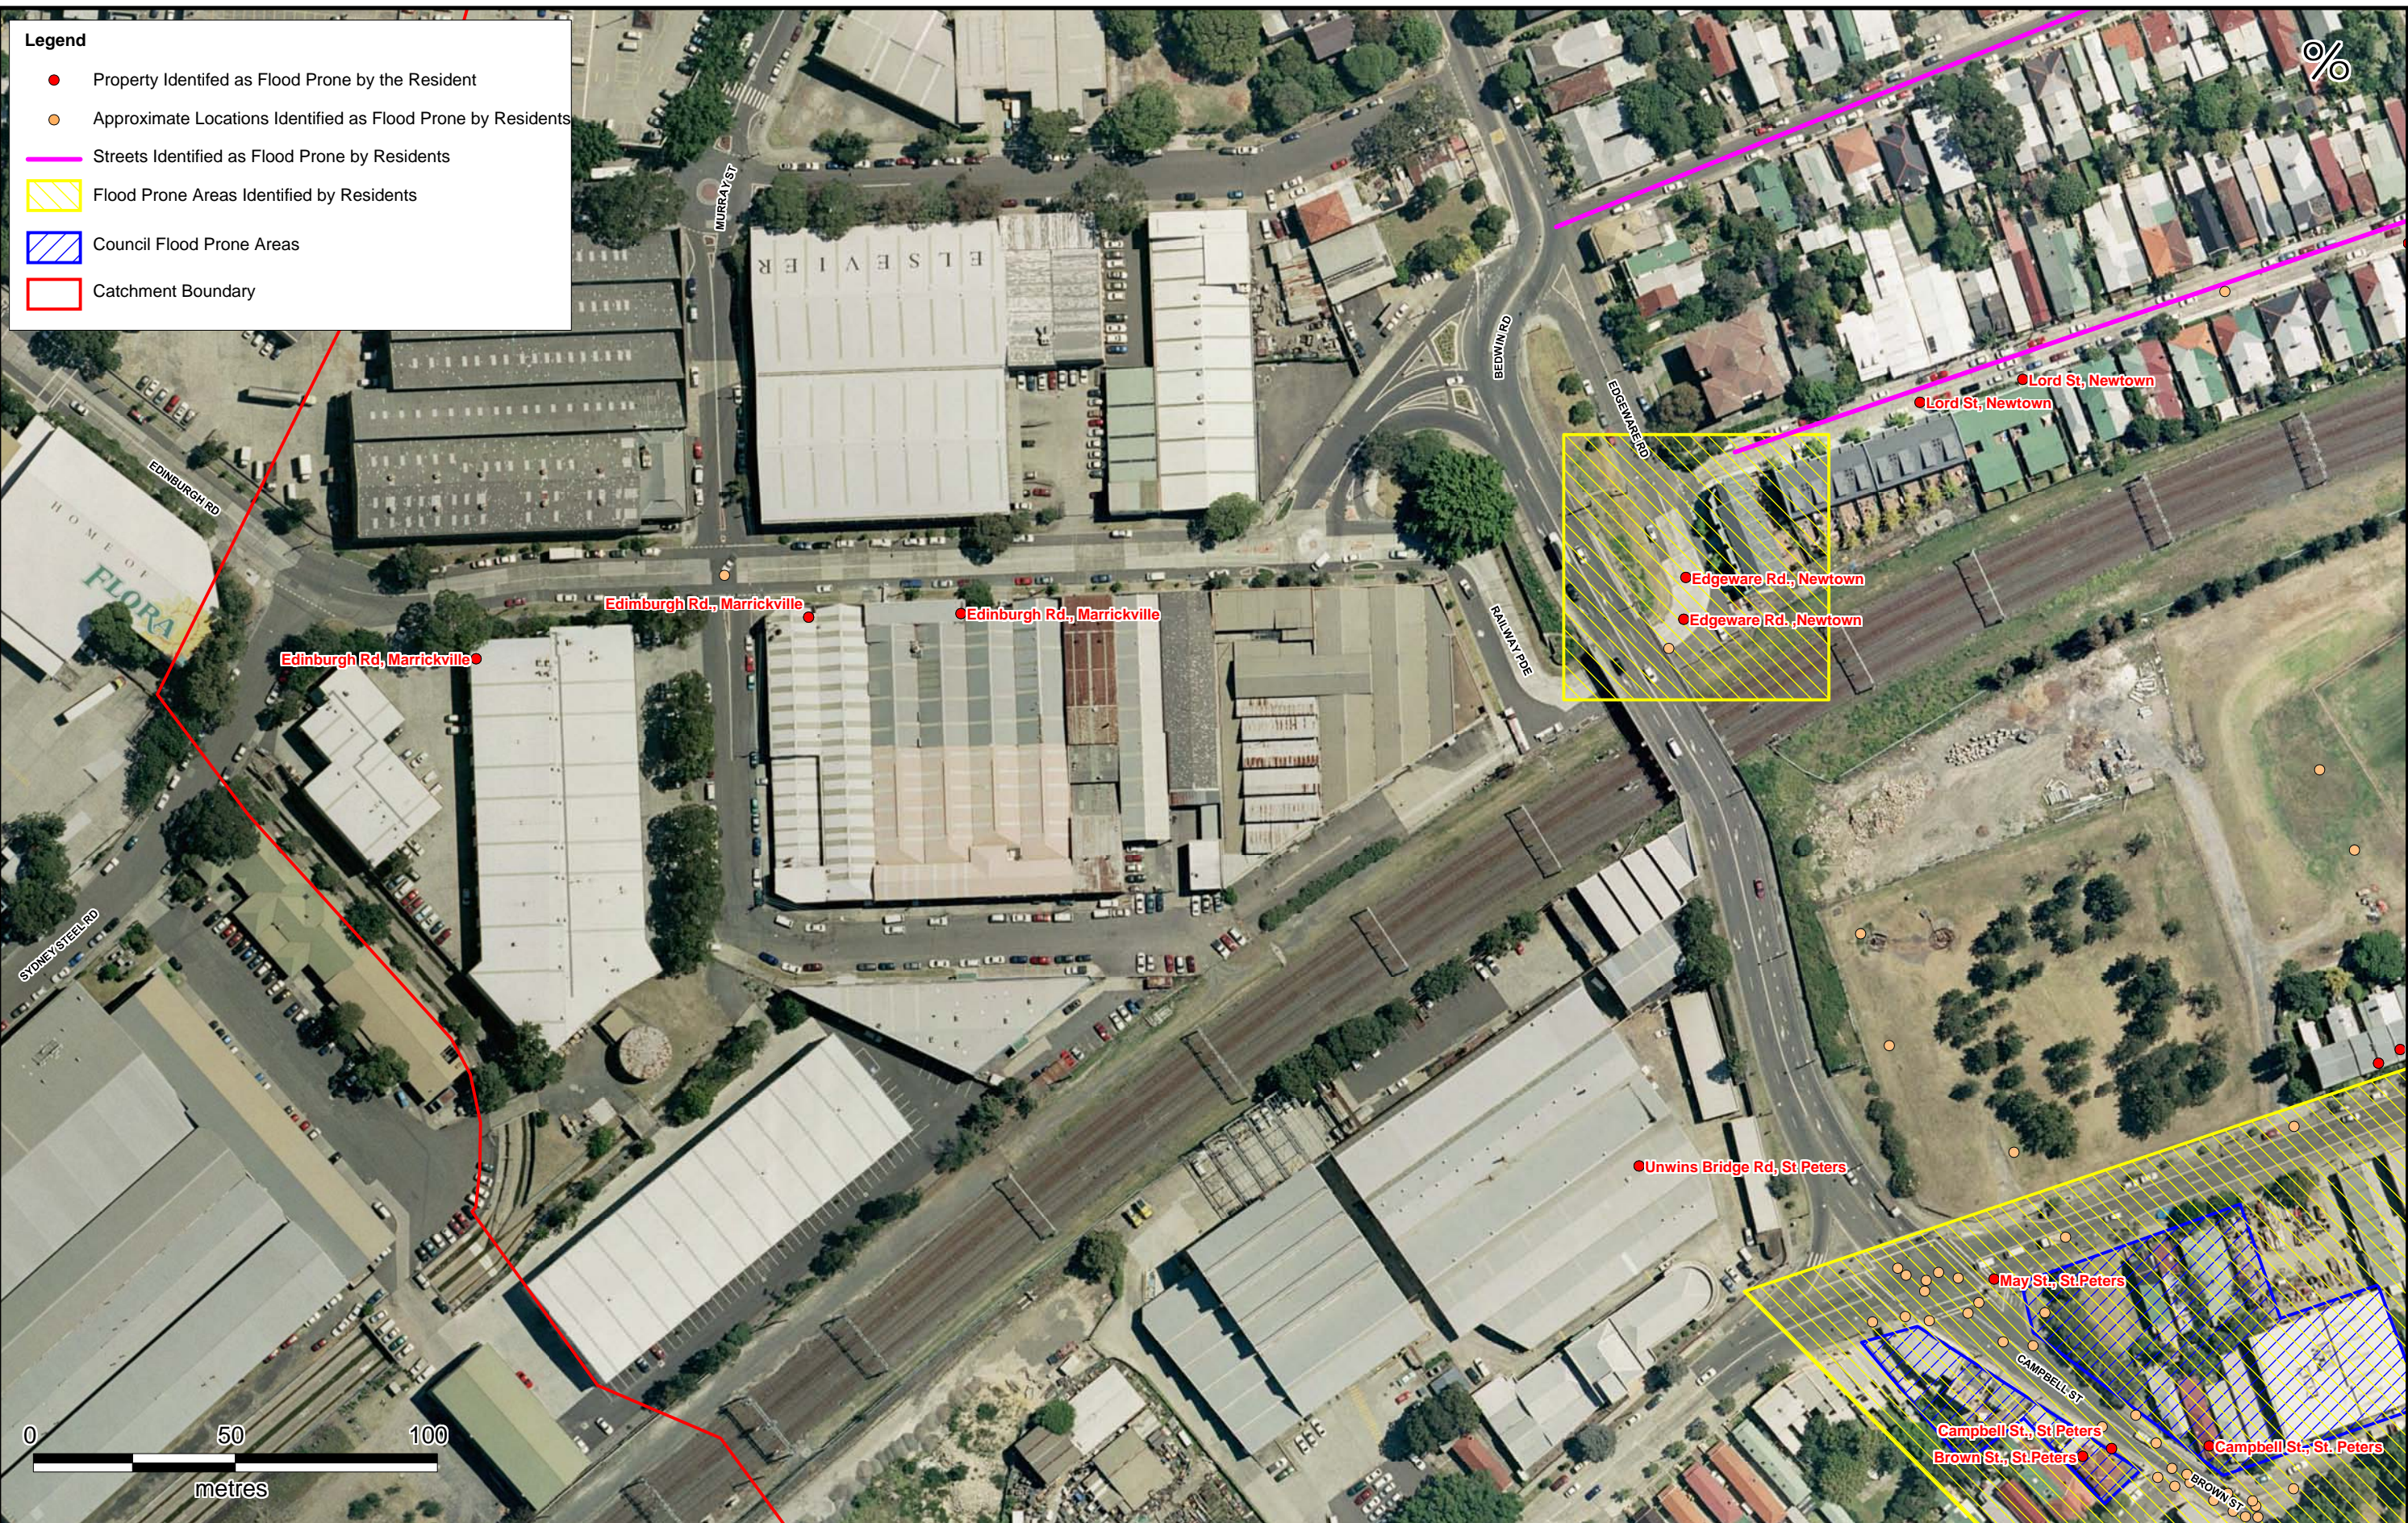
- Property Identified as Flood Prone by the Resident
- Approximate Locations Identified as Flood Prone by Residents
- Streets Identified as Flood Prone by Residents
- ▨ Flood Prone Areas Identified by Residents
- ▨ Council Flood Prone Areas
- ▭ Catchment Boundary

CLIENT MARRICKVILLE COUNCIL		PROJECT Results of Community Flood Study	
DRAWN AJW	DATE 9/06/2011	TITLE INDUSTRIAL AREA ON EDIMBURGH RD NEWTOWN	
CHECKED JRB	DATE 9/06/2011	PROJECT No 097626003	FIGURE No 5
SCALE 1:150		REV No 1	A3
