MARRICKVILLE COUNCIL

EC East Subcatchment Management Plan Volume 2 - Flood Study

Report Number. 097626003-008-Rev4-4000
(For Public Exhibition)

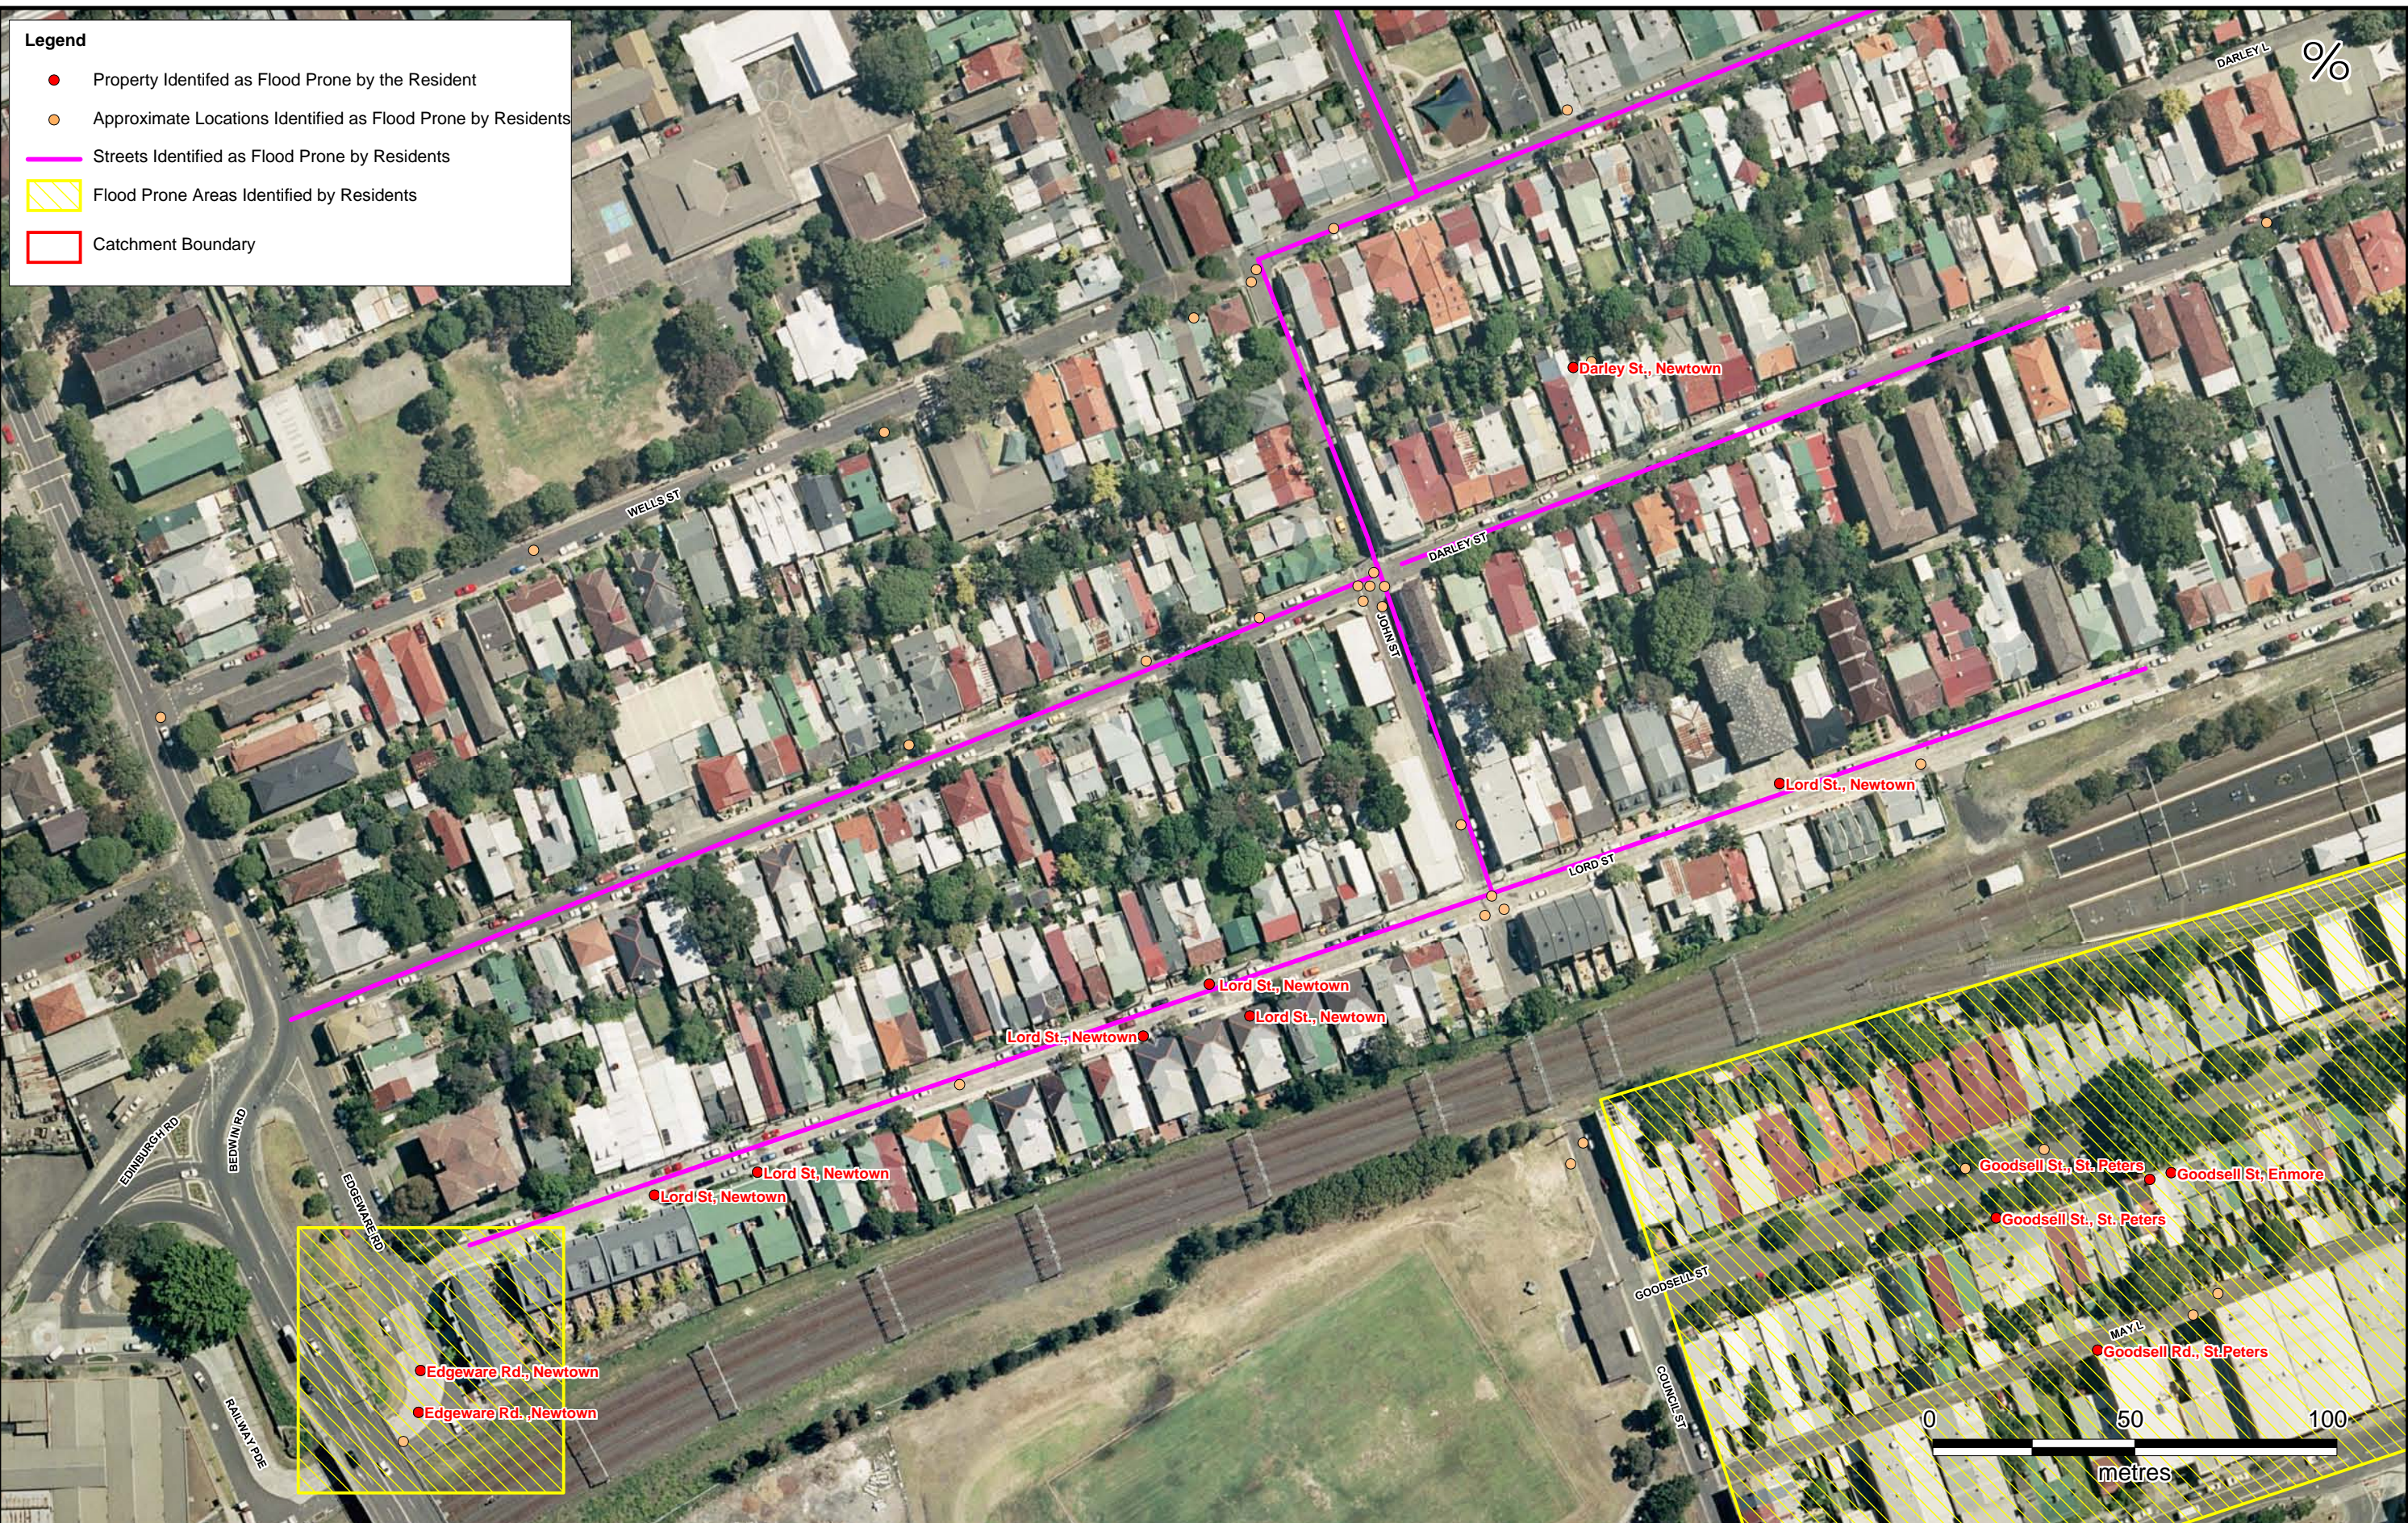
CLIENT MARRICKVILLE COUNCIL		PROJECT Results of Community Flood Study		
	DRAWN AJW	DATE 9/06/2011	TITLE LORD ST., EDGEWARE RD/LORD ST. INTERSECTION AND SURROUNDING AREA, NEWTOWN		
	CHECKED JRB	DATE 9/06/2011	PROJECT No 097626003	FIGURE No 6	REV No 1 A3
	SCALE 1:150

The area around Lord St., which includes Darley St., Wells St. and John St. that was identified to experience flooding by various residents, is shown in Figure 6. The following table outline the properties that have experienced flooding.

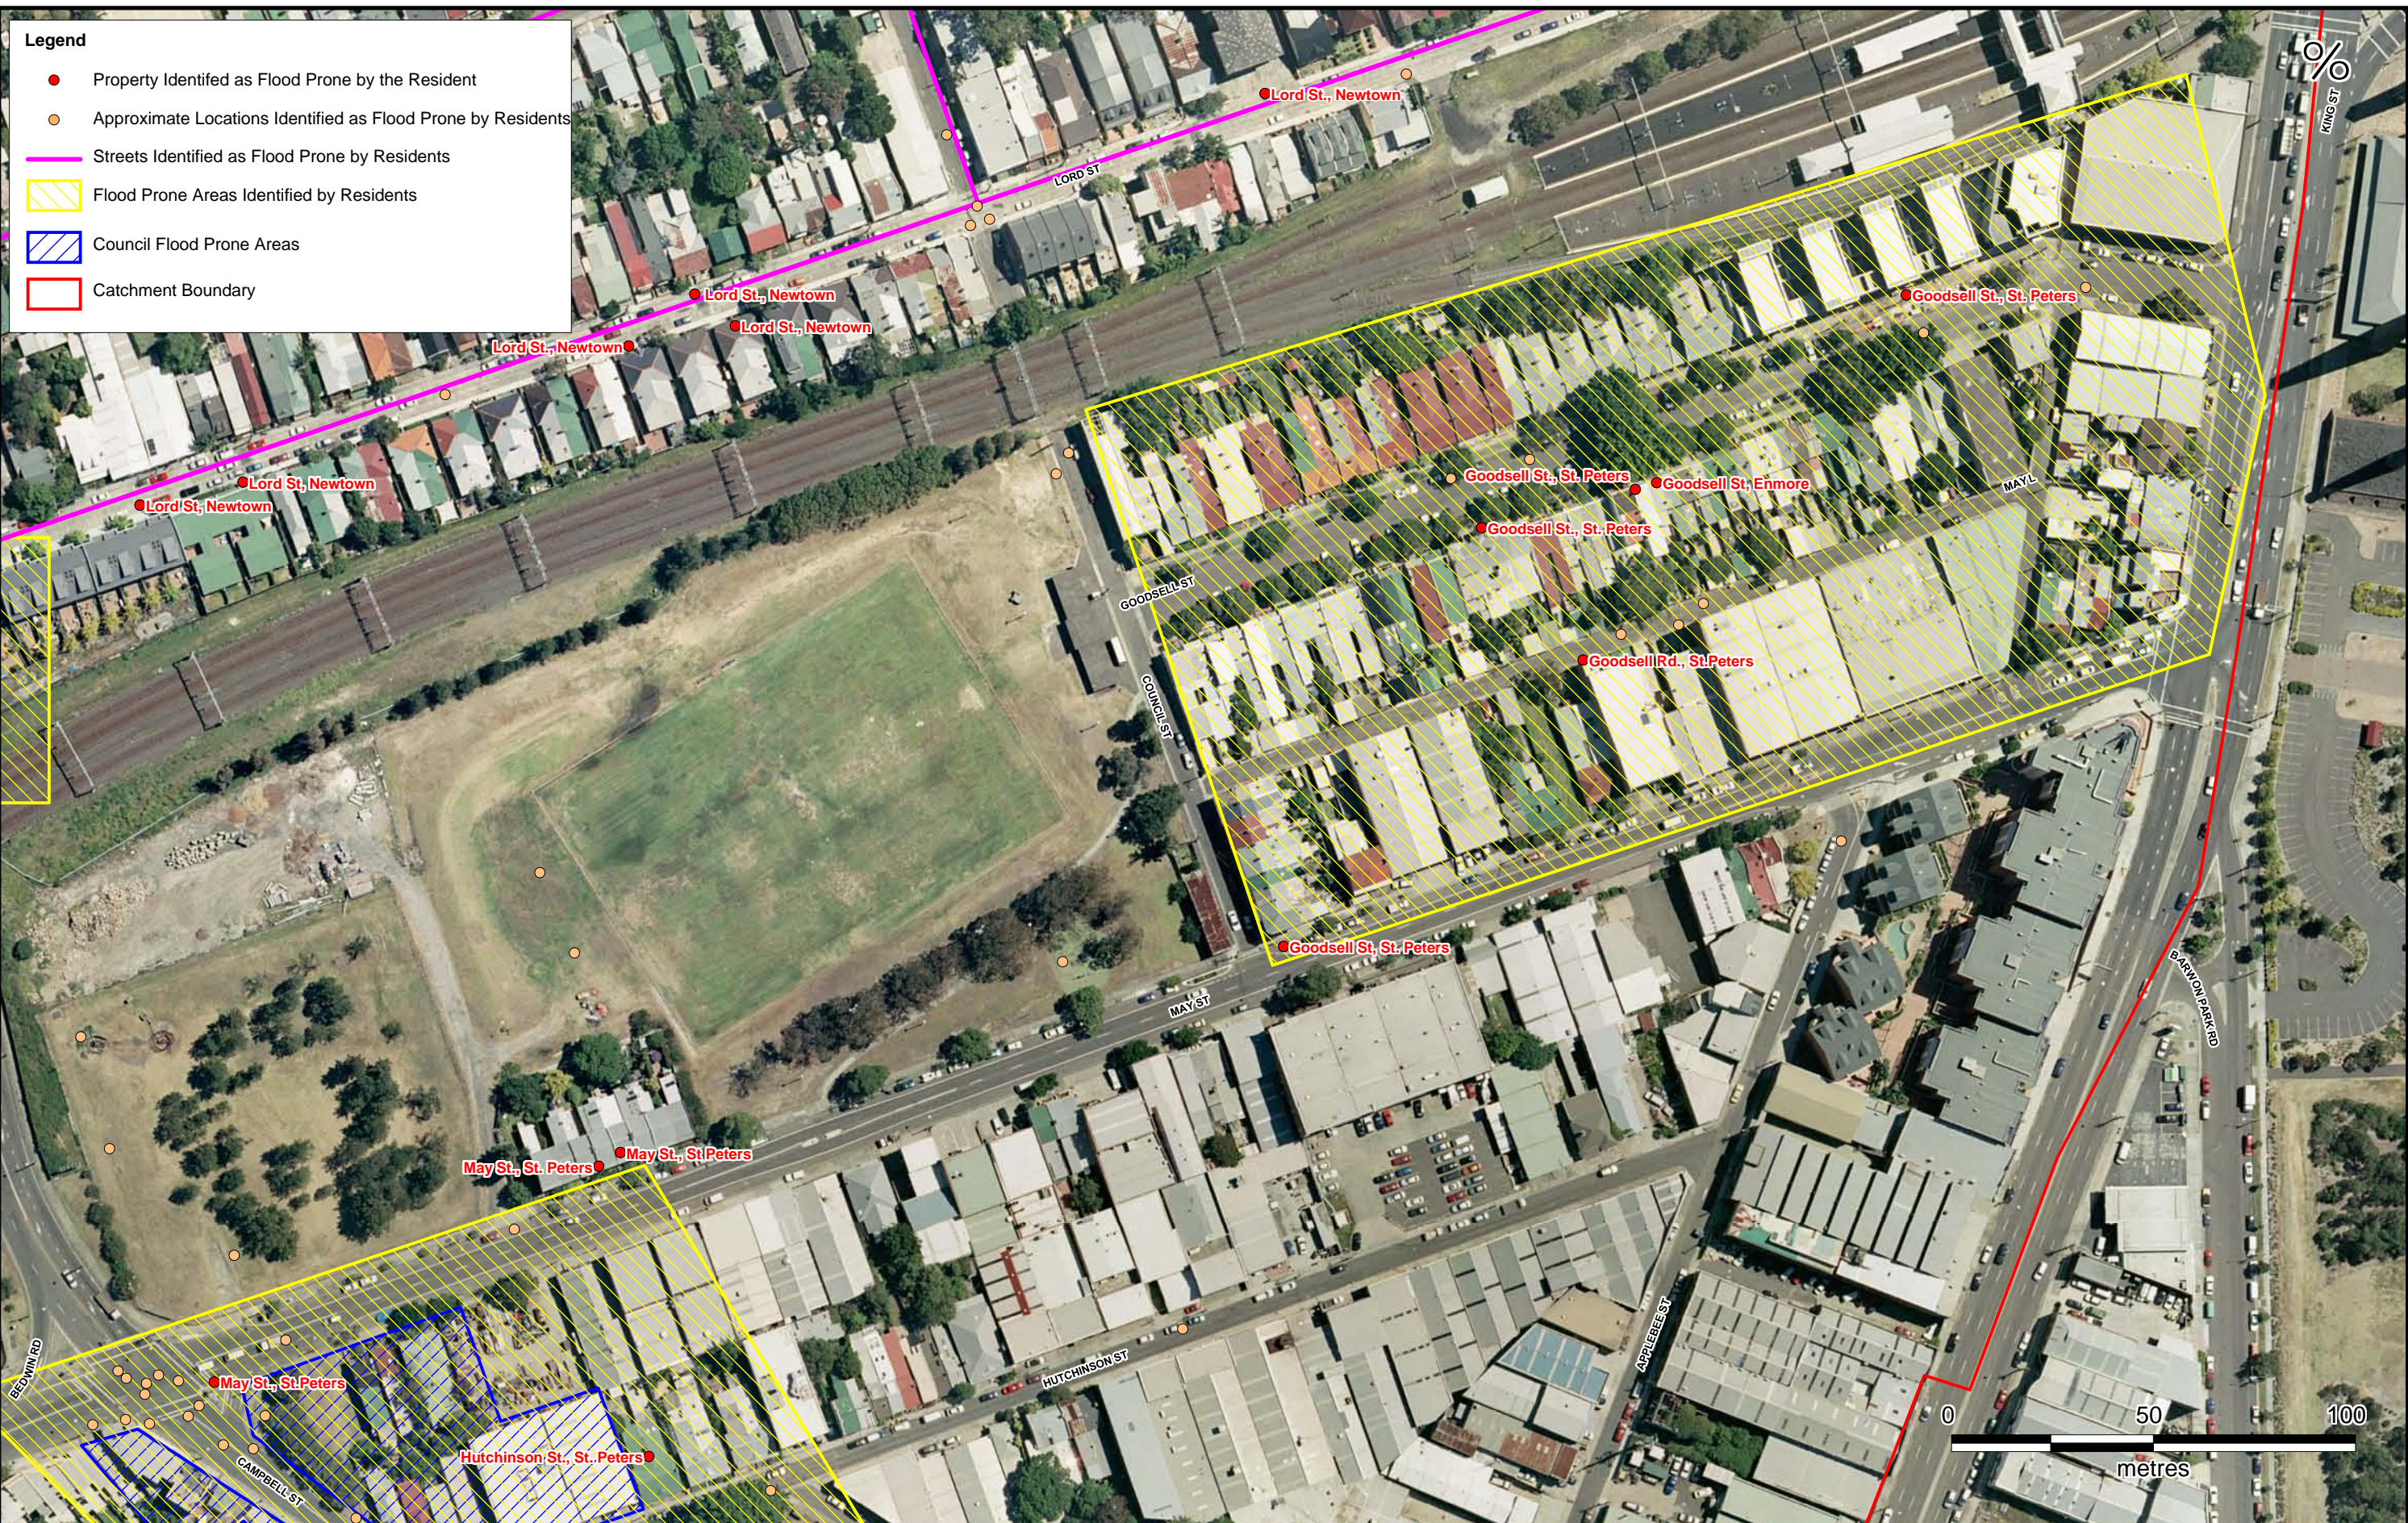
- Property Identified as Flood Prone by the Resident
- Approximate Locations Identified as Flood Prone by Residents
- Streets Identified as Flood Prone by Residents
- ▨ Flood Prone Areas Identified by Residents
- ▨ Council Flood Prone Areas
- ▭ Catchment Boundary
