THE TRUSTEE FOR MHA PBR ANNANDALE UNIT TRUST

Acid Sulfate Soil Management Plan

122-128 & 130 Pyrmont Bridge Road and 206
Parramatta Road, Annandale NSW

E25196.E14_Rev0
16 June 2021

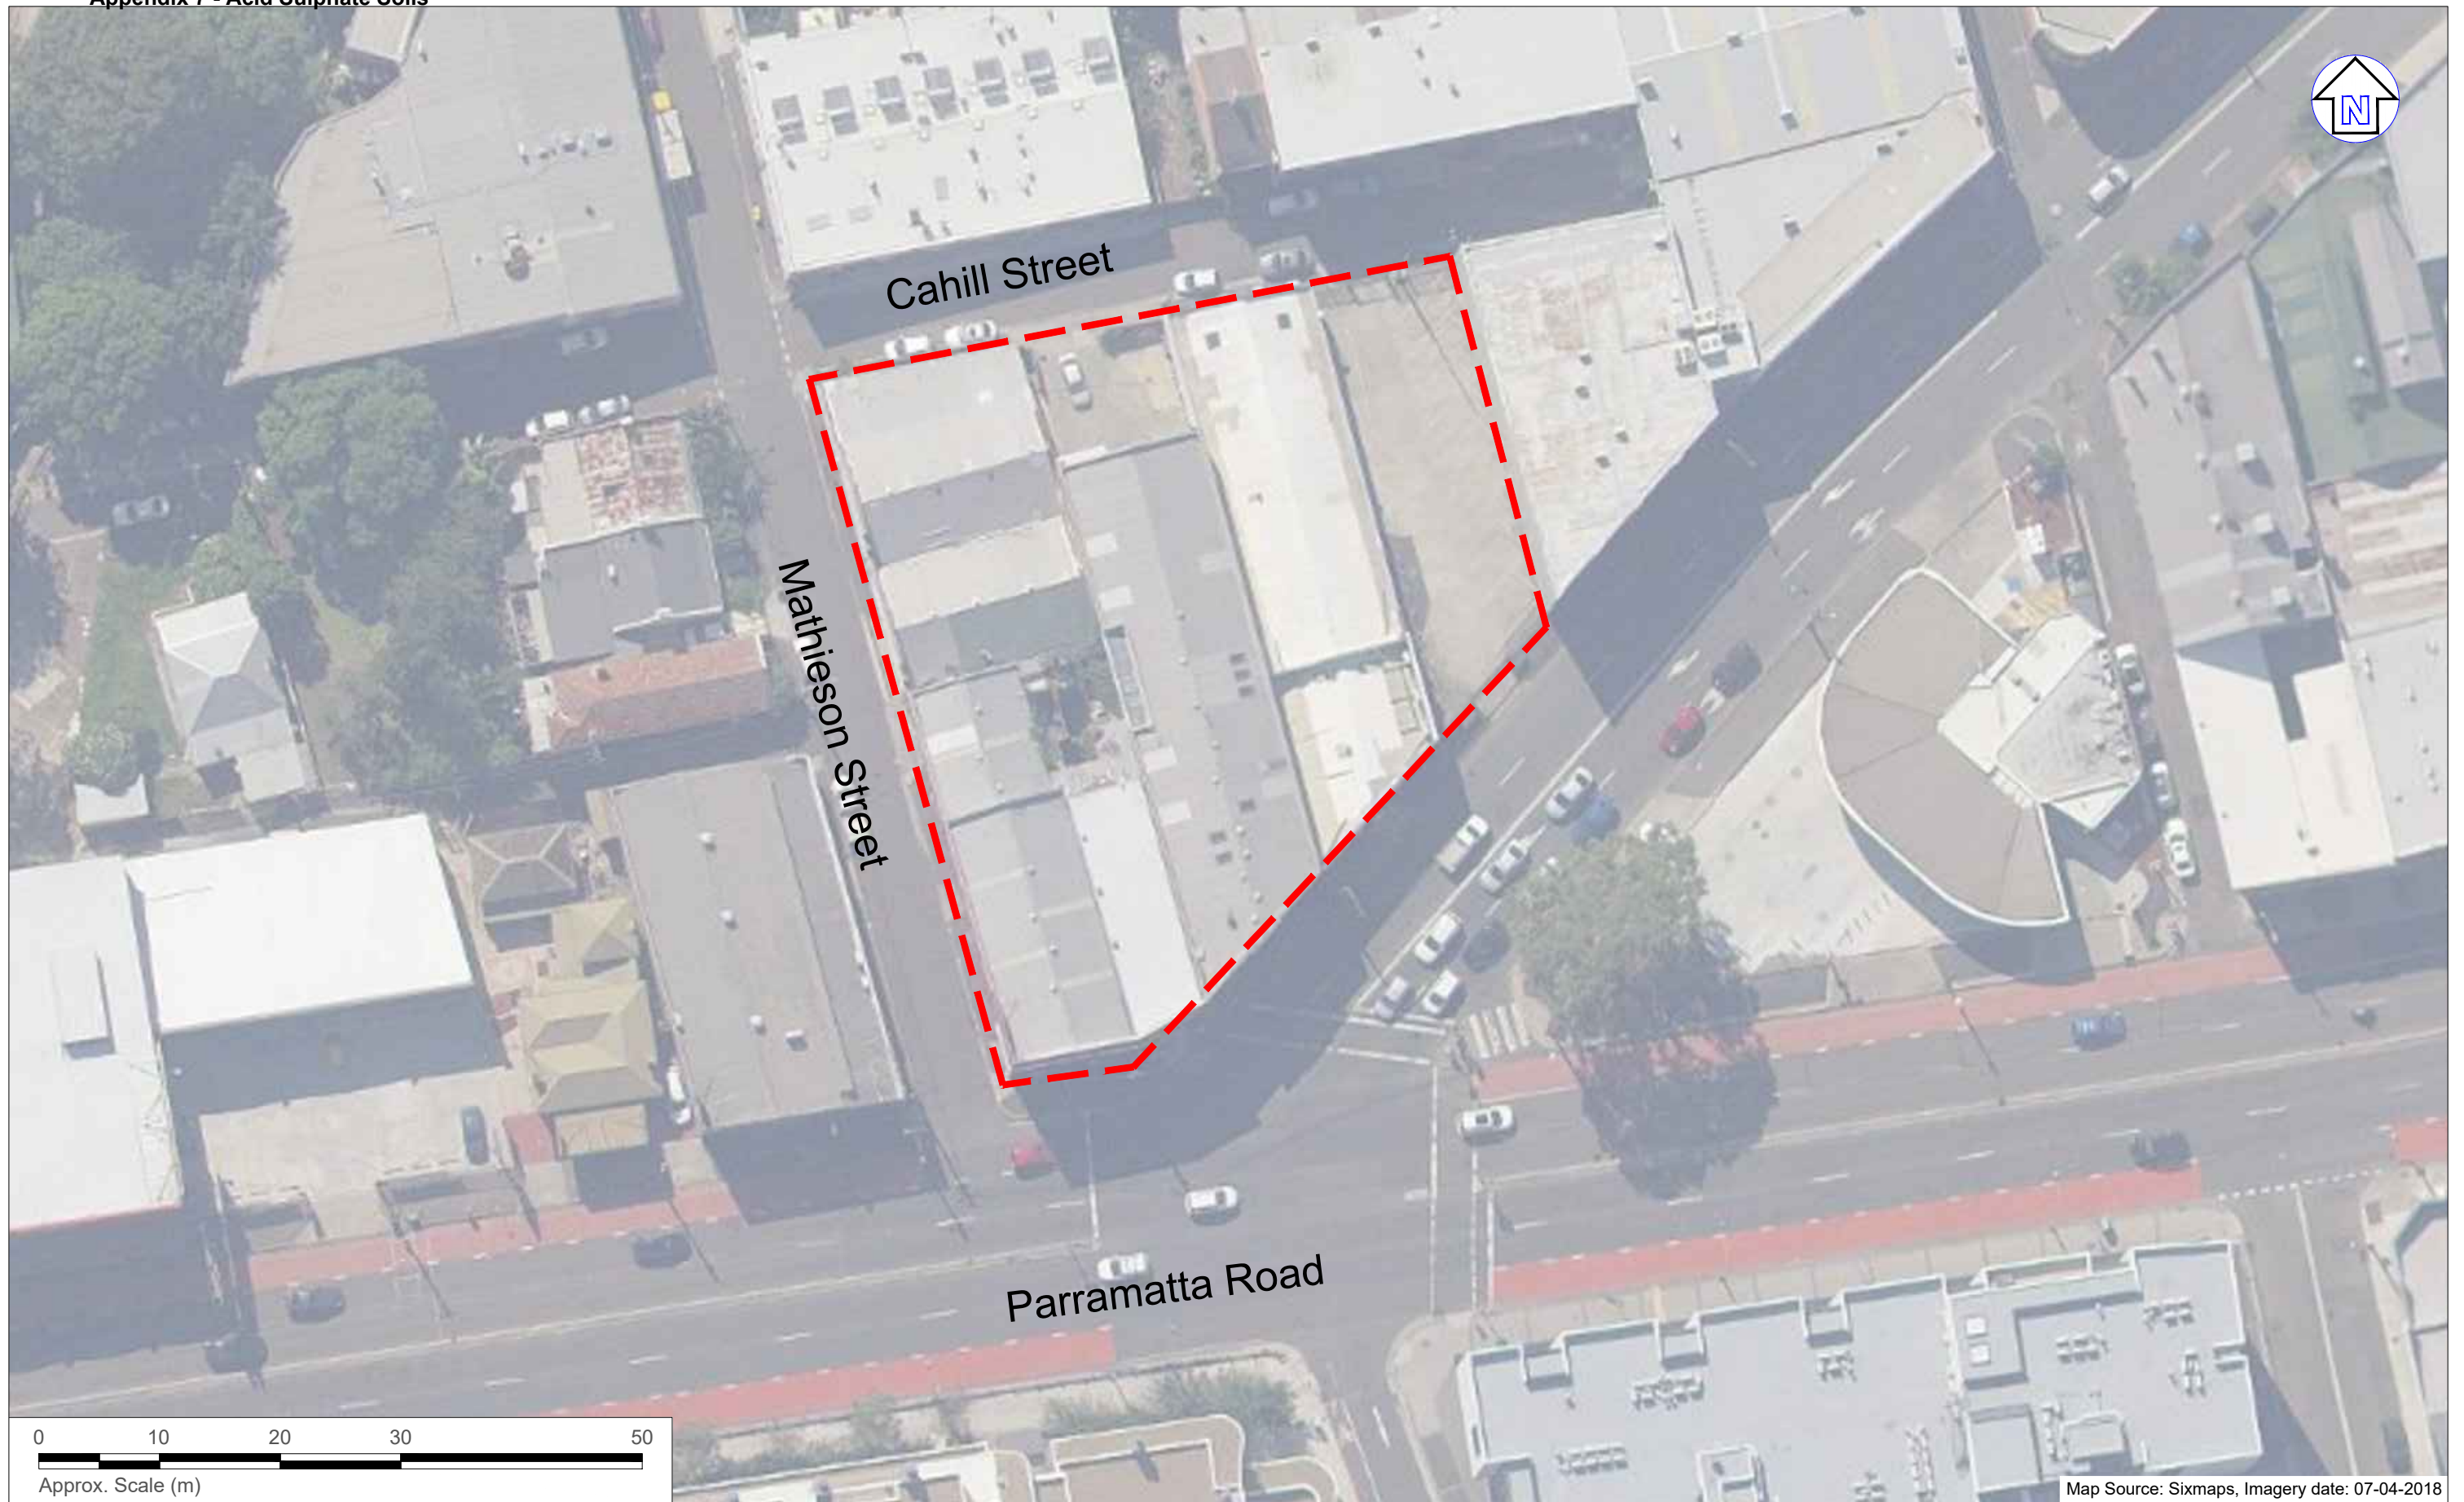
--- Approximate site boundary

As shown in **Figure 1** and **Figure 2**, the site covers an area of 2,623 m² and is located about 4 km south-west of the Sydney central business district, within the Local Government Area of the Inner West Council. The site is further identified as Lot 1 in DP 539271, Lot 100 DP1101482, Lots 3/1, 4/1, 5/1, 6/1 and 12 in DP 976387.

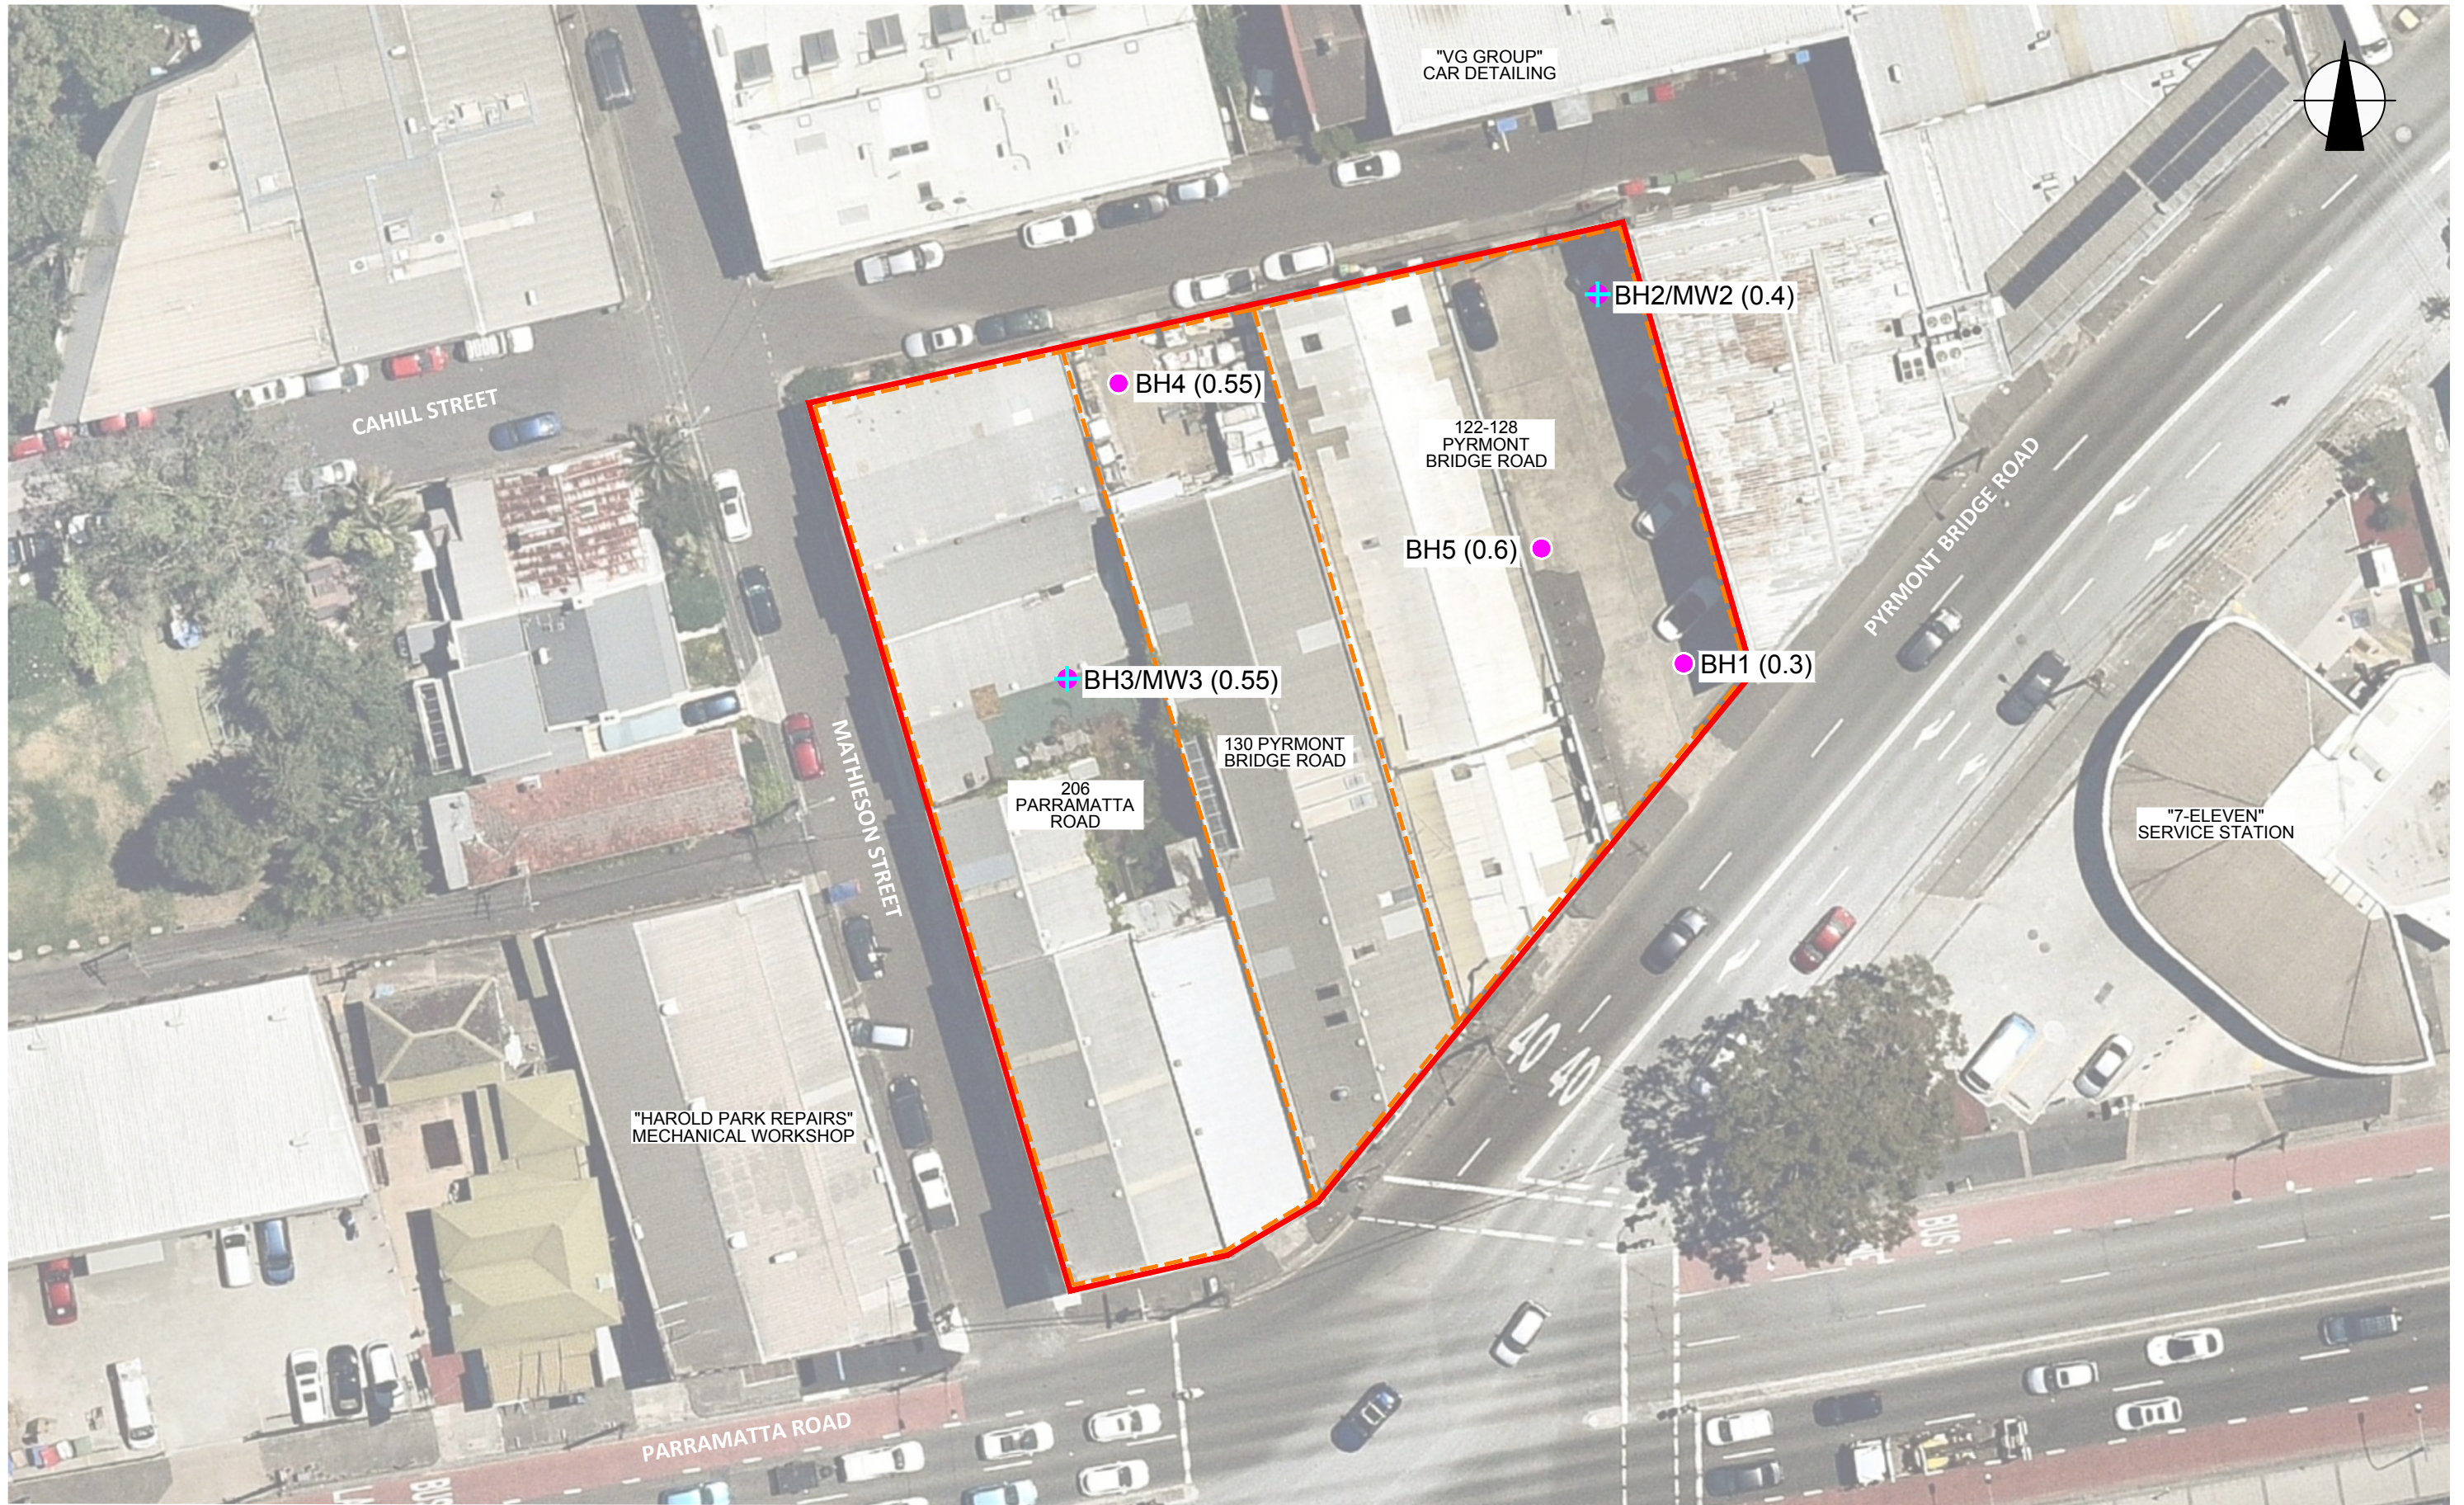
LEGEND	
	APPROXIMATE SITE BOUNDARY
	APPROXIMATE COMPRISING PROPERTY BOUNDARIES
	BH(Fill Depth) BOREHOLE LOCATION, NUMBER AND DEPTH OF FILL (m)
	BH/MW(Fill Depth) BOREHOLE AND GROUNDWATER MONITORING WELL LOCATION, NUMBER AND DEPTH OF FILL (m)

MHA PBR Pty Ltd ('the client') commissioned JK Environments (JKE) to undertake a Limited Environmental and Hazardous Materials Assessment at 122-130 Pyrmont Bridge Road and 206 Parramatta Road, Annandale, NSW ('the site'). The purpose of this assessment is to make a preliminary evaluation of site contamination and to assess the potential for hazardous building materials to be present onsite for due diligence purposes, prior to acquisition. The site location is shown on Figure 1 and the investigation was confined to the site boundaries as shown on Figure 2.
