# Hazardous Building Materials Register and Asbestos Management Plan

**Ashfield Council**

**Ashfield Park  
Parramatta Road  
ASHFIELD NSW 2131**

**Report Number: 9206.18.HMSR**

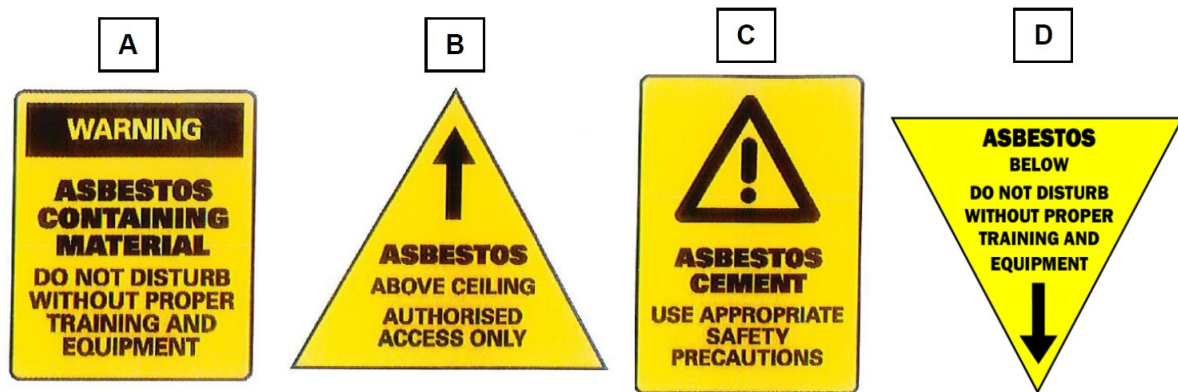
All Labels are to comply with Australian Standards AS1216 and AS1319. Examples of Labels are provided below:

The approximate dimensions of each label seen above will be as per follows:

- A: Height 72mm, Width 60mm;
- B: Height 67mm, Width at widest point 75mm;
- C: Height 76mm, Width 54mm;
- D: Height 67mm, Width at widest point 75mm;
