Hazardous Building Materials Register and Asbestos Management Plan

**Allman Park
Corner of Norton and Victoria Streets
ASHFIELD NSW 2131**

Report Number: 9206.13.HMSR

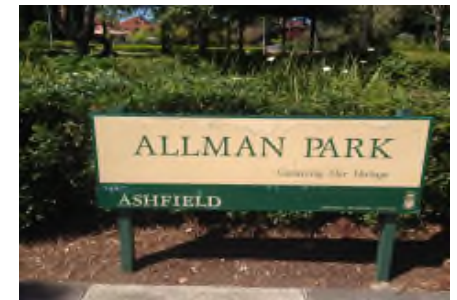
Asset Photo

ID	Location	Material Type	Sample No.	Analysis Result	Extent	Condition	Friability	Disturbance Potential	Risk Status	Re-inspect Date	Control Priority	Control Recommendation	Removed	Photos
Grounds														
1	Beams and poles to structures Throughout - Green paint	Paint	9206.13/LPST05	Negative Lead in Paint <1.0%	-	-	-	-	-	-	-	-	-	Photo 1
