Hazardous Building Materials Register and Asbestos Management Plan

Ashfield Council

**S.H.A.R.E. Children's Activities Centre
135 Smith street
SUMMER HILL NSW 2130**

Report Number: 9206.16.HMSR

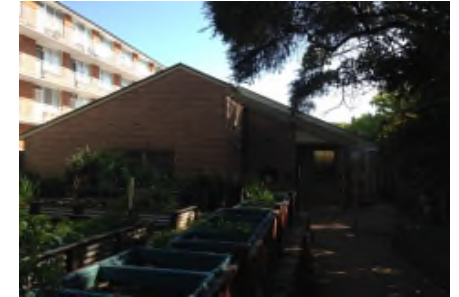
Asset Photo

ID	Location	Material Type	Sample No.	Analysis Result	Extent	Condition	Friability	Disturbance Potential	Risk Status	Re-inspect Date	Control Priority	Control Recommendation	Removed	Photos
Exterior														
1	Northern wall Beige paint and undercoats	Paint	9206.16/ LP01	Negative Lead in Paint <1.0%	-	-	-	-	-	-	-	-	-	Photo 1
